# Milestone Inspection Report

**Project # 22RS-1258**  
**March 4, 2024**  
**FINAL COPY**

**Project:**  
*Bahia Mar Apartments, Inc.*

**Address:**  
*1100 Tarpon Center Drive*  
*Venice, FL 34285*

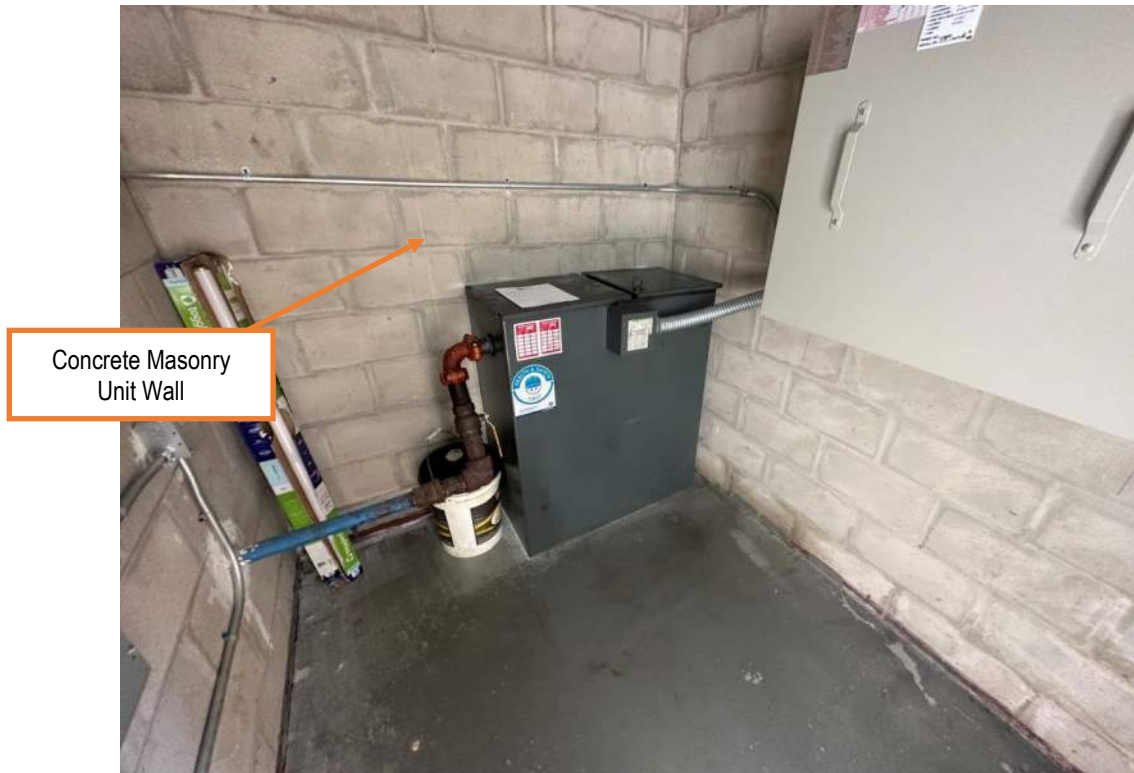
Figure 5: Elevator Machine Room

Concrete Masonry  
Unit Wall

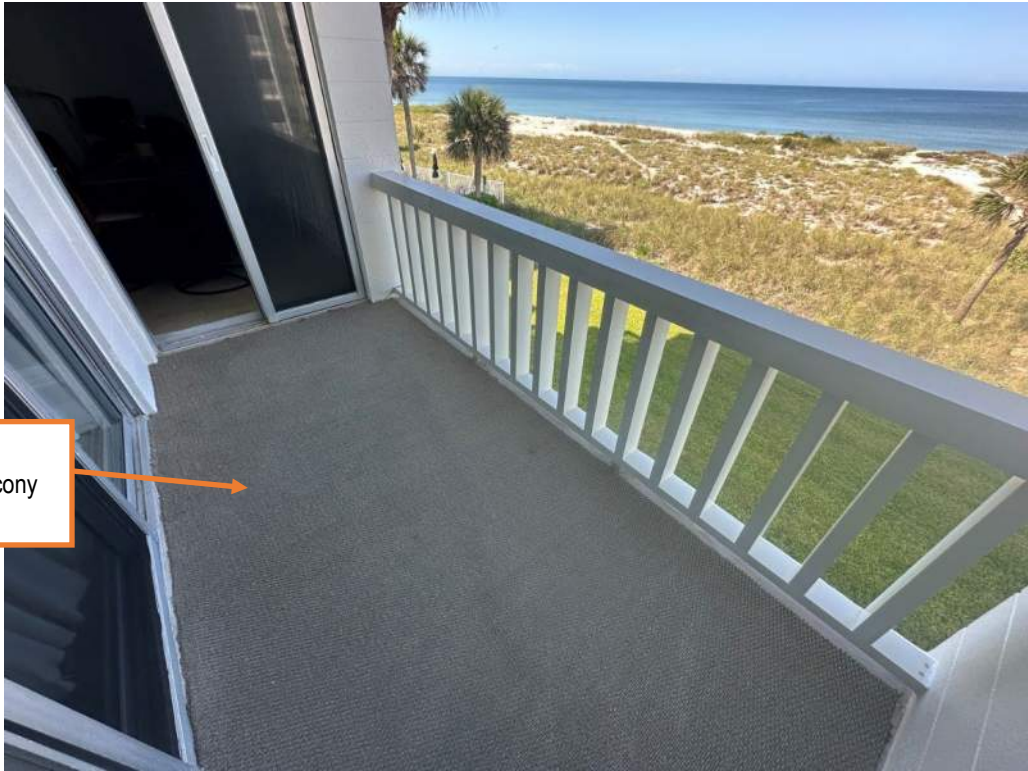
Figure 7: Unit 401

Typical Non-Cantilevered Balcony Slab

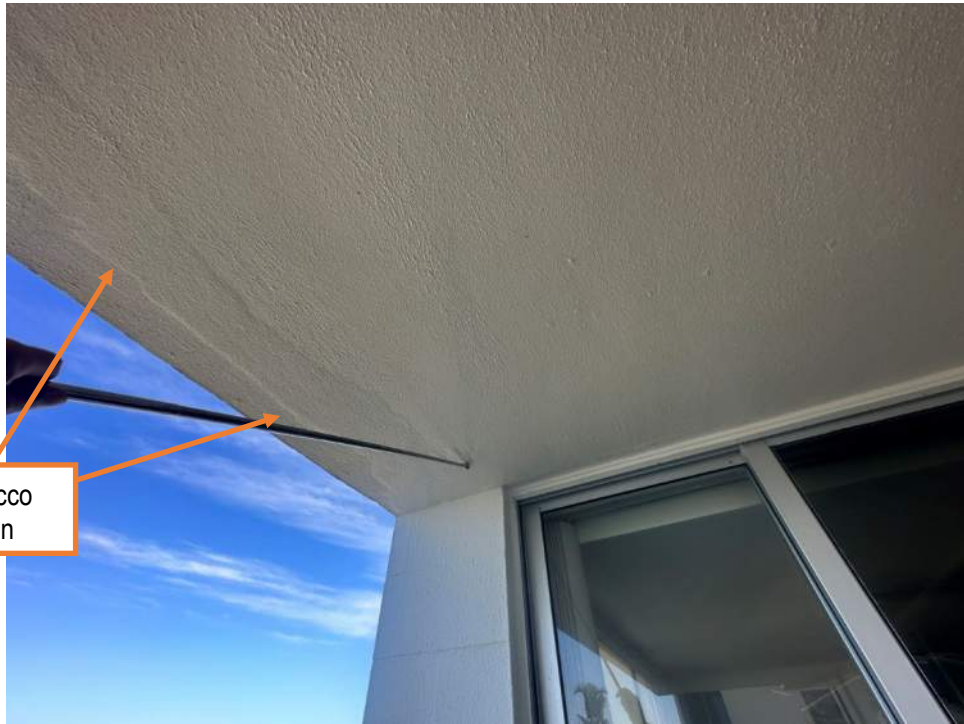
**Figure 4: Unit 401**

Apparent Stucco  
Delamination

- Important and Urgent
  - N/A
- Important and Not Urgent
  - Repair Cracks and Delamination in Stucco
  - Repair deteriorated post pockets
- Not Important and Urgent
  - N/A
- Not Important and Not Urgent
  - N/A

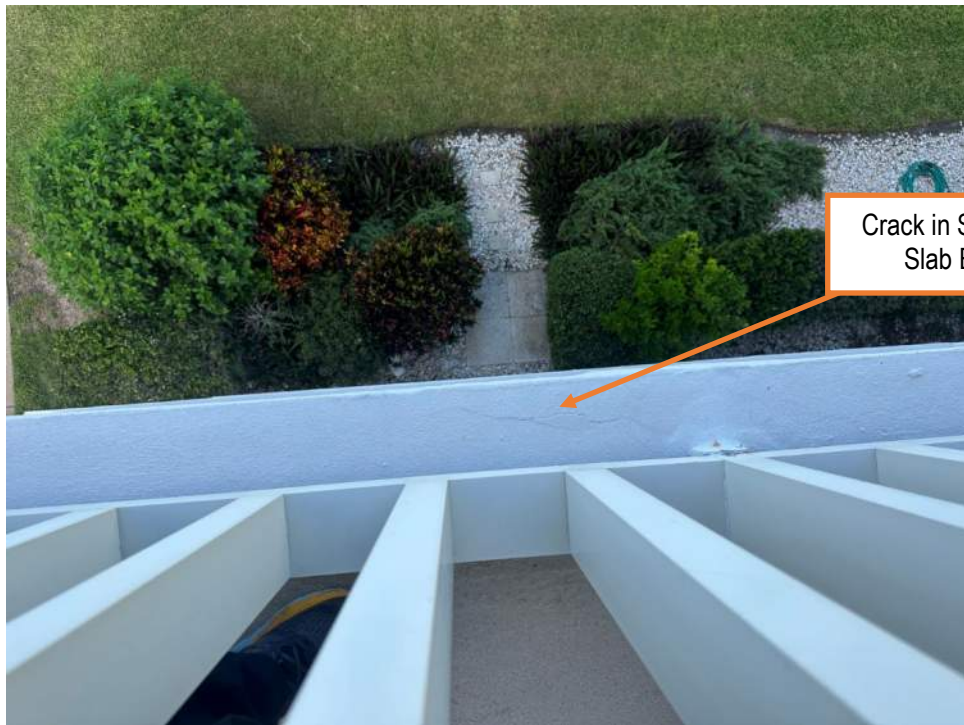
**Figure 5: Unit 401**

Crack in Stucco at  
Slab Edge

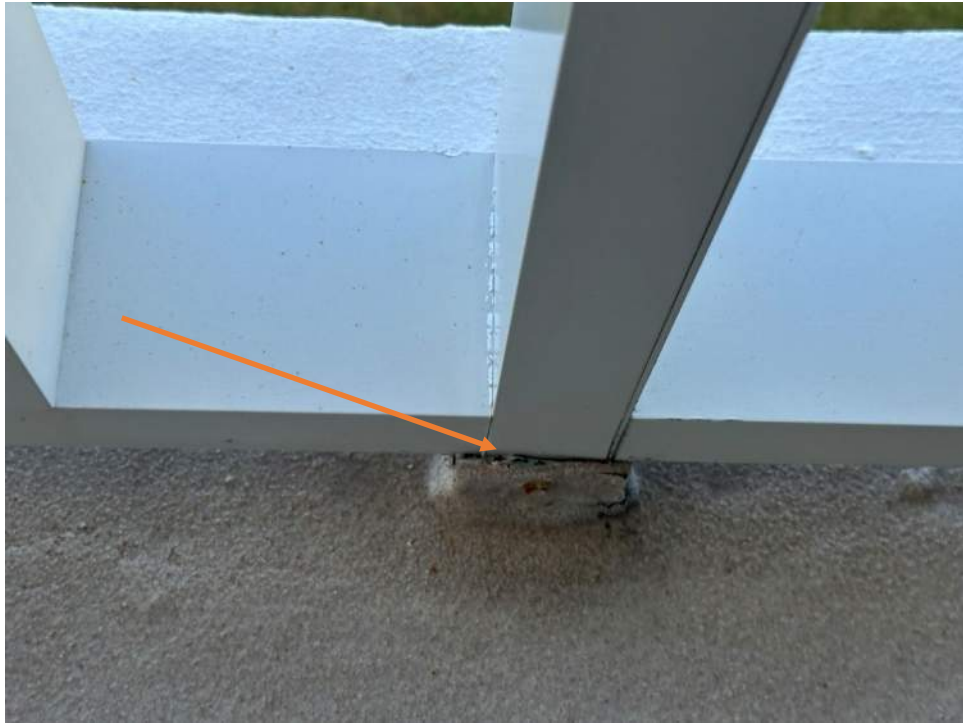
**Figure 11: Deterioration at Guardrail Post Connection**
