# Milestone Inspection Report

**Project #22RS-1191**  
**May 24, 2023**  
**FINAL COPY**

*Estuaries II  
Condominium Association, Inc.*

*Estuaries II*

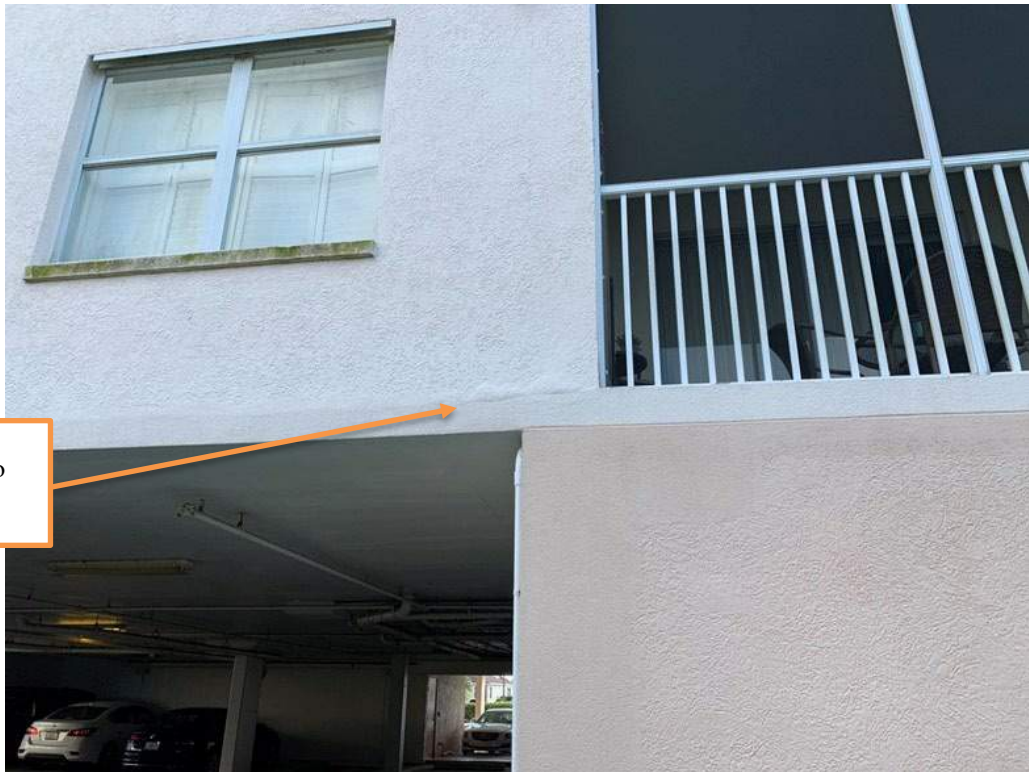
Figure 3: North side exterior, ground floor

Puckering of stucco  
near column

- Important and Urgent
  - N/A
- Important and Not Urgent
  - Investigate and facilitate repair of delamination or spalling at columns.
- Not Important and Urgent
  - All floor cracks to be sealed to prevent water intrusion and corrosion of reinforcement.
- Not Important and Not Urgent
  - All cracks in masonry to be periodically monitored for changes.

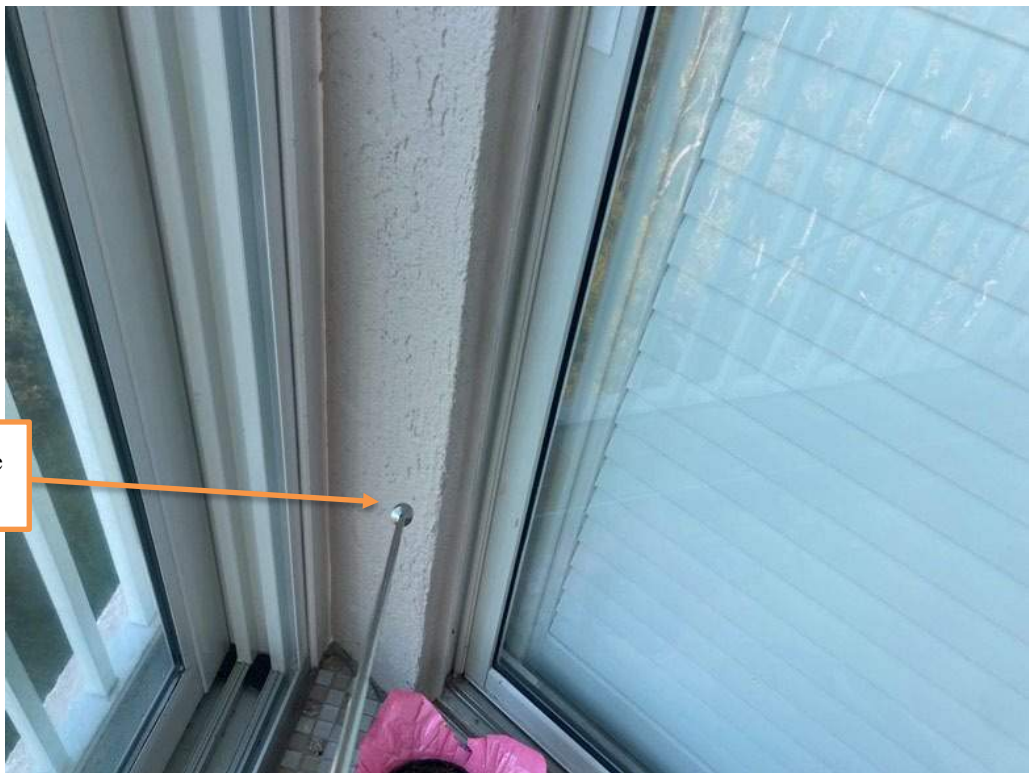
Figure 4: Unit 801 balcony.

Soundings indicate  
delamination

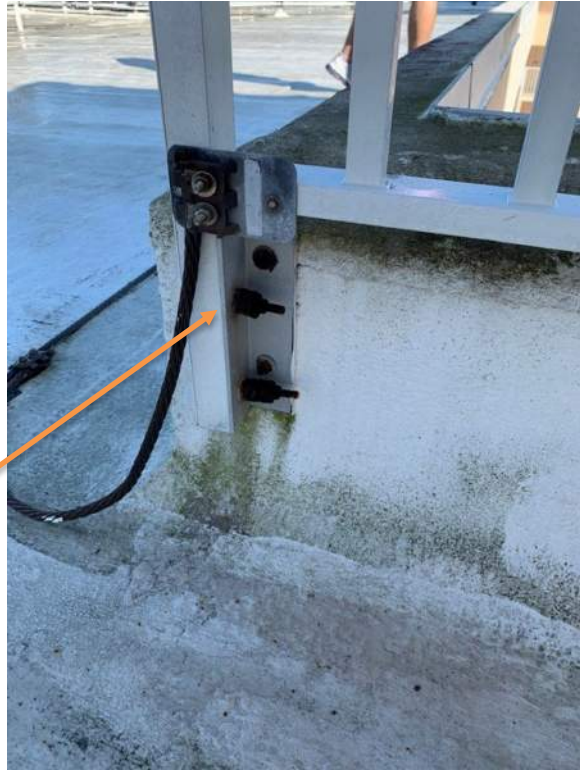
**Figure 2: Main Roof.**

Corroded fasteners and anchors

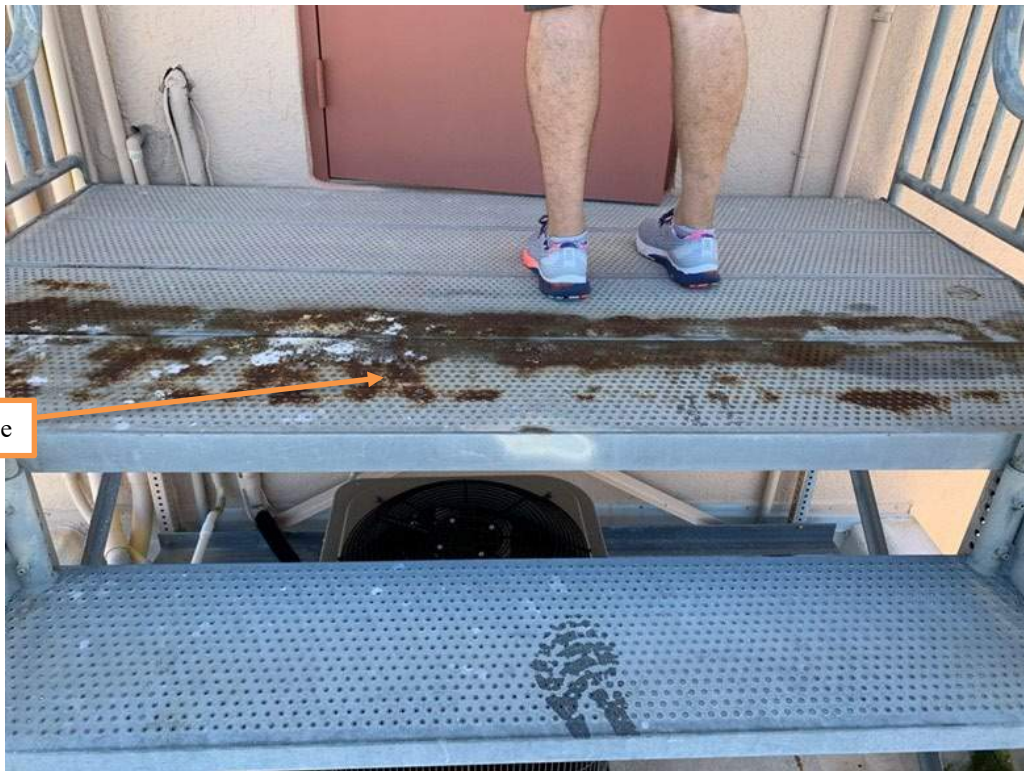
**Figure 3: Main Roof at Elevator Equipment Room.**

Corrosion of staircase

- Consider replacement or refurbishment project for railings.
  - Facilitate spot repair of corroded areas of stairwell to Elevator Equipment Room and Elevator door frames.

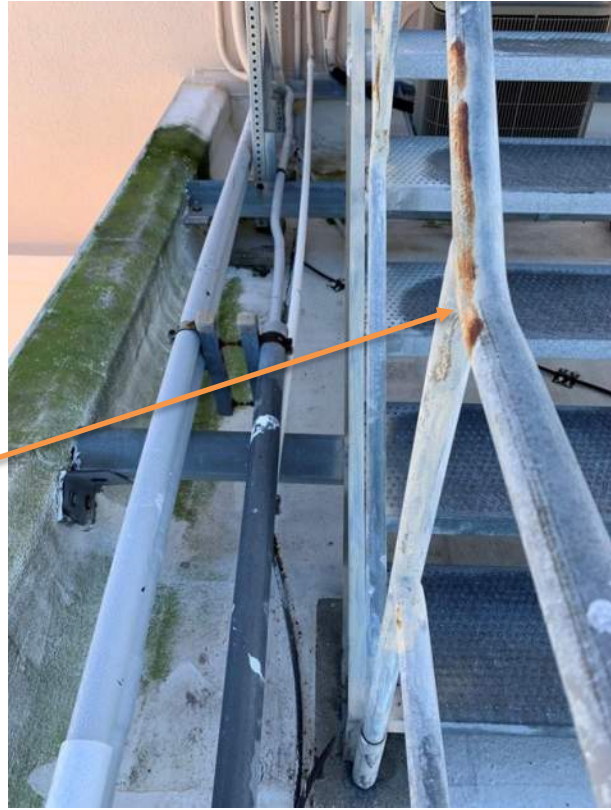
**Figure 4: Main Roof at Elevator Equipment Room.**

Further corrosion of staircase

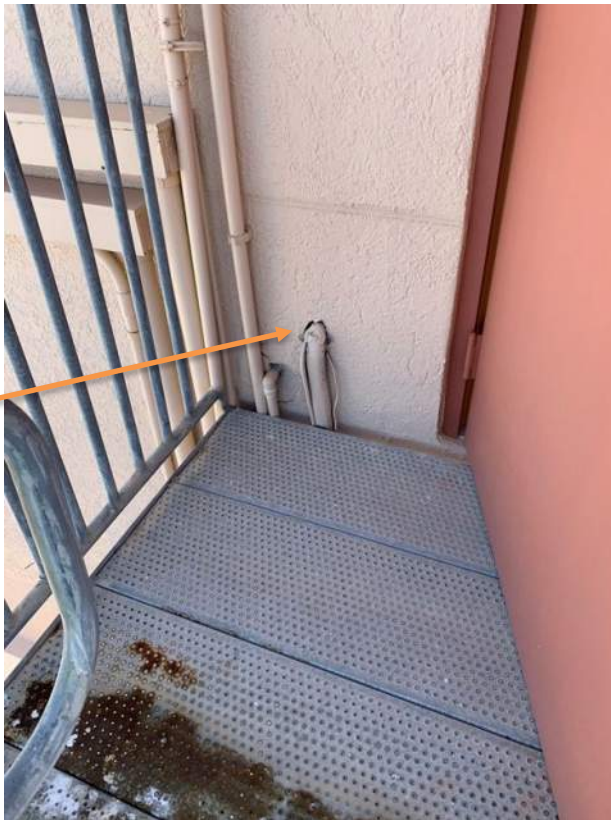
**Figure 5: Main Roof at Elevator Equipment Room.**

Void at penetration

- Replace or supplement sealant at exterior balcony floors where failed.
  - Fill any voids at penetrations of building envelope. Install sealant around perimeter of all electrical housings to prevent water intrusion.

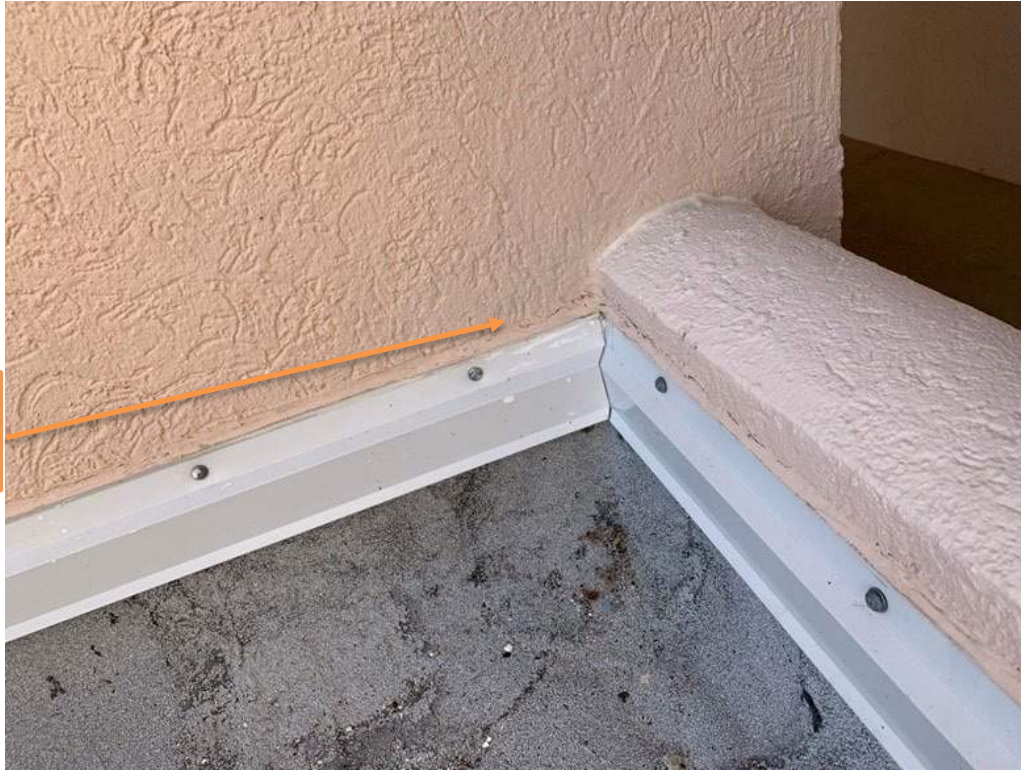
**Figure 6: 2<sup>nd</sup> Level Roof.**

Sealant cracking at counter flashing

- Facilitate replacement of push-bar at egress doors with exterior grade equivalent.
- Not Important and Urgent
  - Facilitate replacement or supplement sealant at lower roof counterflashing.

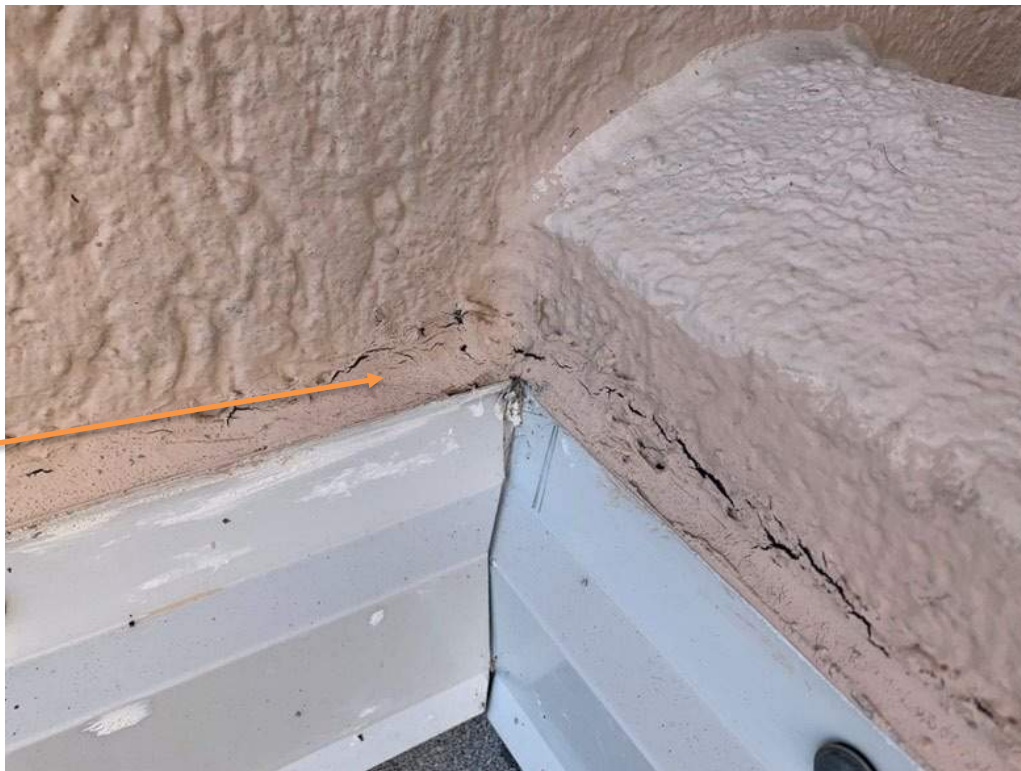
**Figure 7: 2<sup>nd</sup> Level Roof, magnified.**

Sealant cracking

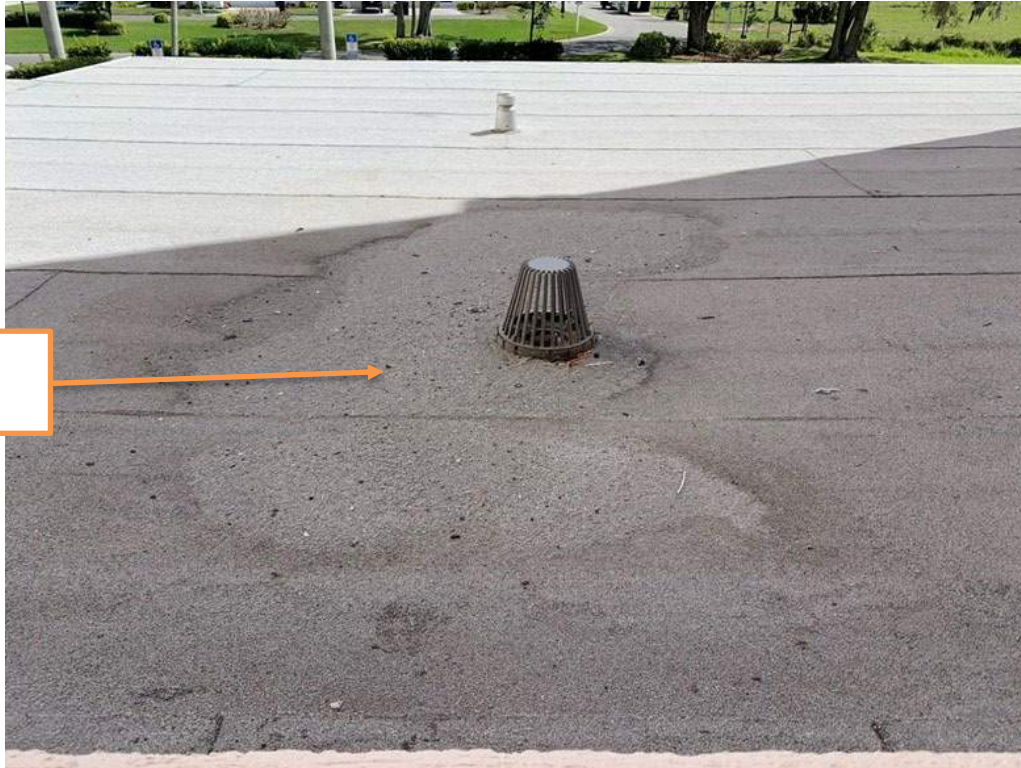
**Figure 8: 2<sup>nd</sup> Level Roof.**

Debris and aggregate accumulation.

- Periodically monitor lower roof drains for effective drainage and remove excessive debris.
  - Increase frequency of power-washing of exterior of building to minimize the degree of staining and mildew accumulation and extend the lifespan of paint finish.

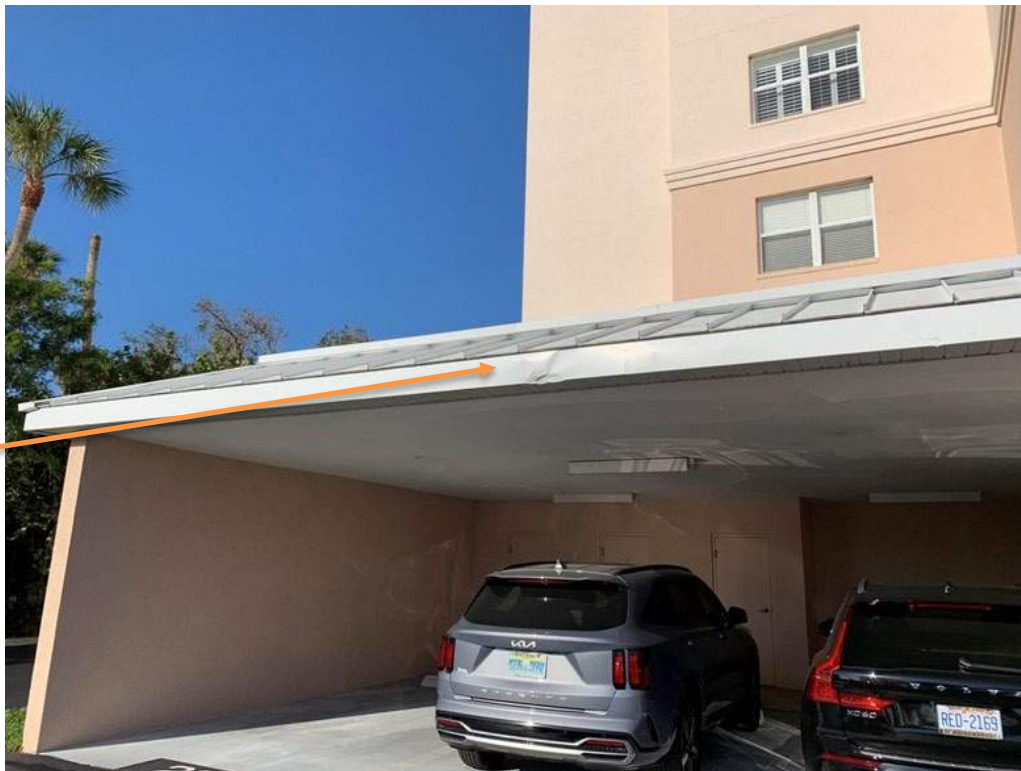
**Figure 9: South end ground floor parking**

Damaged fascia

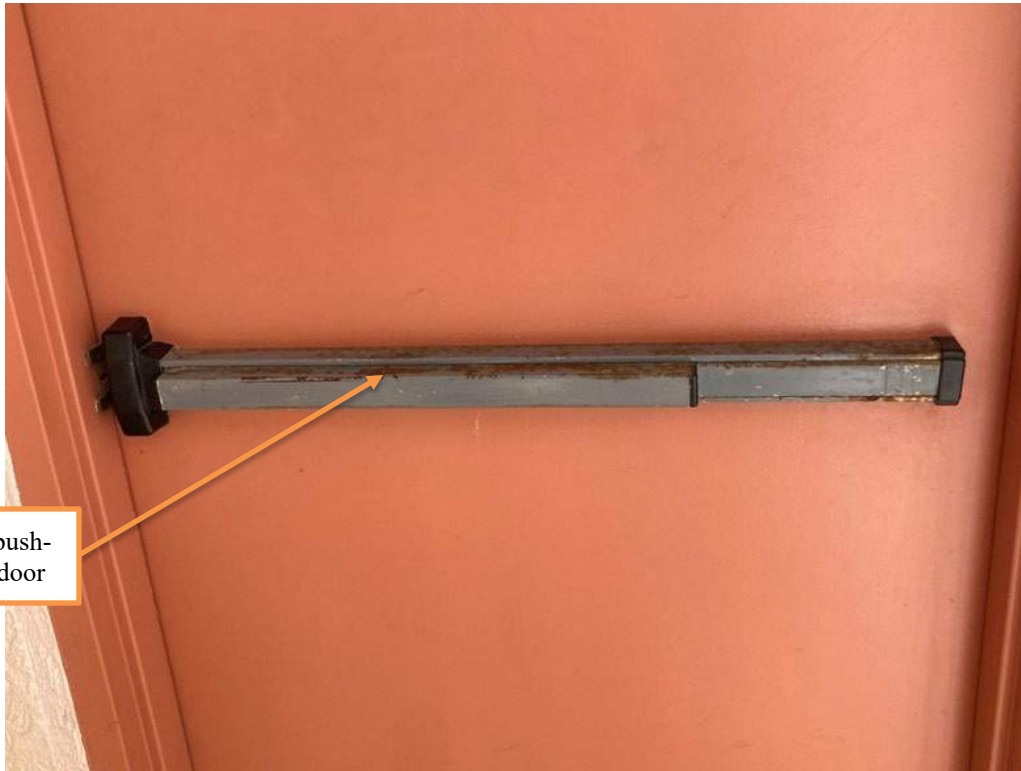
**Figure 13: North side stairwell, 3<sup>rd</sup> floor.**

Corrosion of push-bar at egress door

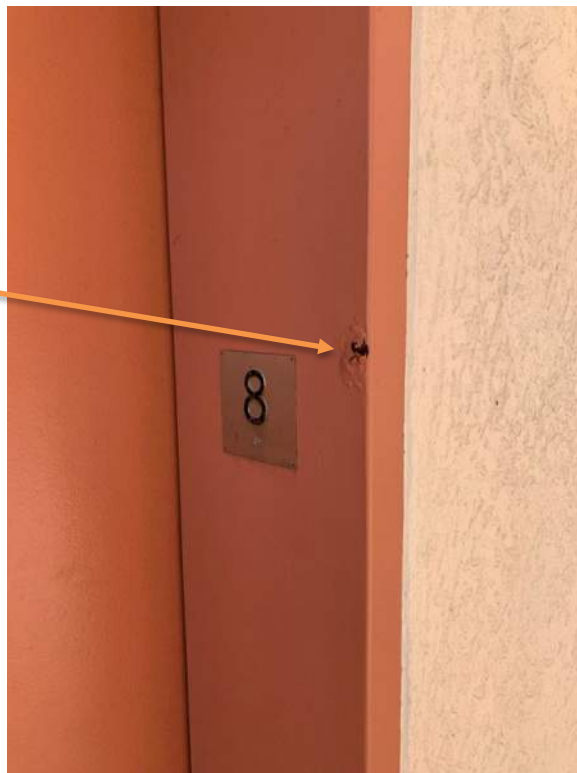
**Figure 14: Elevator door frame, 8<sup>th</sup> floor.**

Corrosion at elevator door frame

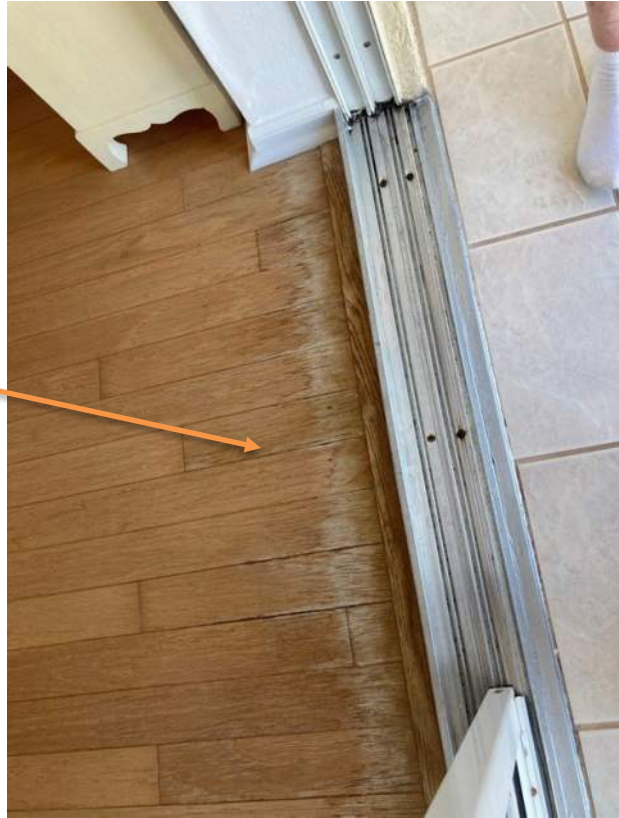
**Figure 16: Unit 805 balcony.**

Fading/discoloration indicates past water intrusion

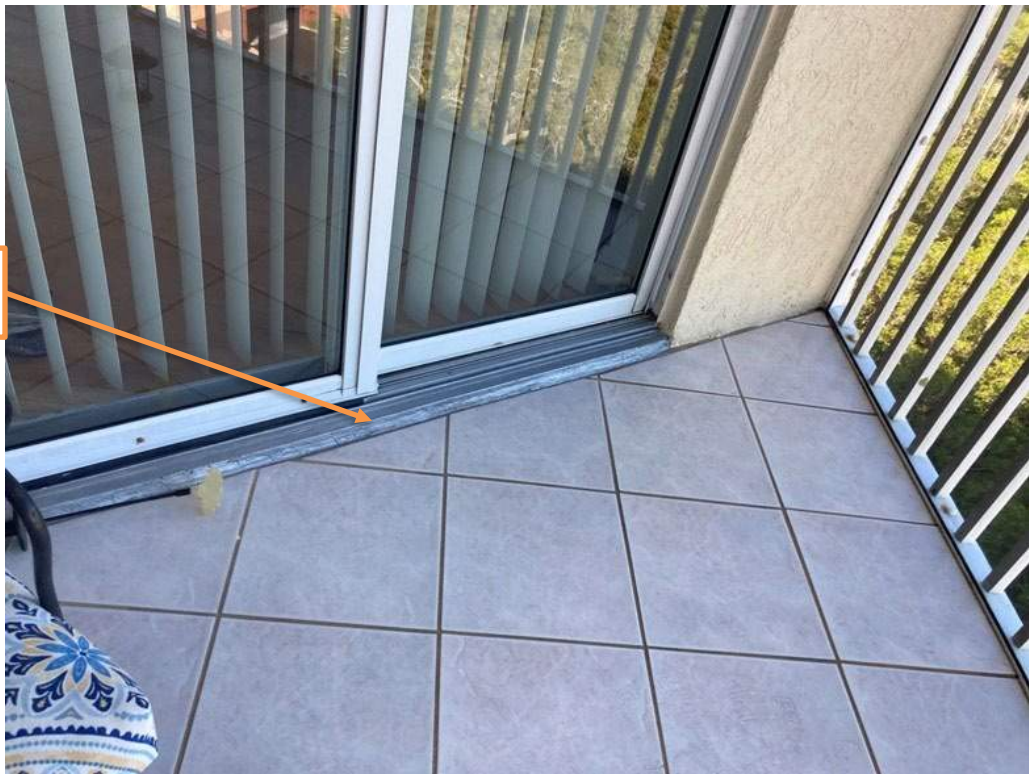
**Figure 17: Unit 805 balcony.**

Duct tape at threshold

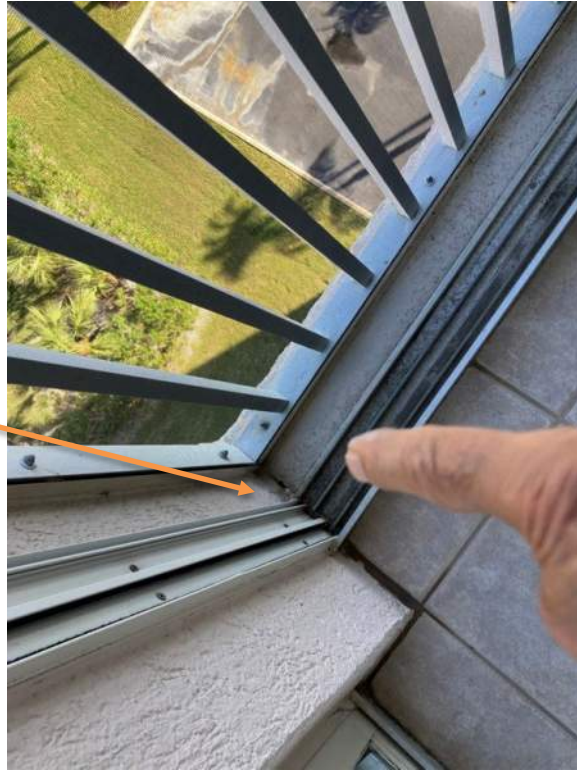
**Figure 18: Unit 706 balcony.**

Void in grout  
at column

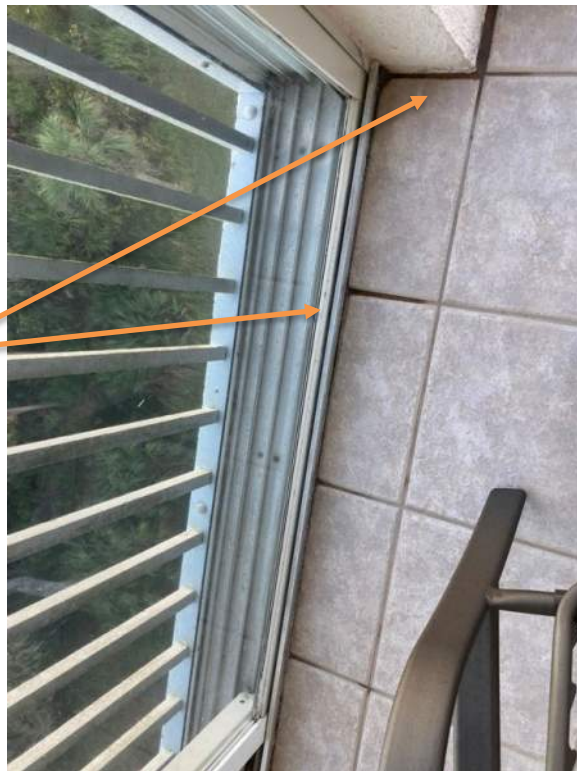
**Figure 19: Unit 706 balcony.**

Staining of grout  
indicates ponding

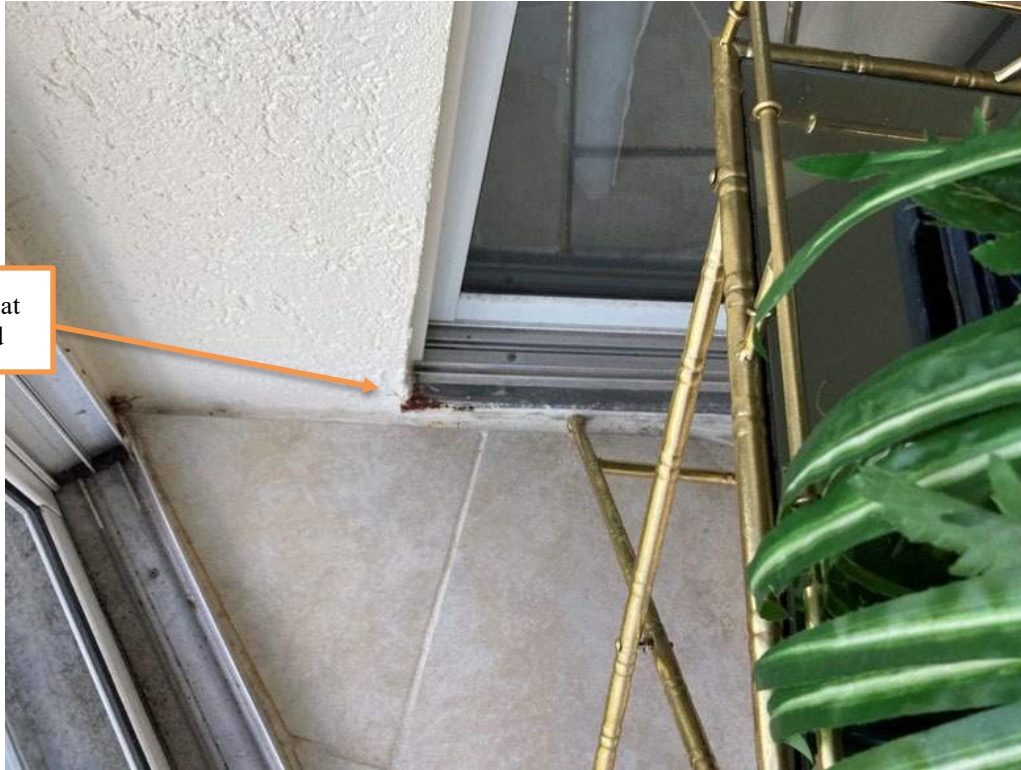
**Figure 20: Unit 602 balcony.**

Corrosion at threshold

- Adequately prepare and paint corroded flashing at thresholds. Sufficiently seal gaps at flashing, threshold, and walls to prevent potential water intrusion.

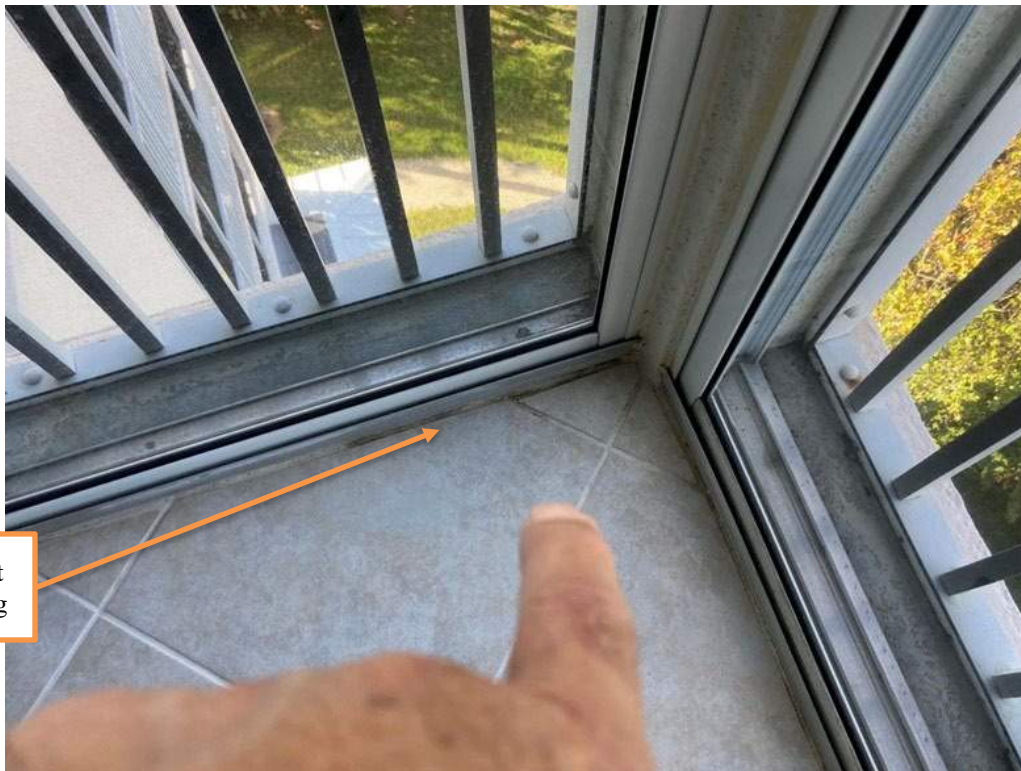
**Figure 21: Unit 602 balcony.**

Staining of grout indicates ponding

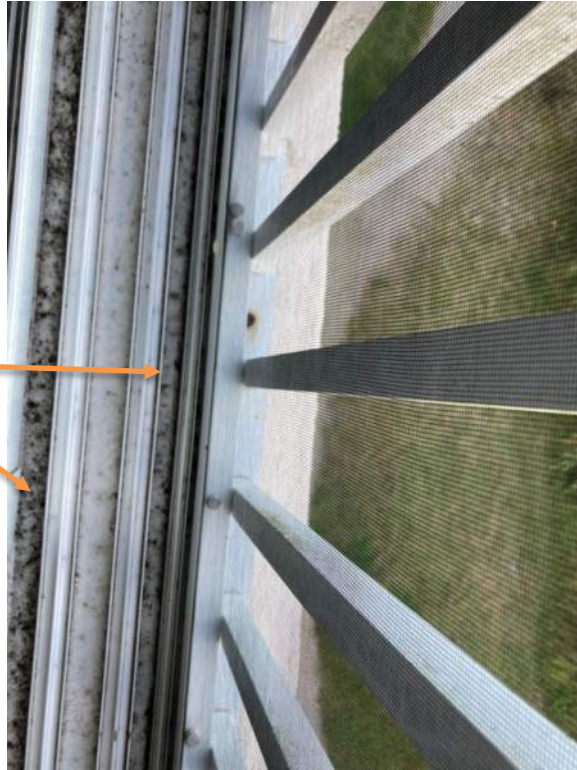
**Figure 22: Unit 505 balcony.**

Mildew and debris indicates trapped water

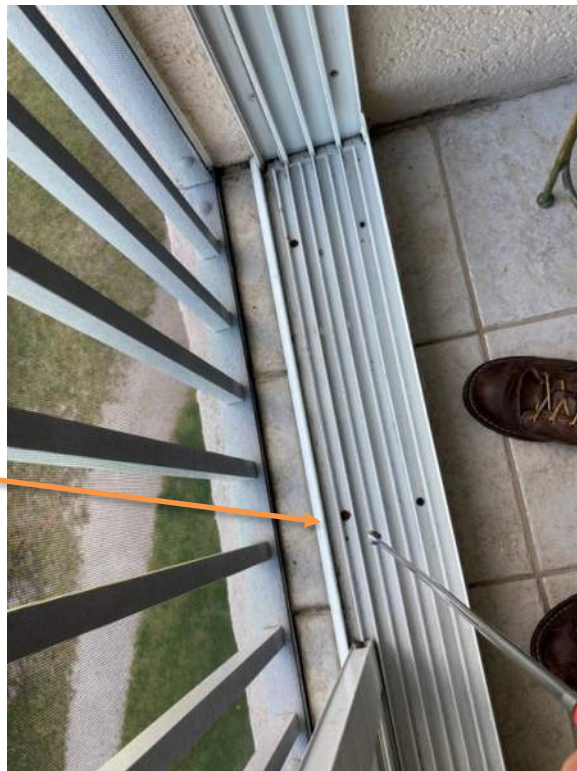
**Figure 23: Unit 504 balcony.**

Corrosion of anchors at sill

- Replace corroded anchors at sliding glass doors, shutters, and railings with stainless steel equivalent and utilize urethane-based sealant at holes prior to anchor installation.

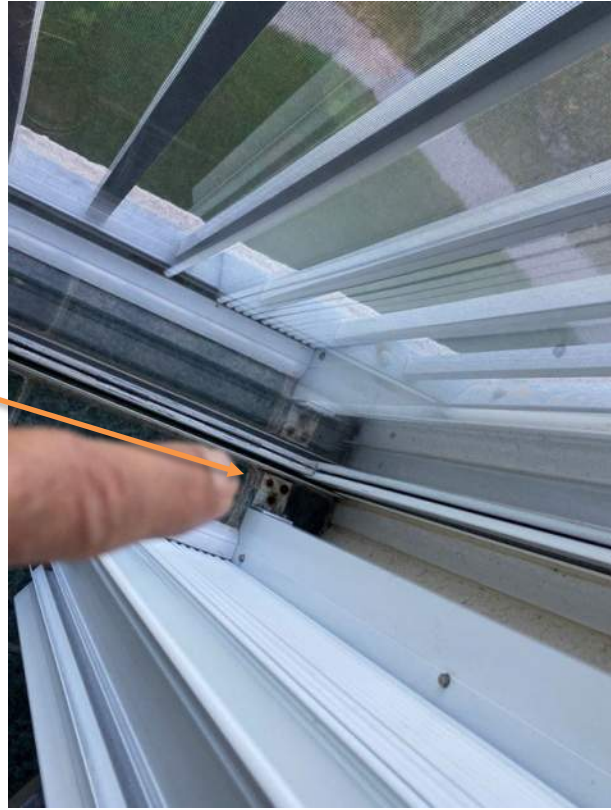
Figure 24: Unit 503 balcony.

Corrosion of anchors at shutters

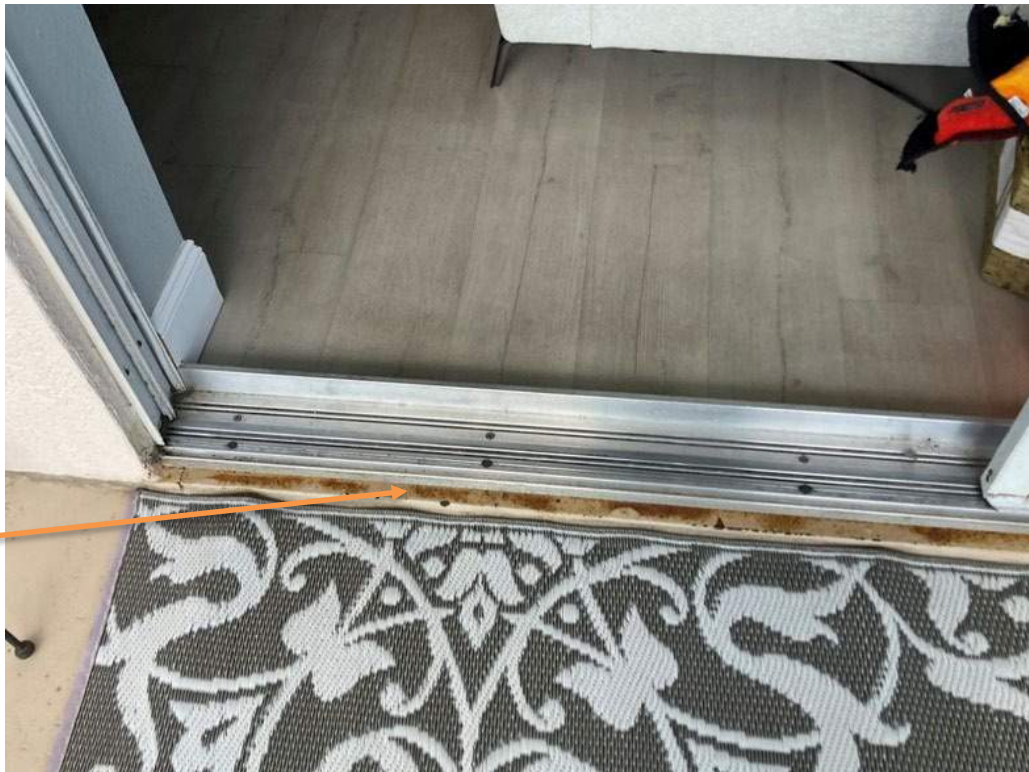
Figure 25: Unit 402 balcony.

Corrosion of flashing at threshold

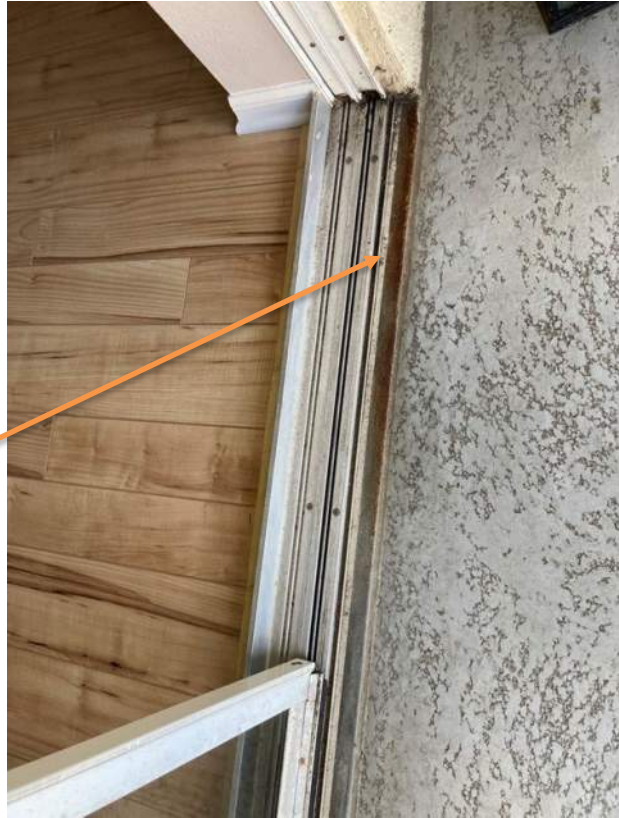
**Figure 26: Unit 305 balcony.**

Corrosion of flashing  
at threshold

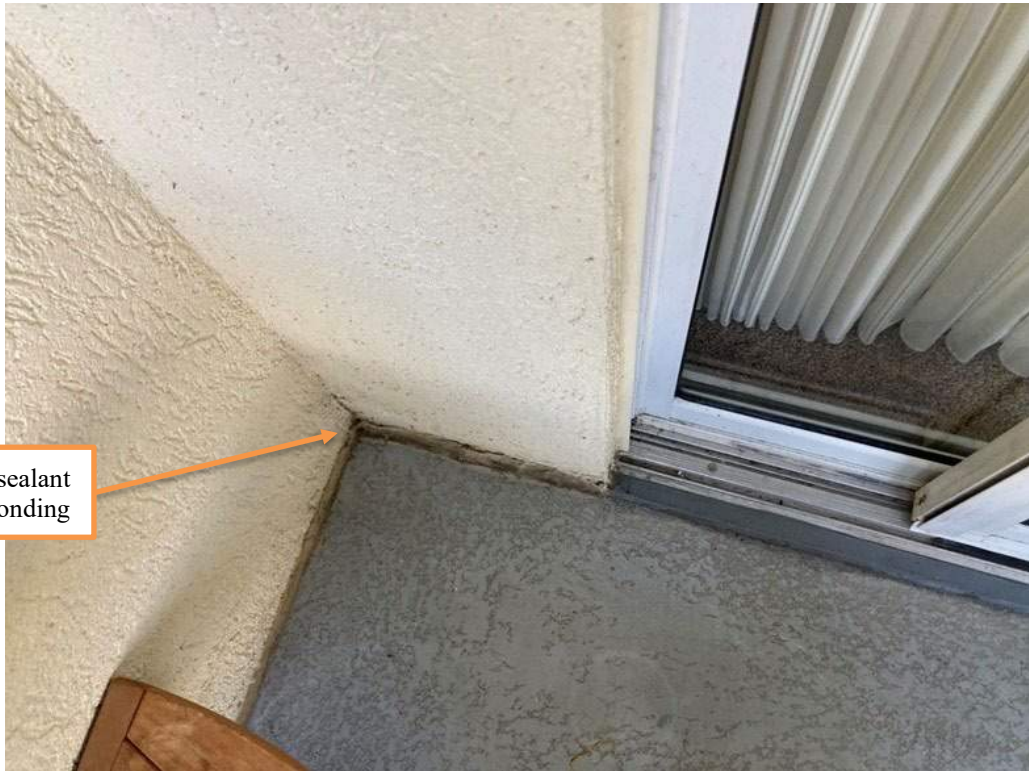
**Figure 27: Unit 104 balcony.**

Mildew at sealant  
indicates ponding

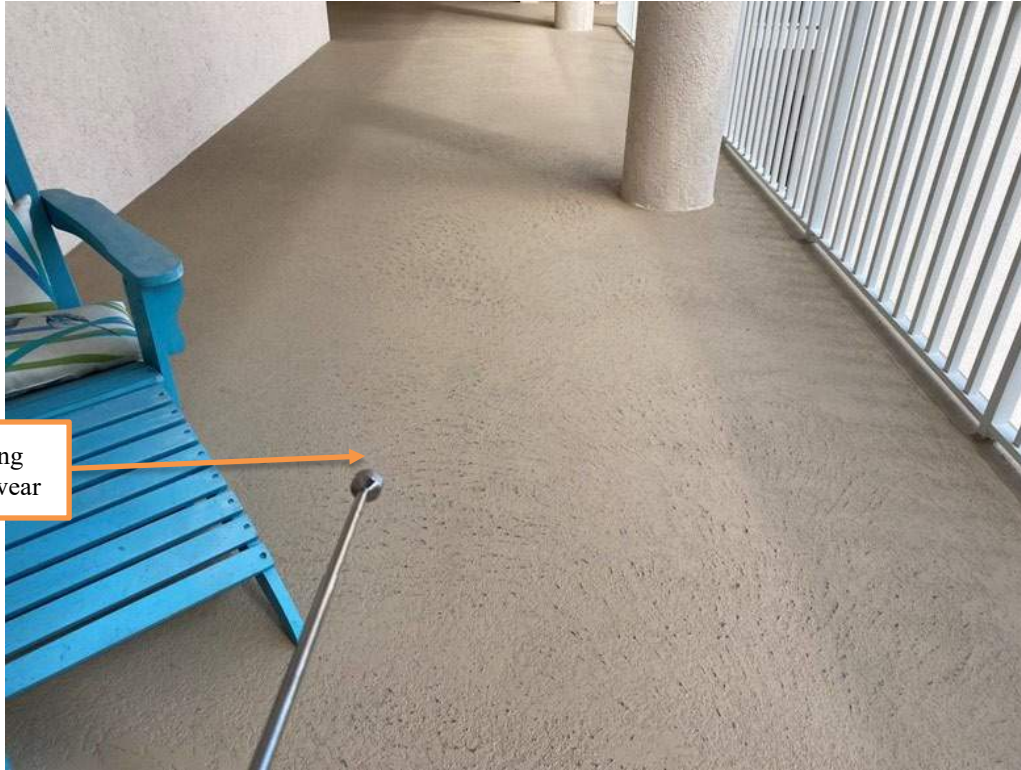
**Figure 30: 8<sup>th</sup> floor walkway.**

Slab waterproofing showing signs of wear

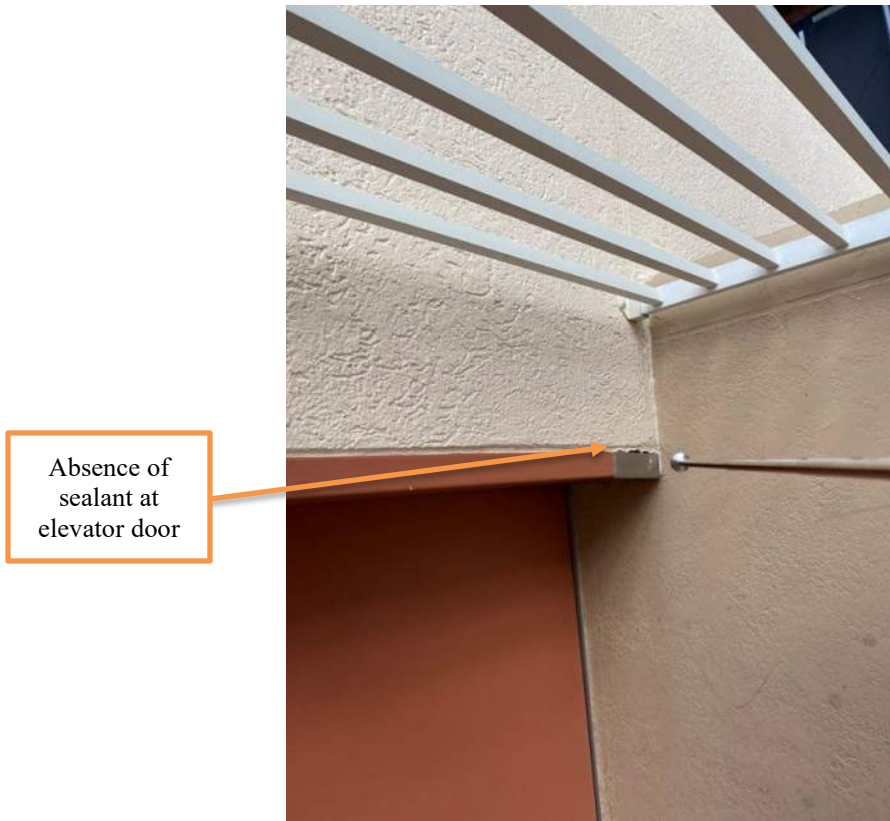
**Figure 31: 7<sup>th</sup> floor elevator.**

Absence of sealant at elevator door

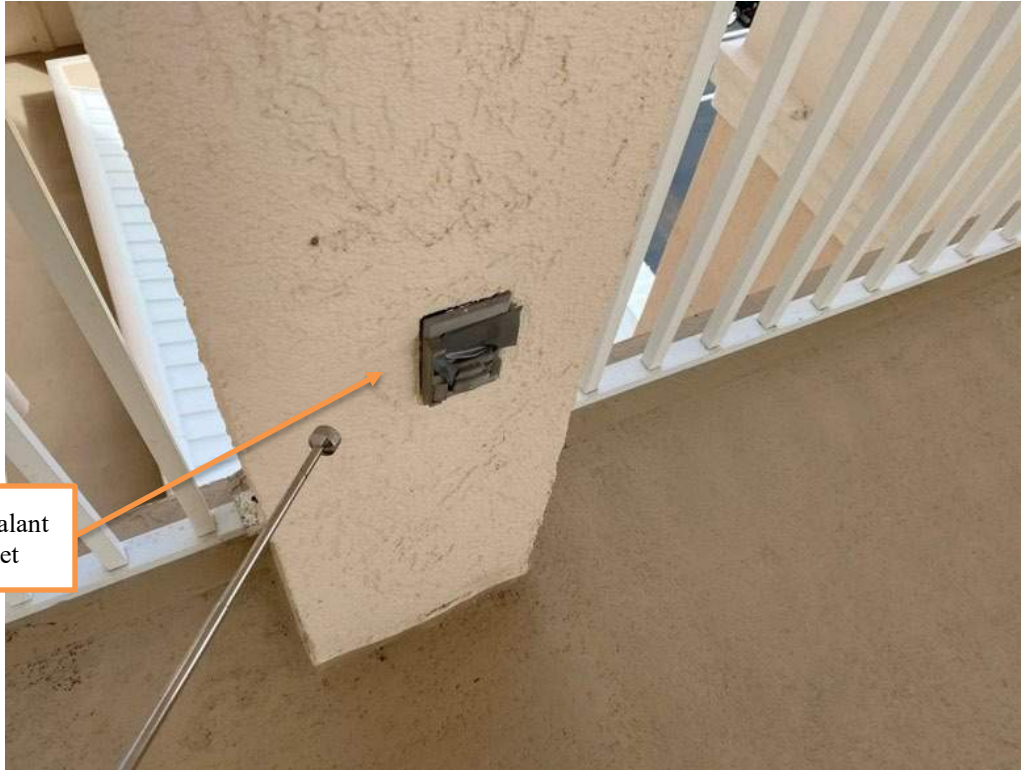
Figure 32: 5<sup>th</sup> floor walkway.

Absence of sealant around outlet

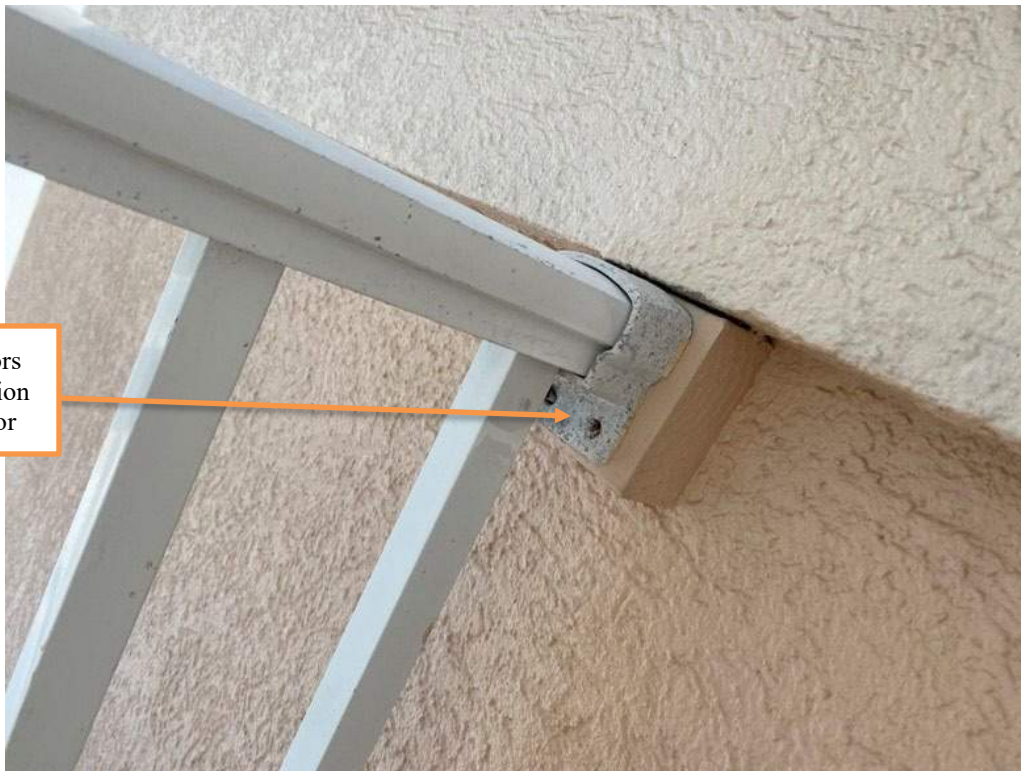
Figure 33: 4<sup>th</sup> floor walkway.

Corrosion of anchors and paint deterioration at top rail connector

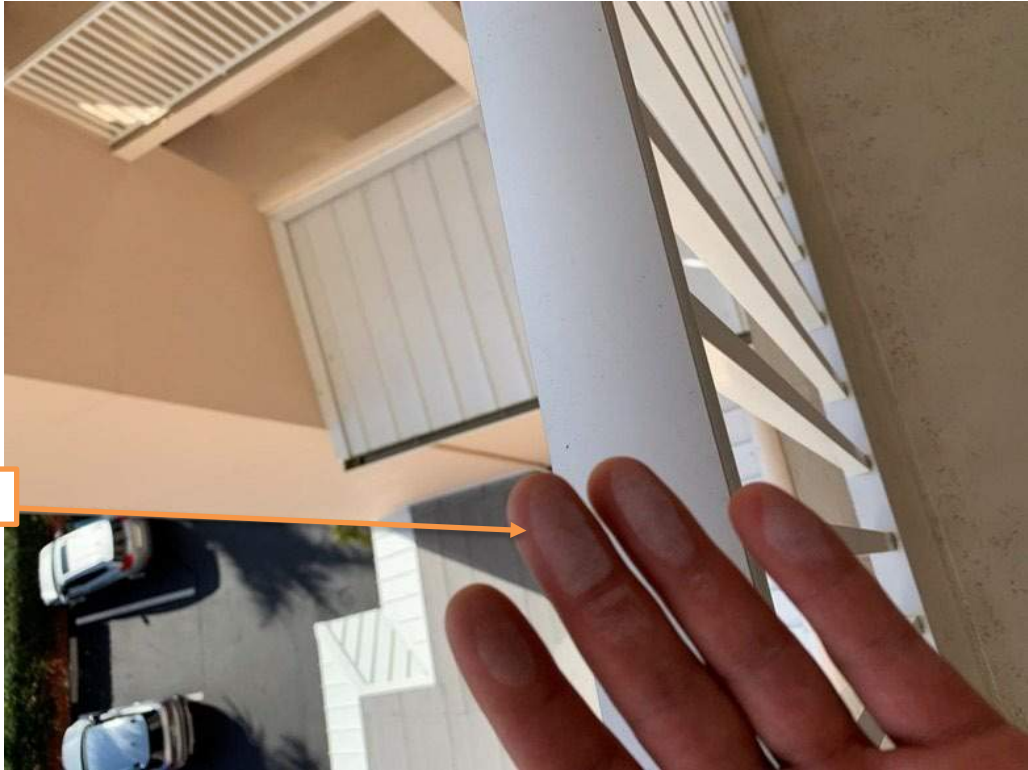
**Figure 34: 5<sup>th</sup> floor walkway.**

Chalking of paint

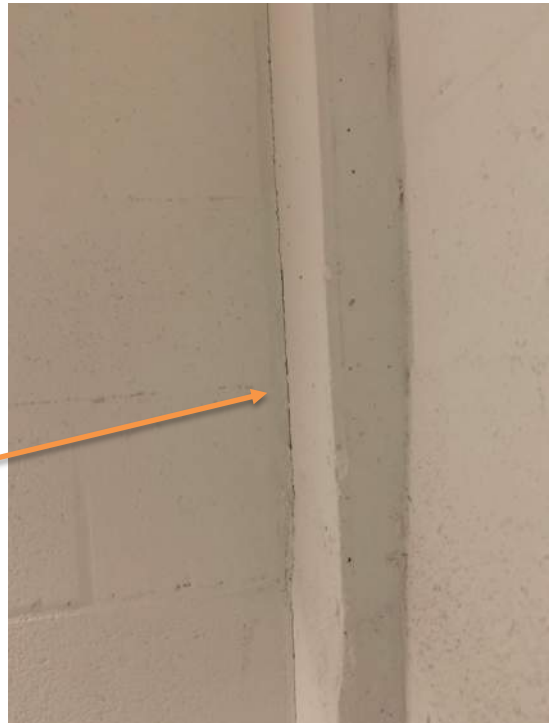
**Figure 35: Ground floor south stairwell.**

Crack between masonry wall and concrete column

- Monitor for development of cracks at exterior envelope of stairwells at the interface of structural members.
  - Facilitate replacement of sealant at structural members in Parking Garage.

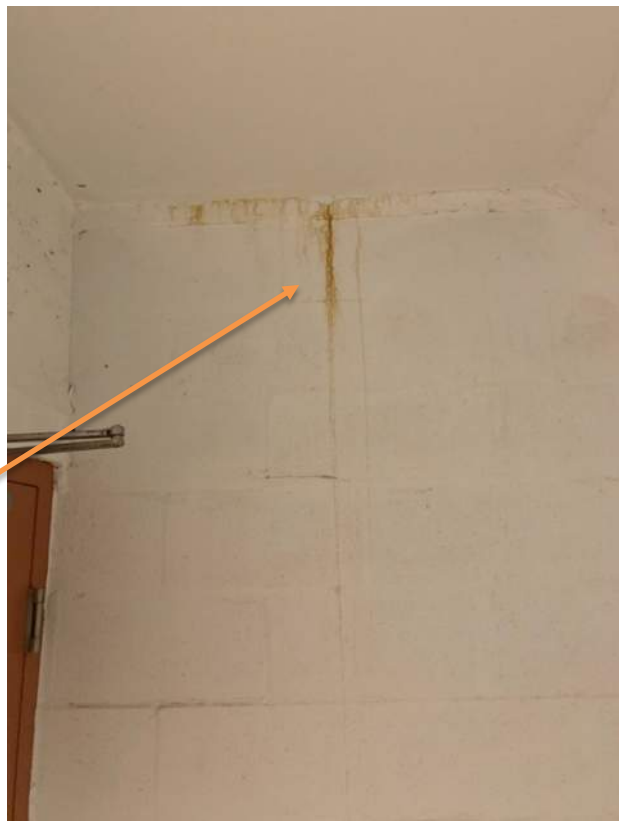
**Figure 36: 8<sup>th</sup> floor south stairwell.**

Staining indicates water intrusion

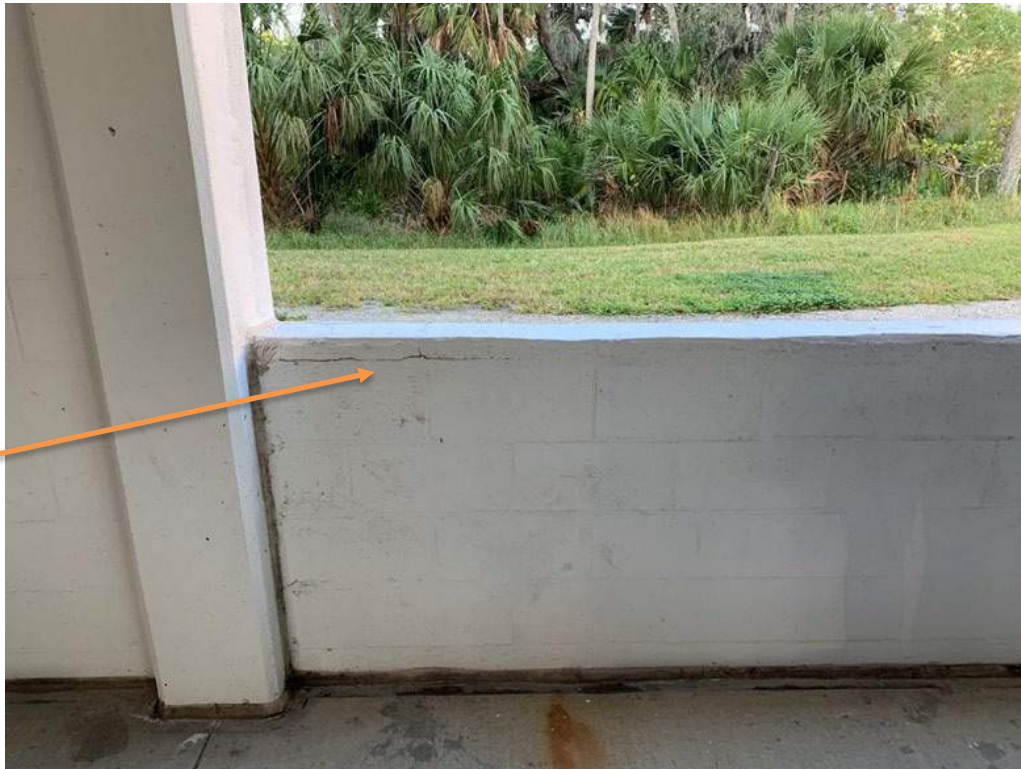
**Figure 37: Ground floor.**

Crack at masonry wall cap

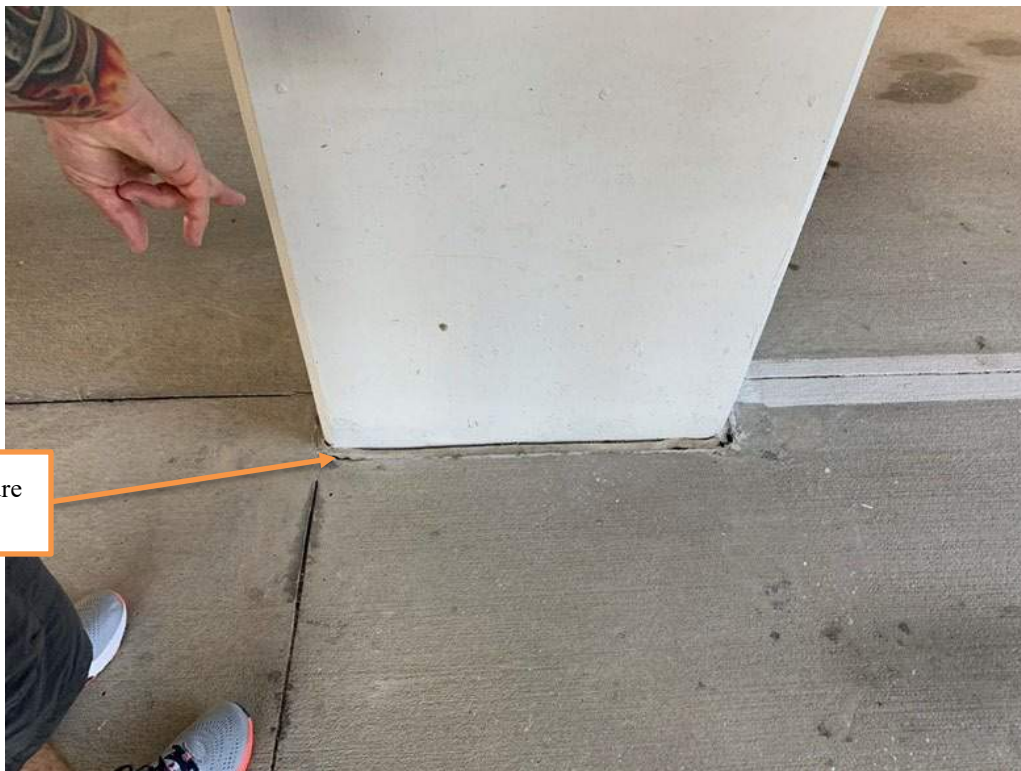
**Figure 38: Ground floor.**

Sealant failure at column
