# Milestone Inspection Report

**Project #22RS-1191**  
**May 24, 2023**  
**FINAL COPY**

*Estuaries II  
Condominium Association, Inc.*

*Estuaries II*

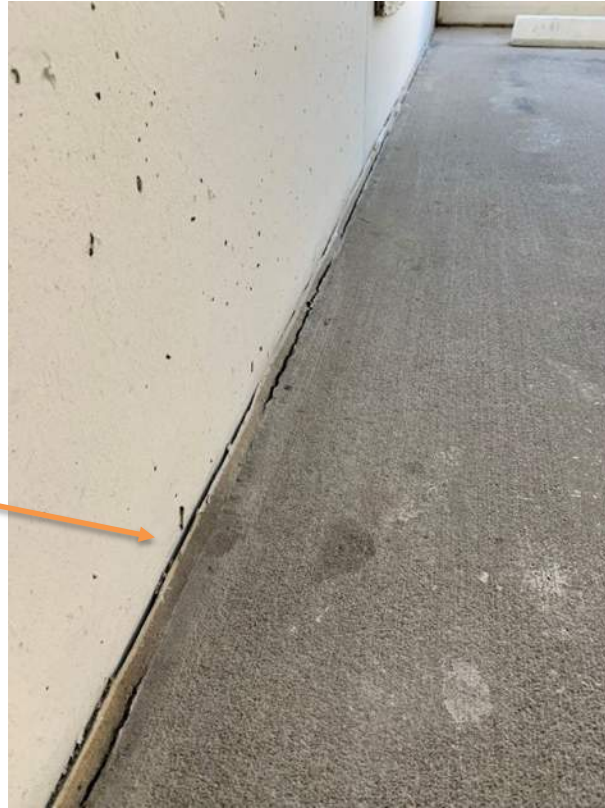
**Figure 39: Ground floor.**

Sealant failure  
at shearwall

- Monitor for development of cracks at exterior envelope of stairwells at the interface of structural members.
  - Facilitate replacement of sealant at structural members in Parking Garage.

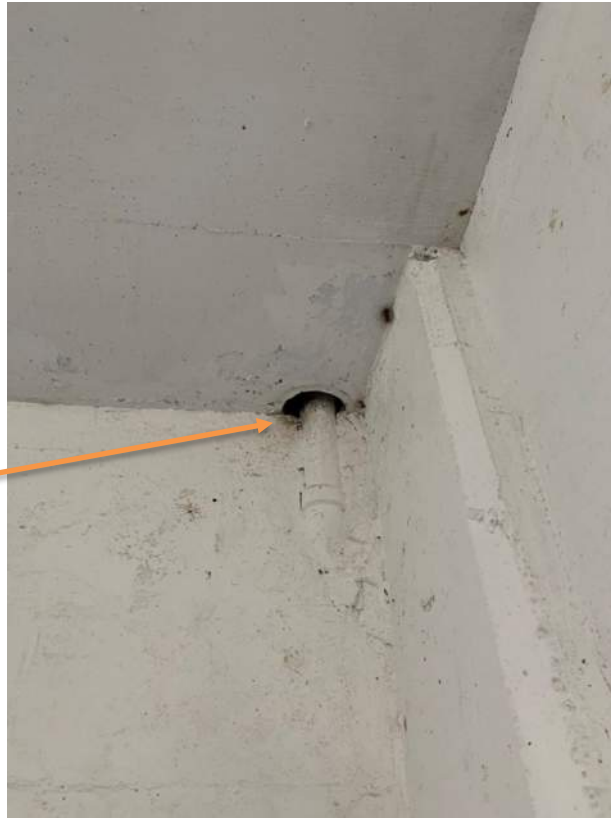
**Figure 40: Ground floor.**

Insufficient fireproofing

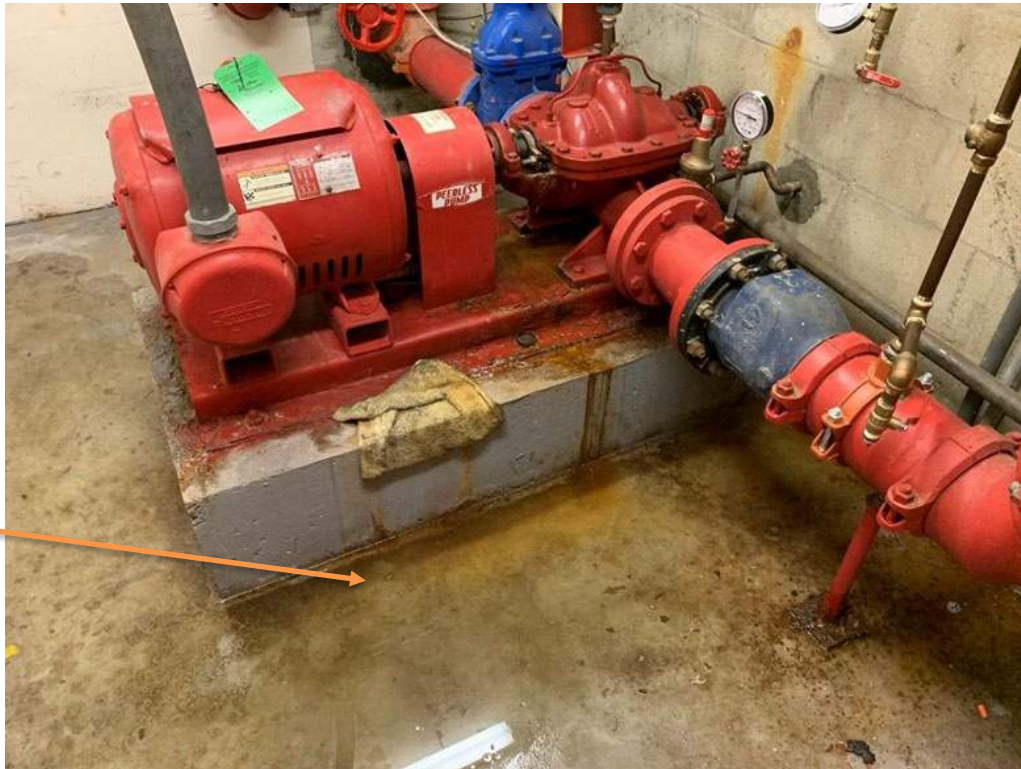
**Figure 41: Fire Control Room.**

Ponding  
at slab

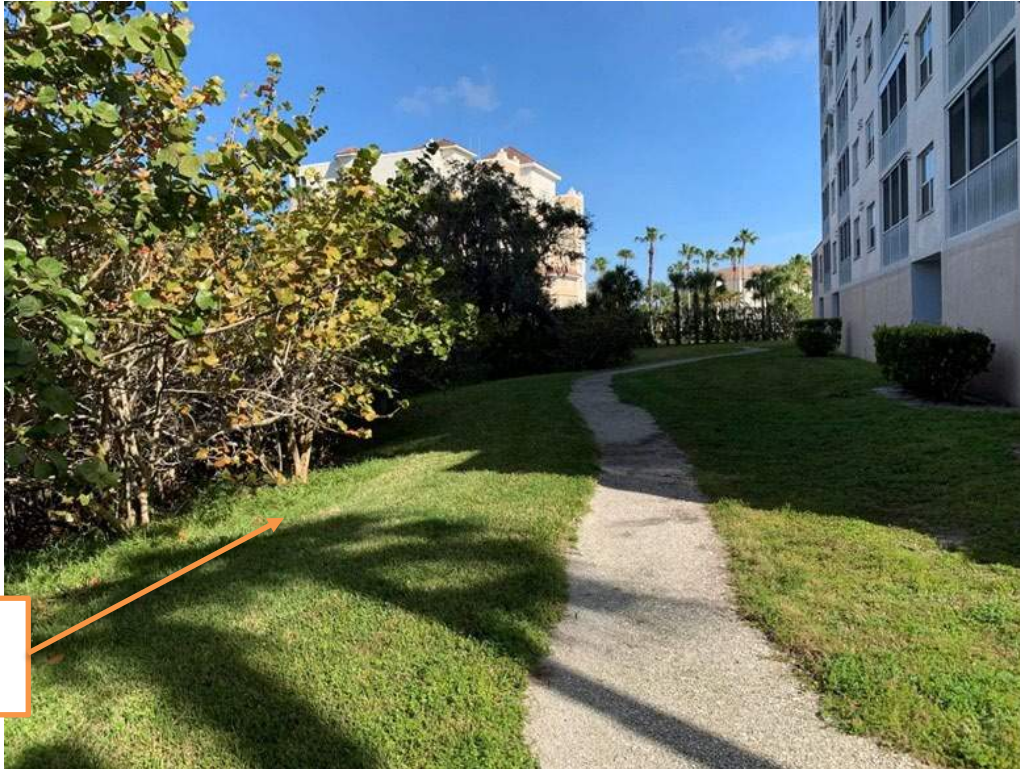
**Figure 42: West side of parcel.**

Absence of  
seawall or  
retaining wall
