# Milestone Inspection Report

**Project # 22RS-1008**

***Palm Aire at Desoto Lakes  
Condominium Association, Inc.***

***7461 West Country Club Dr N,  
Bradenton, FL 34243***

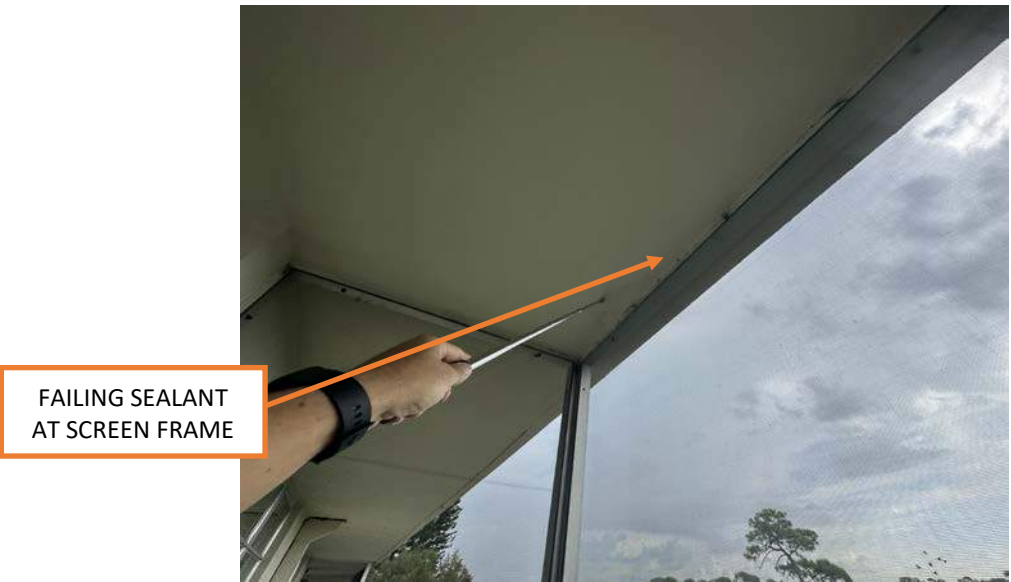
**Figure 4: Unit 408, Level 4**

FAILING SEALANT  
AT SCREEN FRAME

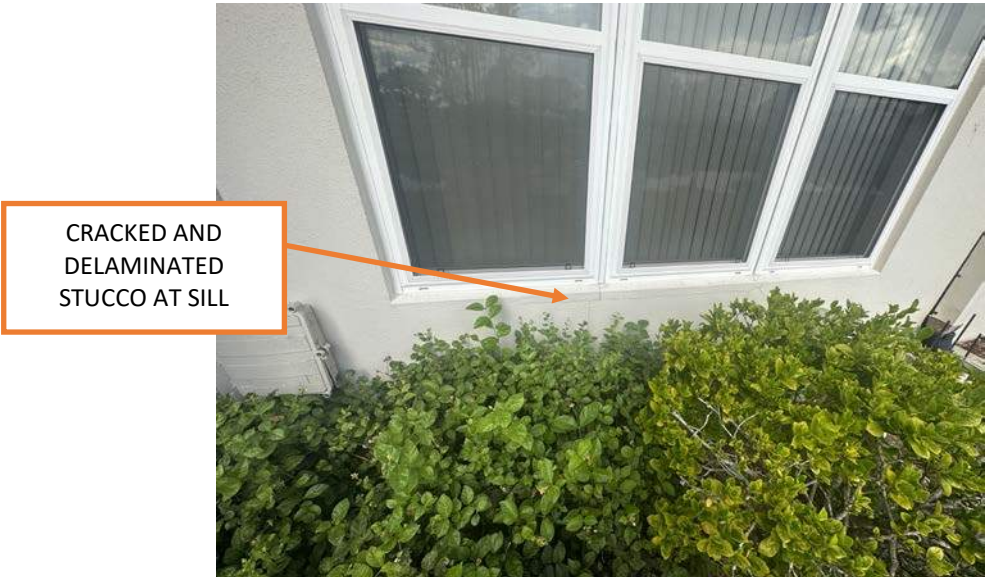
**Figure 5: Exterior Window**

CRACKED AND  
DELAMINATED  
STUCCO AT SILL

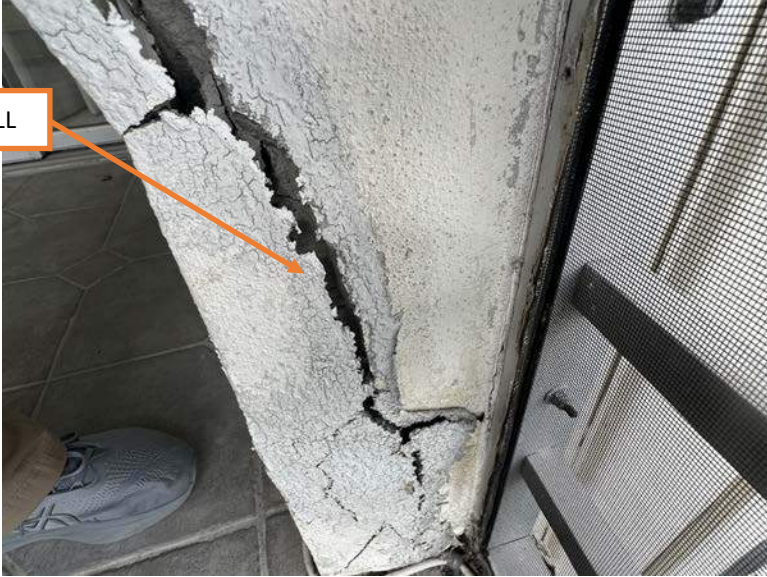
Figure 11: Unit 202, Level 2

DELAMINATED AND CRACKED STUCCO

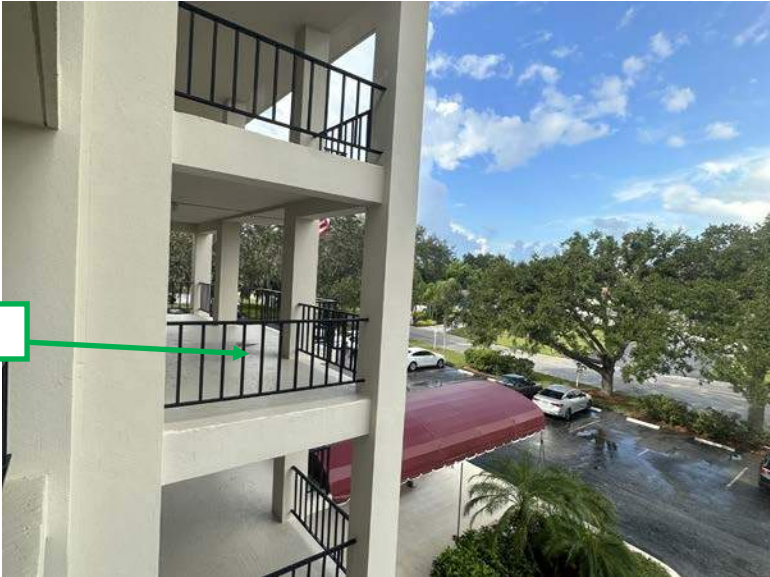
**Figure 15: Terrace, Level 3**

RAILING SYSTEM
