APRIL 8, 2023

THIS MILESTONE PHASE 1 ENGINEERING INSPECTION WAS PRODUCED FOR RIVER YACHT & RACQUET CLUB CONDOMINIUM LOCATED AT 204 3RD ST. W, BRADENTON, FL 34205

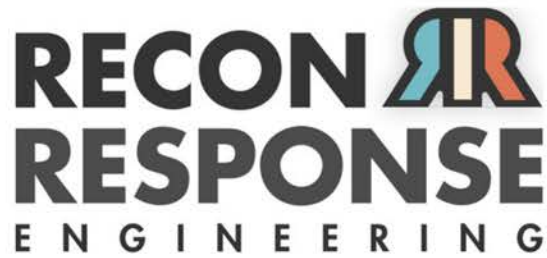
As stated in SB4D, if we find no signs of substantial structural deterioration to the building components under visual examination, then a Phase 2 inspection is not required. If, however, any substantial deterioration is identified during the Phase 1 inspection, then a Phase 2 inspection must be performed.

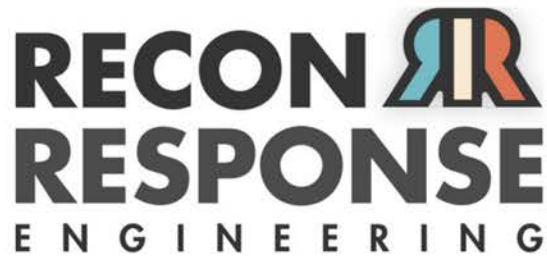
APPLICABLE DEFINITIONS FROM THE FLORIDA BUILDING CODE

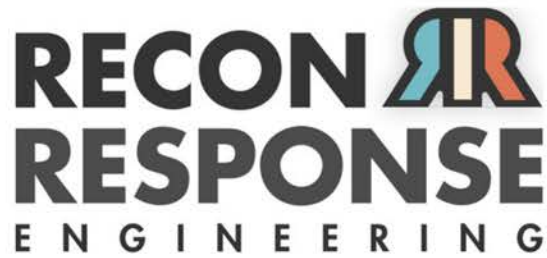
- 1) The Association must distribute a copy of the inspector-prepared summary of the inspection report to each condominium unit owner or cooperative unit owner, regardless of the findings or recommendations in this report, by United States mail or personal delivery and by electronic transmission to unit owners who previously consented to receiving notice by electronic transmission.
- 2) The Association must post a copy of the inspector-prepared summary of the inspection report in a conspicuous place on the condominium or cooperative property.
- 3) The Association must publish the full report and inspector-prepared summary on the Association’s website, if the association is required to have a website
- 4) We also recommend consultation with the Association’s legal counsel to determine what other actions (if any) should be taken

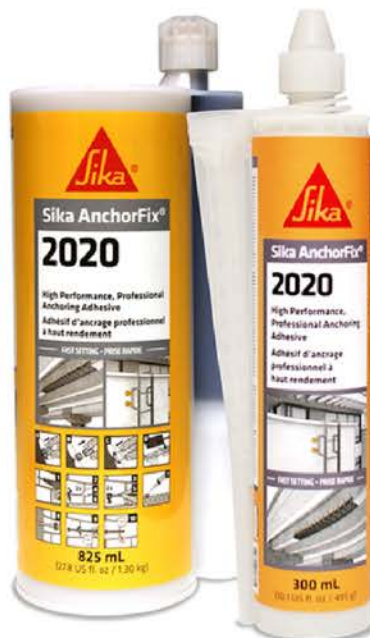
2) The walkway guardrail in front of Unit 201, located adjacent to the stairwell, exhibited excessive deflection during our inspection. The railing post must be re-anchored to the concrete slab by a licensed contractor. This can normally be accomplished by digging out the guardrail post pocket material and replacing it with an anchorage epoxy such as Sika AnchorFix 2020 anchoring adhesive. Install the product in accordance with the manufacturer's instructions. See photo of suggested product below:

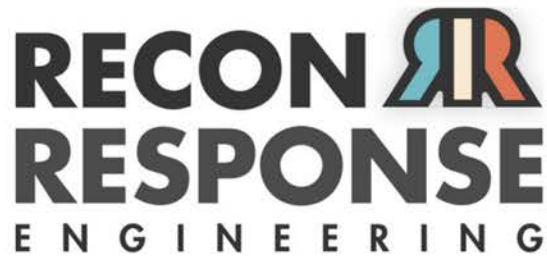
Required Item 5 of 6 (continued): *Recommend any remedial or preventive repair for any items that are damaged but are not substantial structural deterioration*

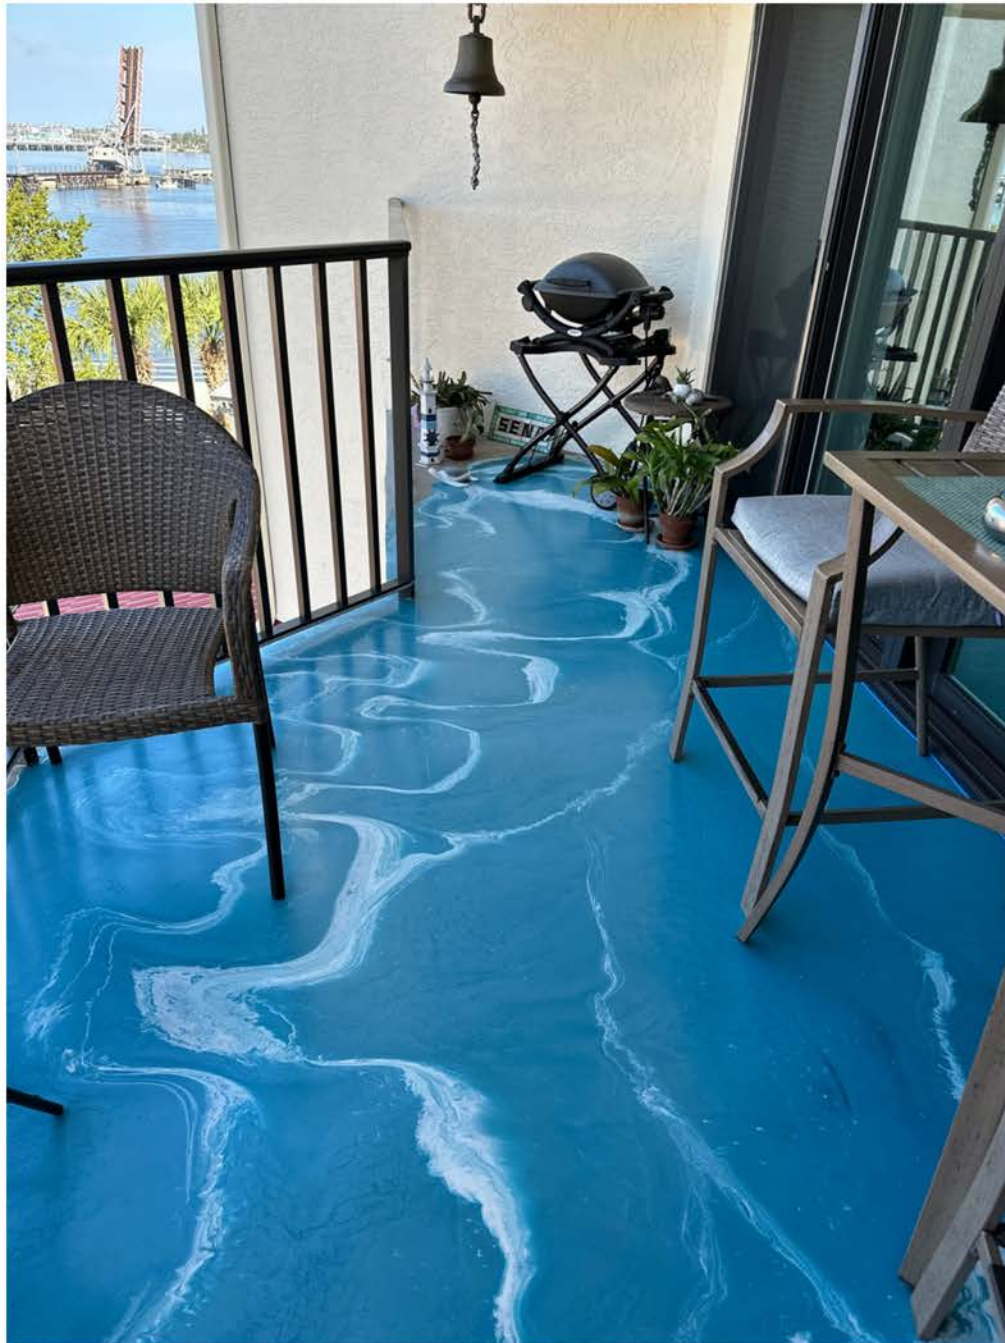
Unit 307 Balcony floor (blue epoxy) in good condition. No issues with guardrails. No cracking on walls or ceilings or adjacent sections. Minor cracking on the drywall ceiling in the kitchen. Appears to be a nonstructural issue related to a concrete joint. No issues on the interior. No action required.

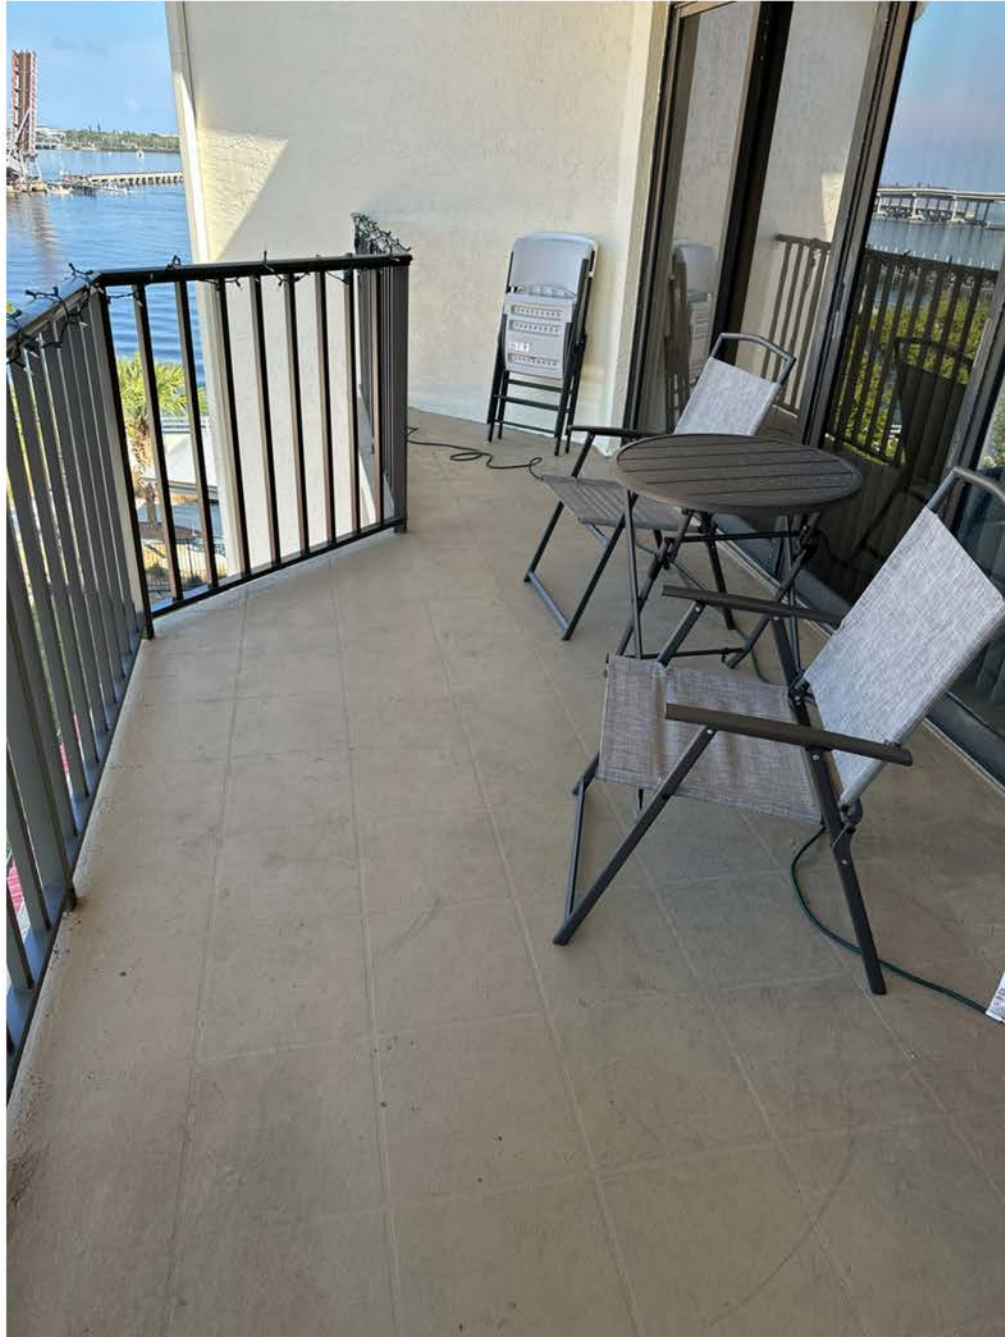
**Unit 407 Balcony floor (Faux tile in brown with cementitious finish) Good condition.
No cracking or issues on walls or ceiling. No action required.**

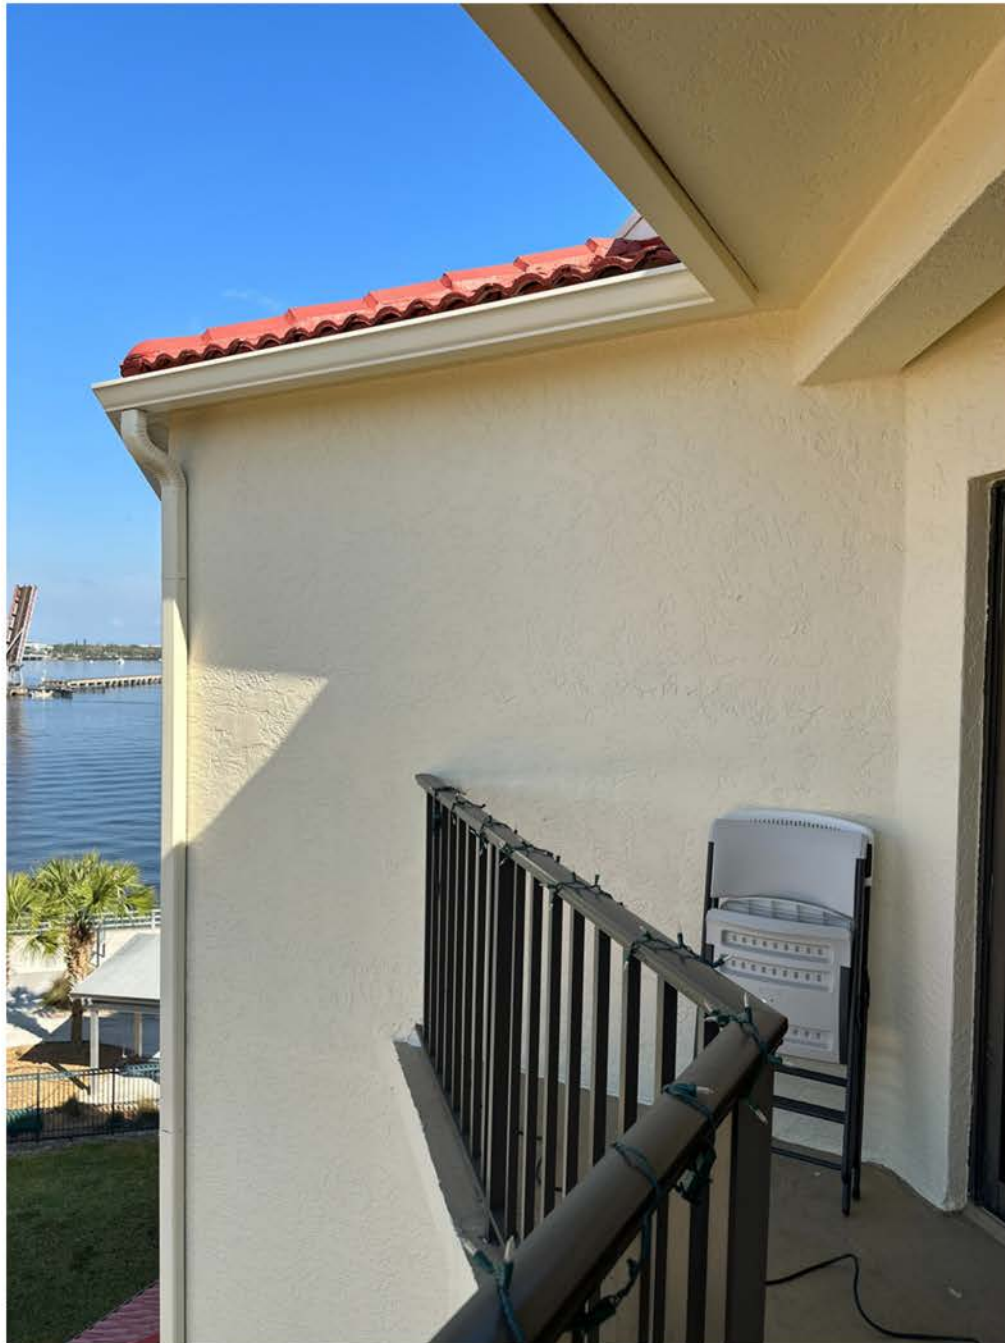
Unit 407, good condition.

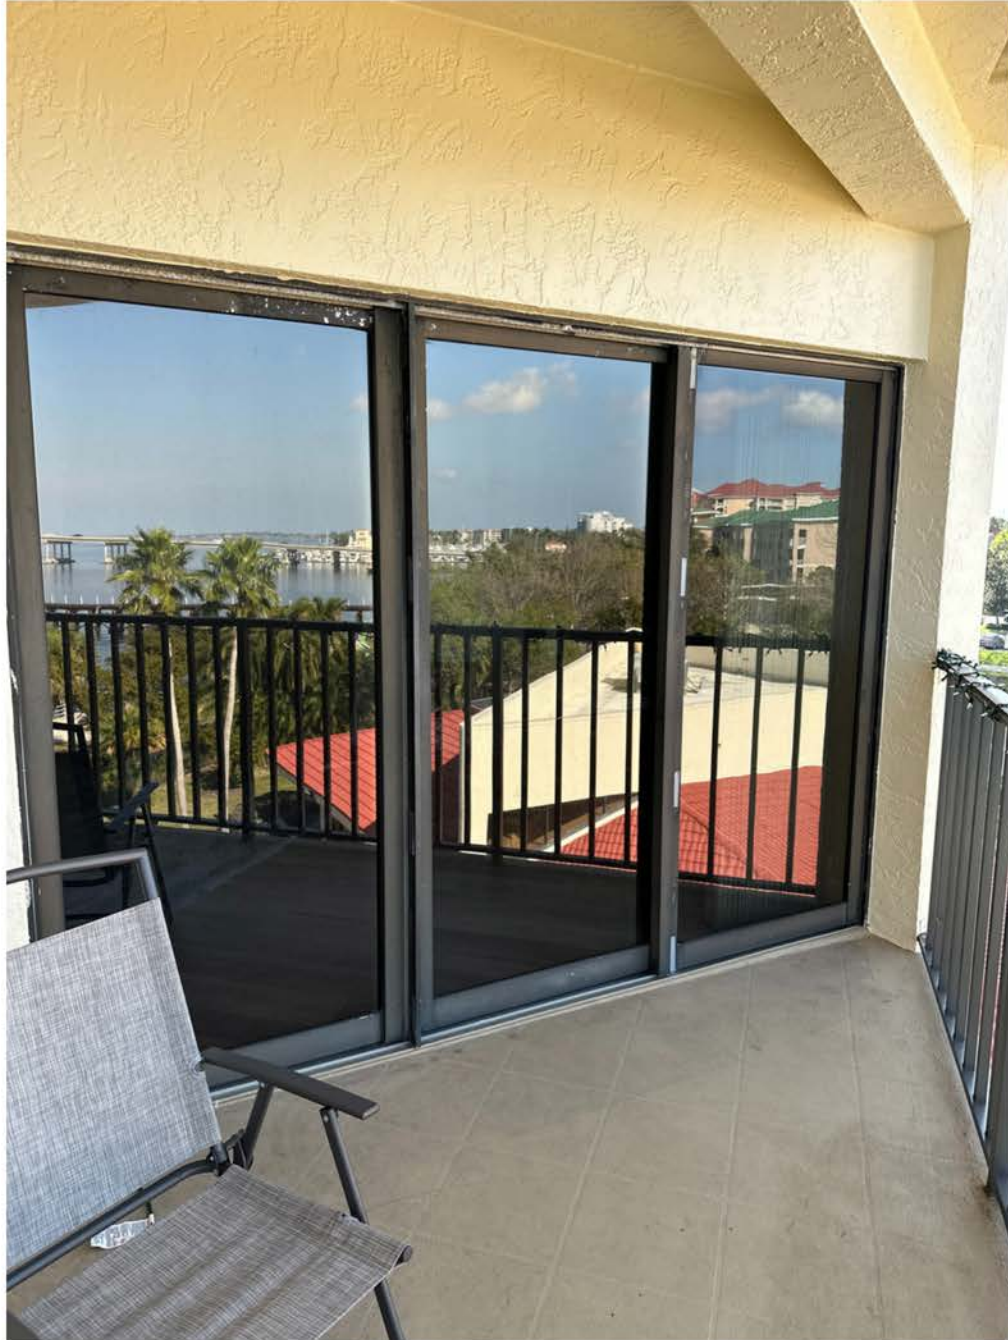
Unit 407 - good condition

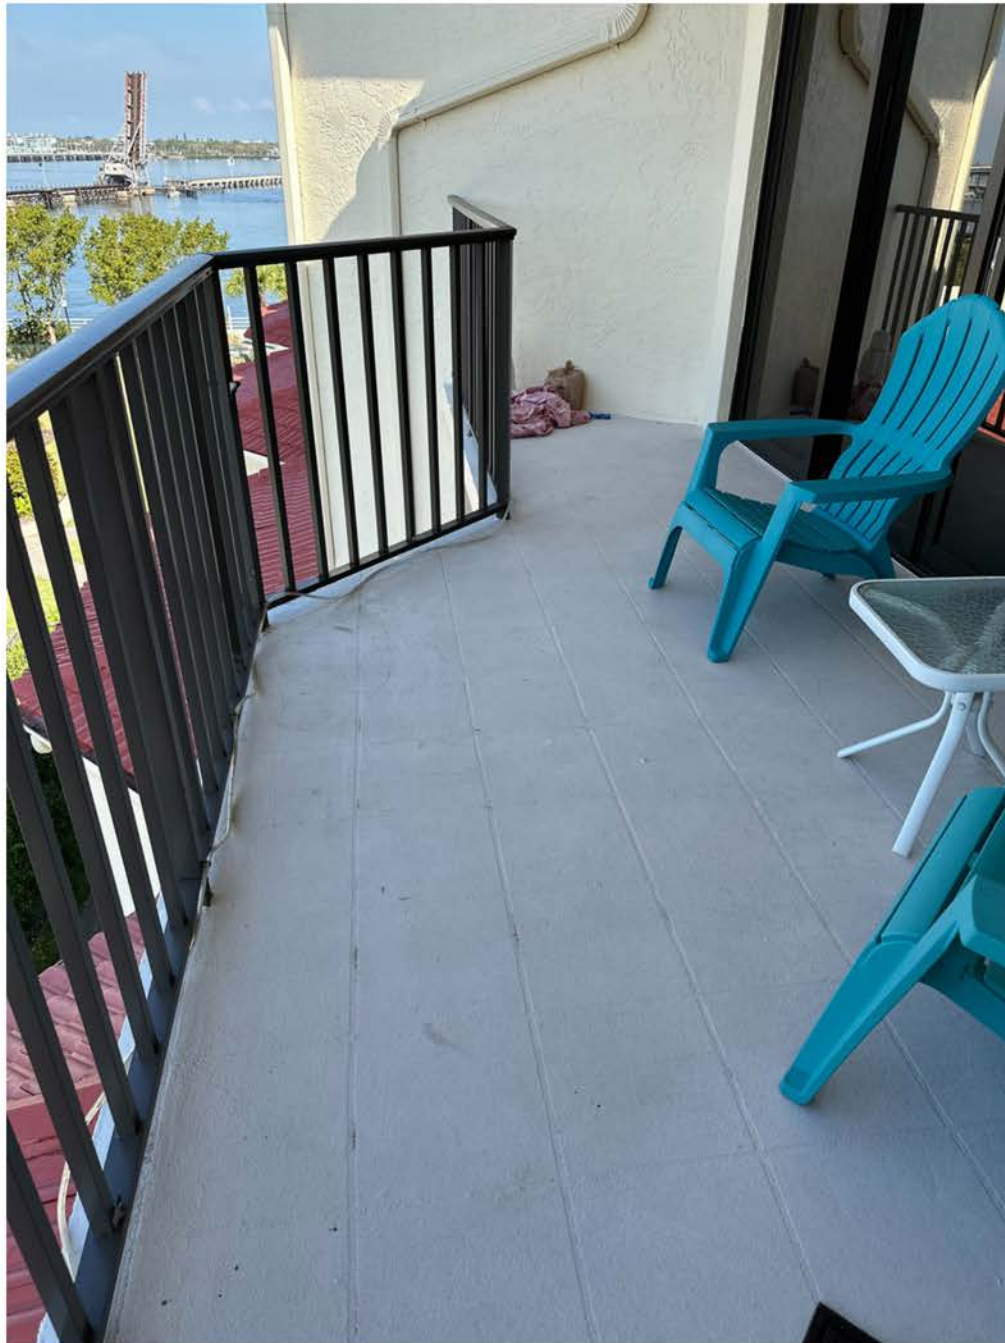
Unit 403 Balcony floor (cementitious faux tile light gray color). Unit is in good condition.

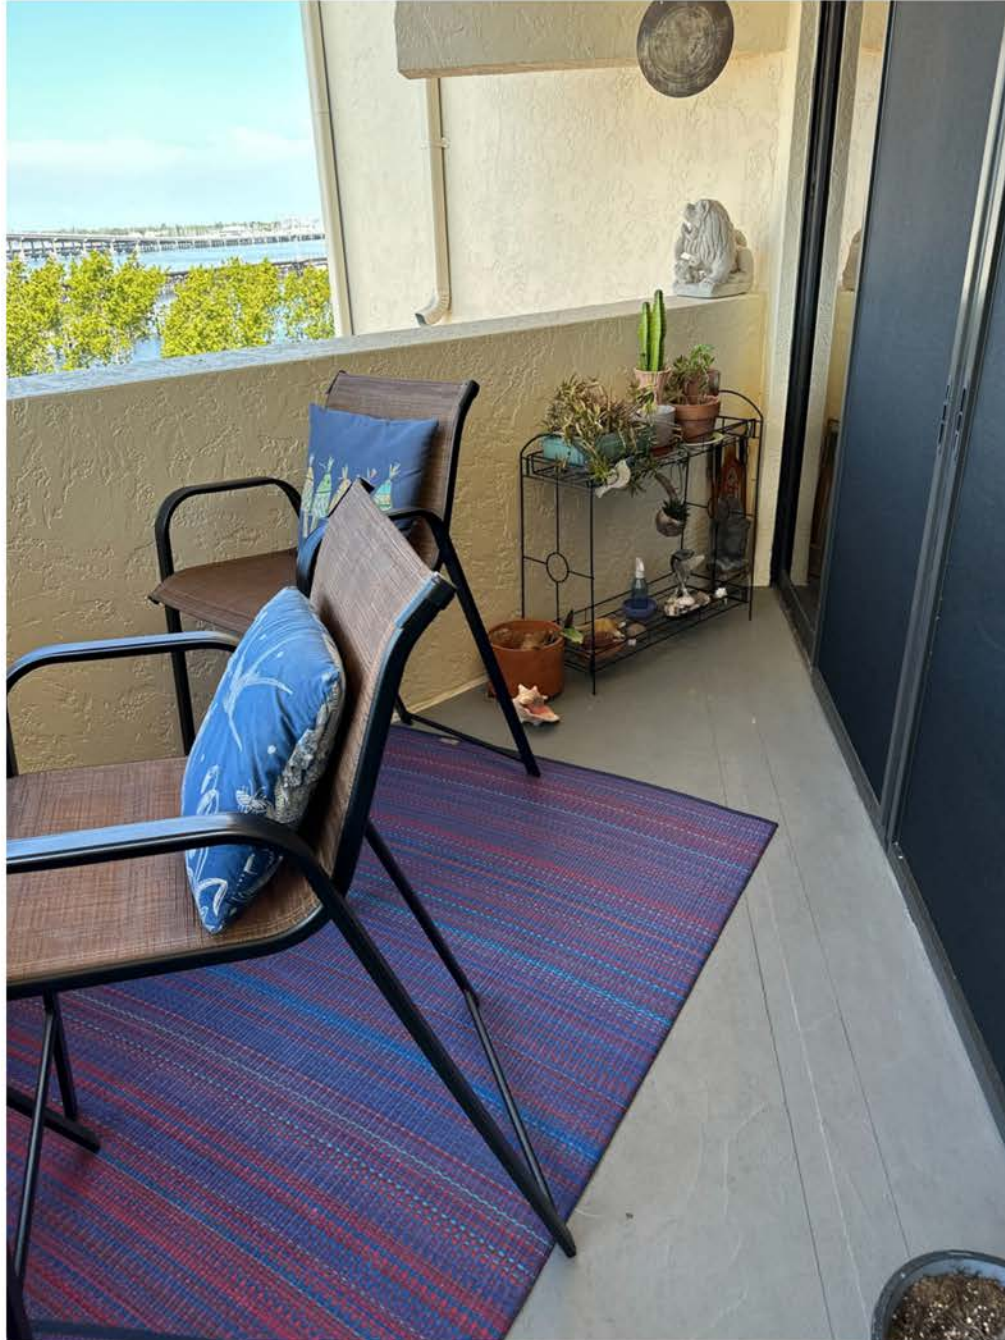
Unit 306 Balcony floor (cementitious gray finish covered in colored rugs). Appears to be in good condition, no cracking or spalling on walls or ceiling or issues anywhere adjacent that are visible.

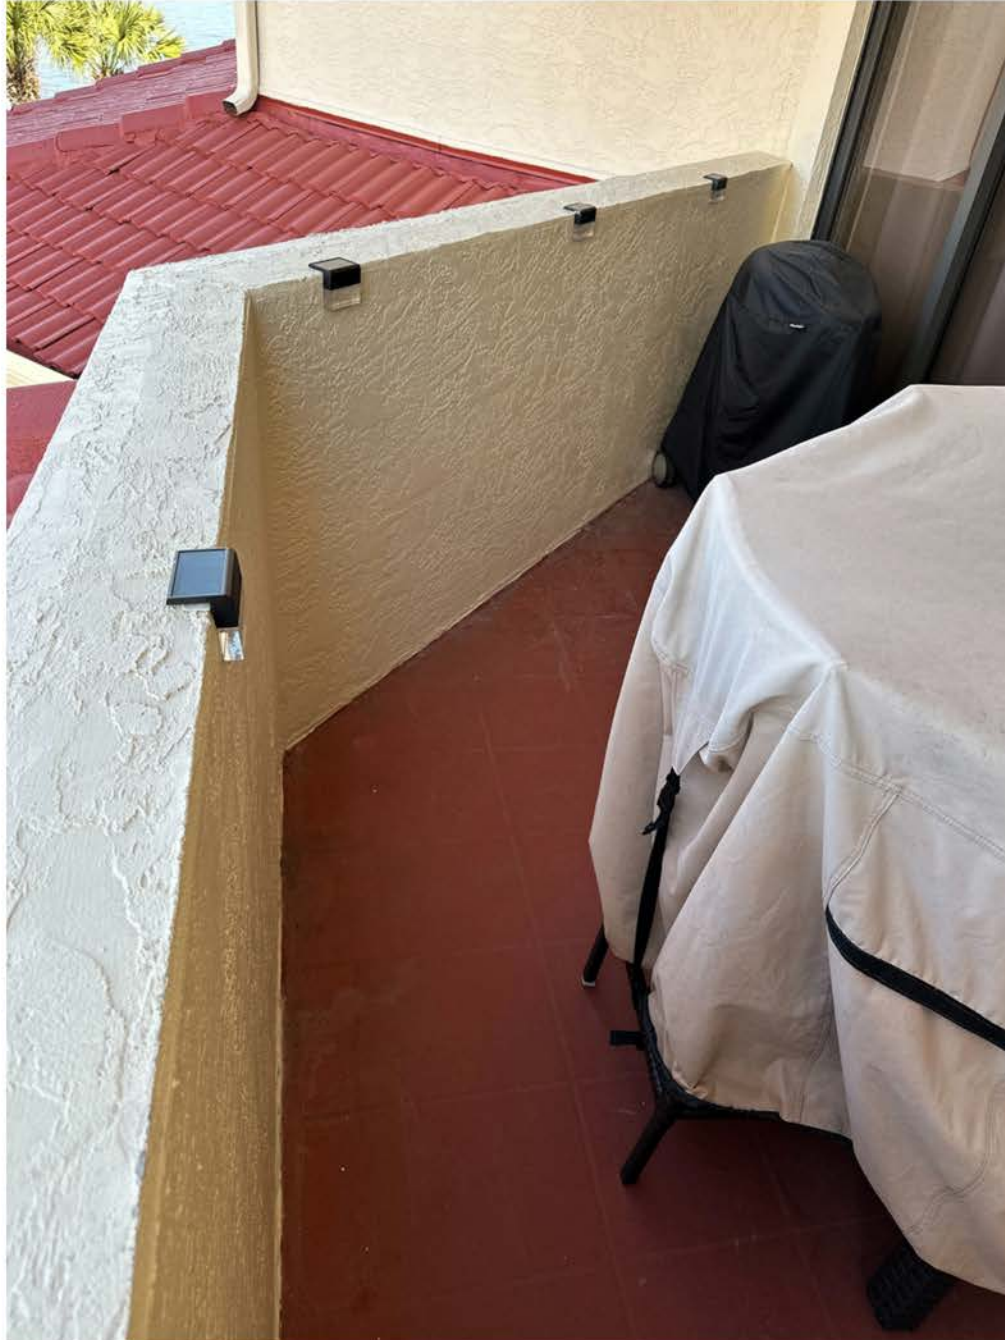
Unit 207 Balcony floor (cementitious finish in red tiles). Good condition. No spalling or cracking observed in wall or ceiling .

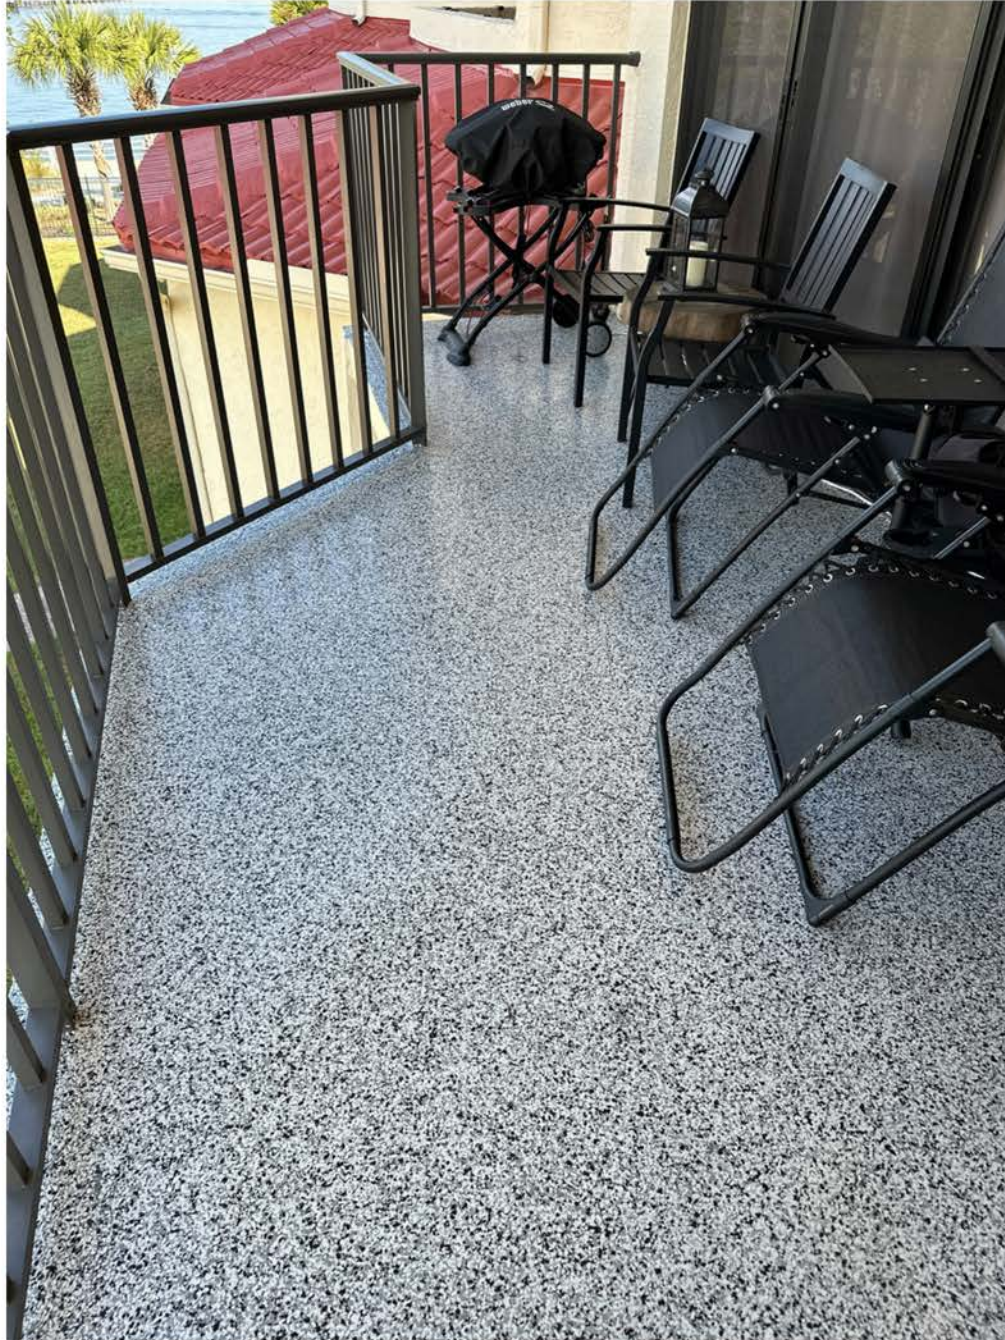
Unit 206 Balcony floor (exterior black-and-white aggregate epoxy finish) Balcony slab in good condition. No cracking or spalling in walls or ceiling or adjacent locations.

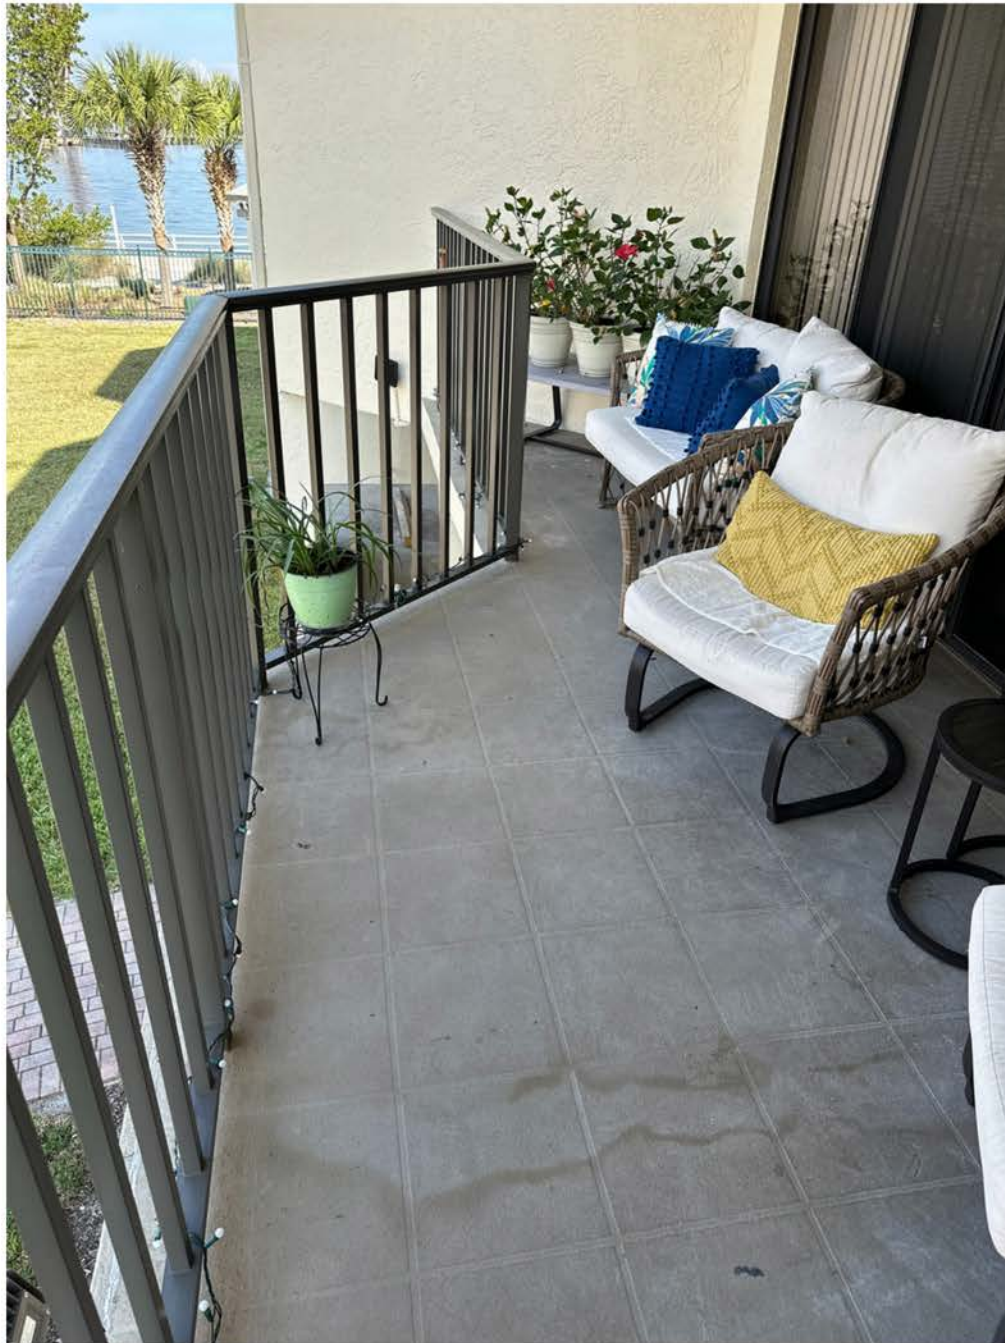
Unit 107 Balcony floor (faux cementitious tile light gray color). In good condition, with some deterioration of coating at slab edges adjacent to the guard rail post. Otherwise, no cracking or spalling in walls or ceiling. Interior drywall ceiling shows evidence of past leak, water staining. Does not appear to be an active leak.

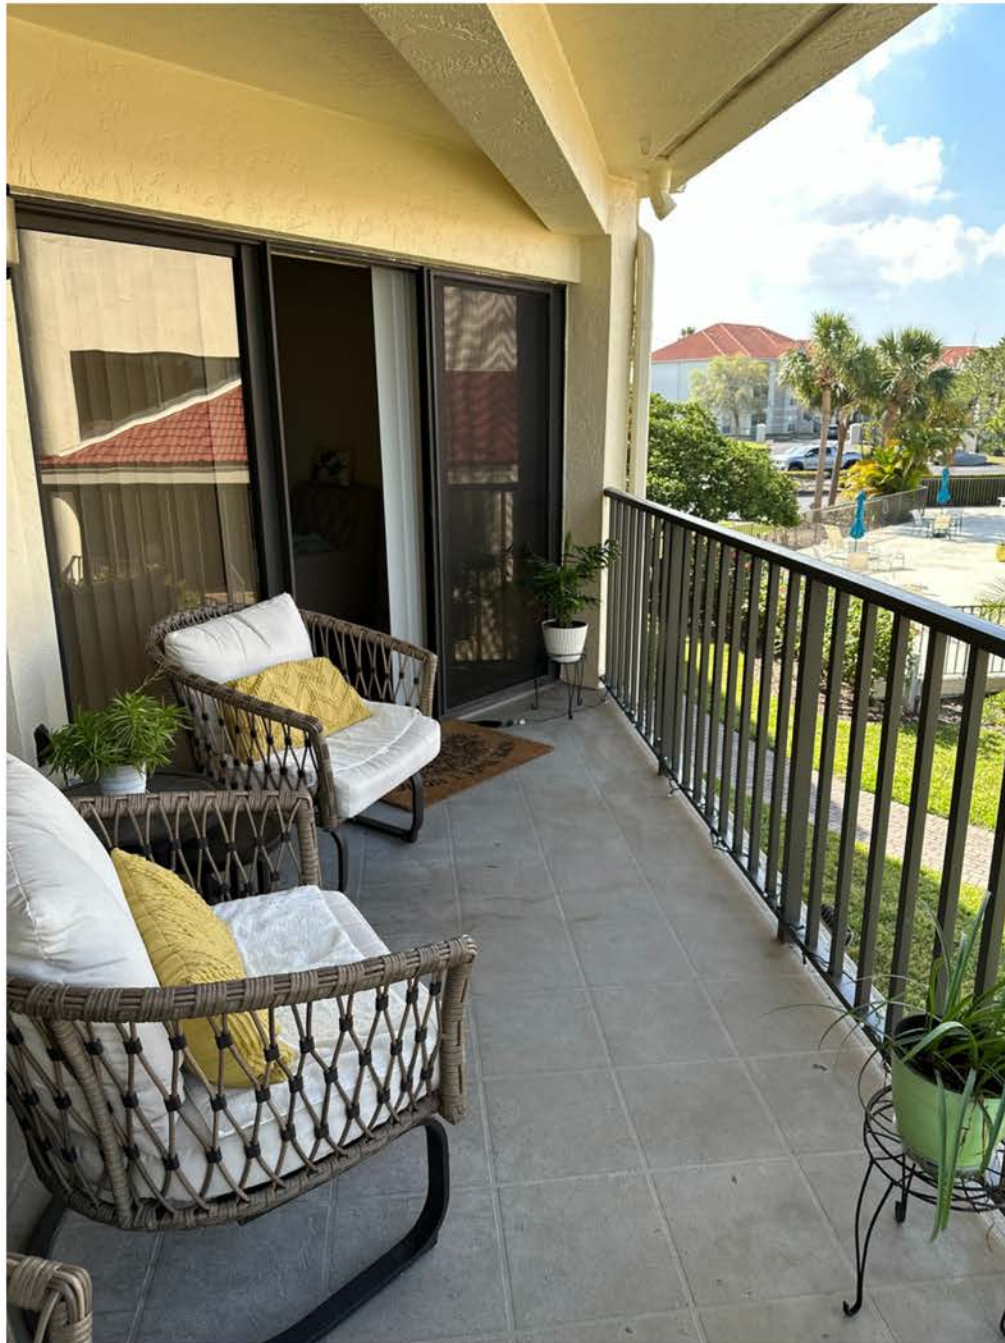
Unit 107 Balcony floor (faux cementitious tile light gray color) in good condition.

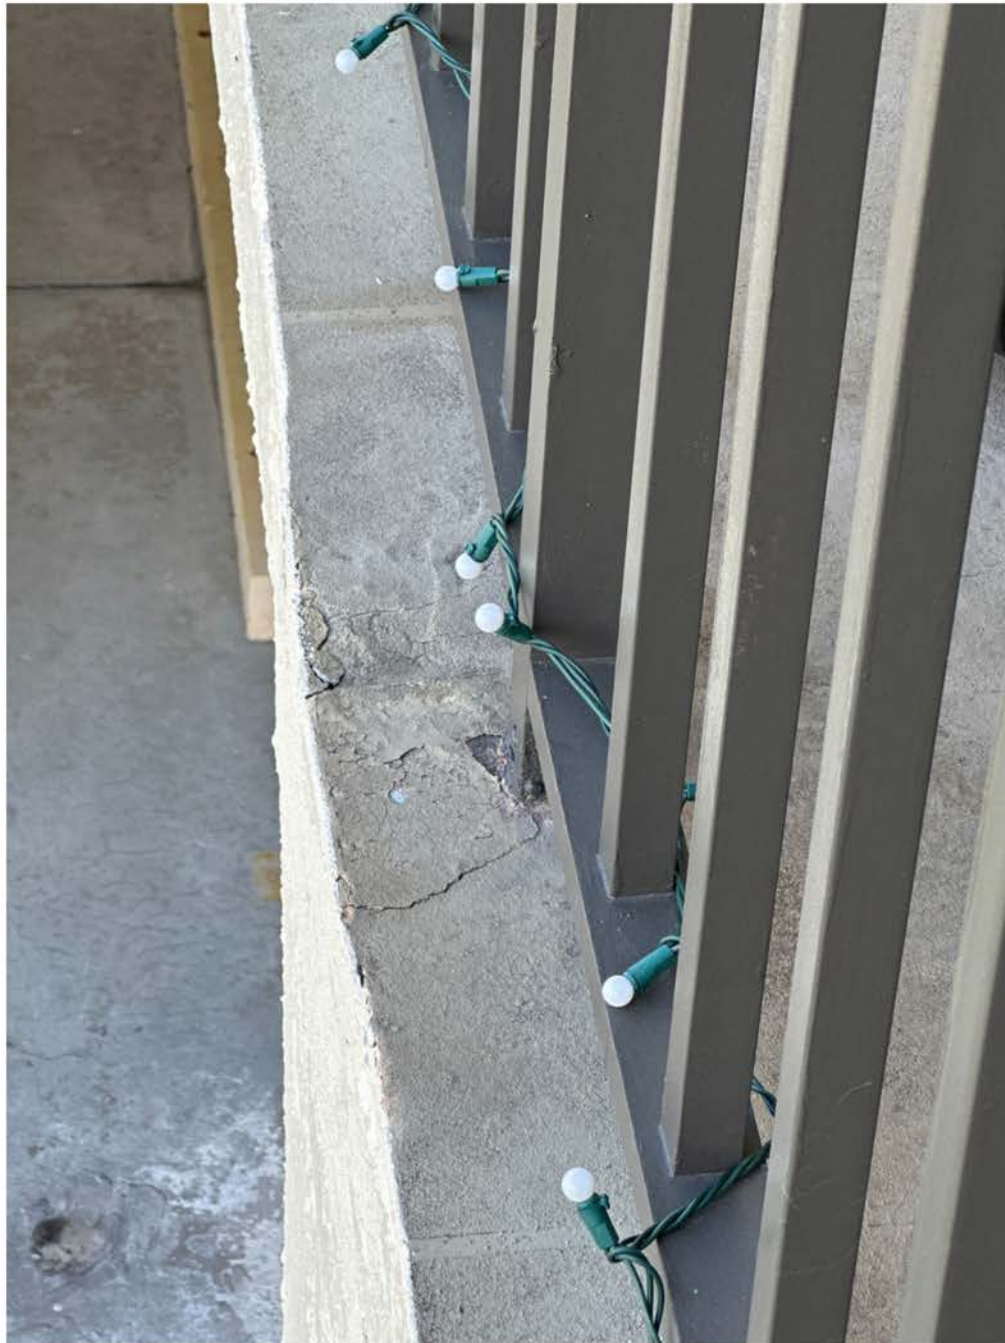
Unit 107 balcony floor is faux cementitious tile light gray color. Coating deterioration observed at outside slab edge of balcony.

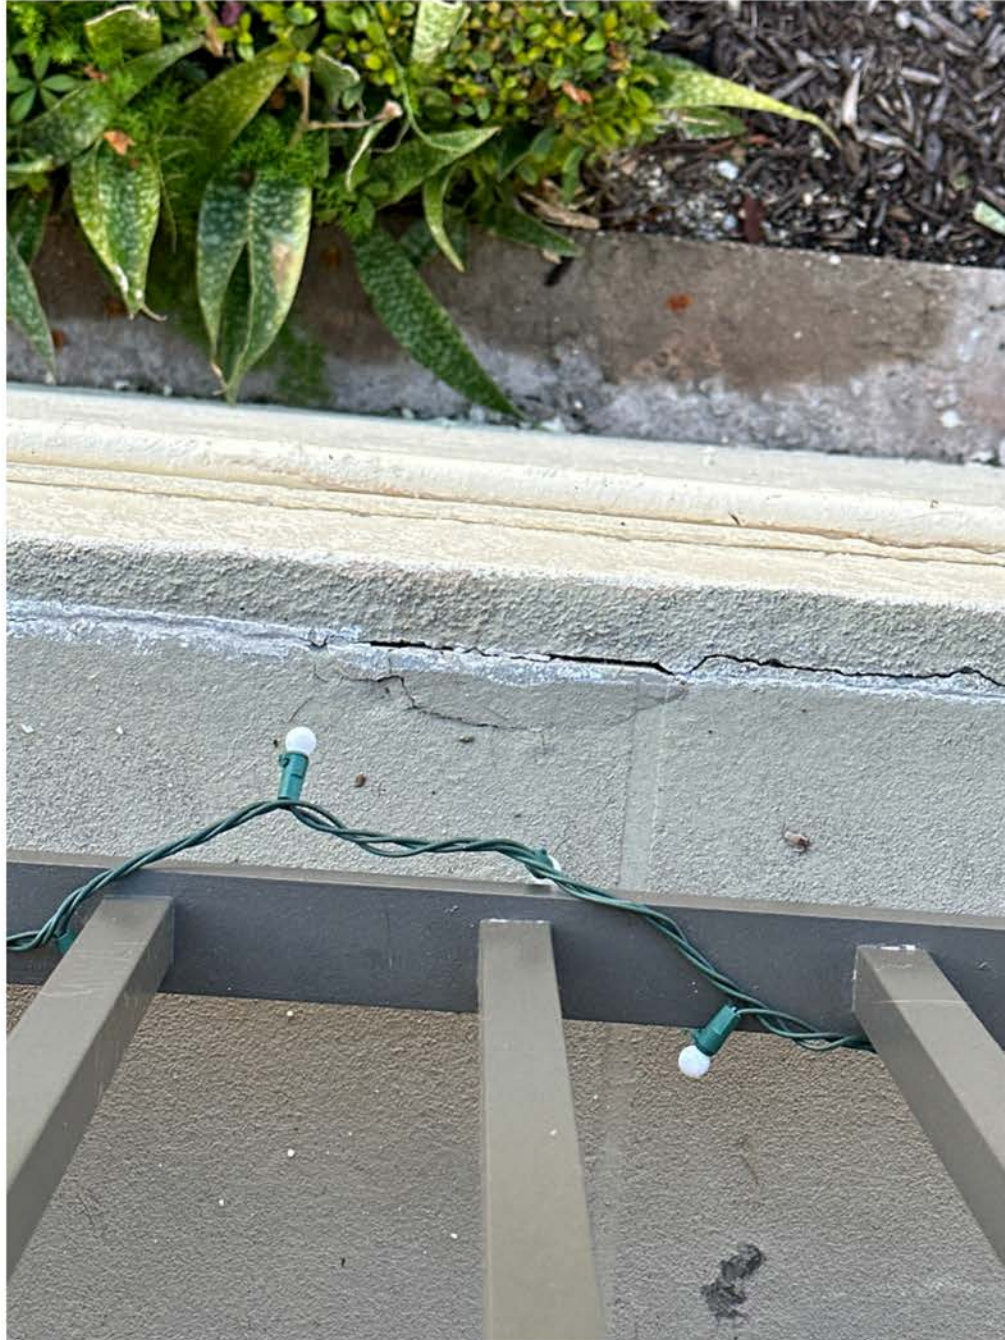
Unit 107 balcony floor at outside slab edge. Recommend investigation and repair of deck coating by licensed contractor.

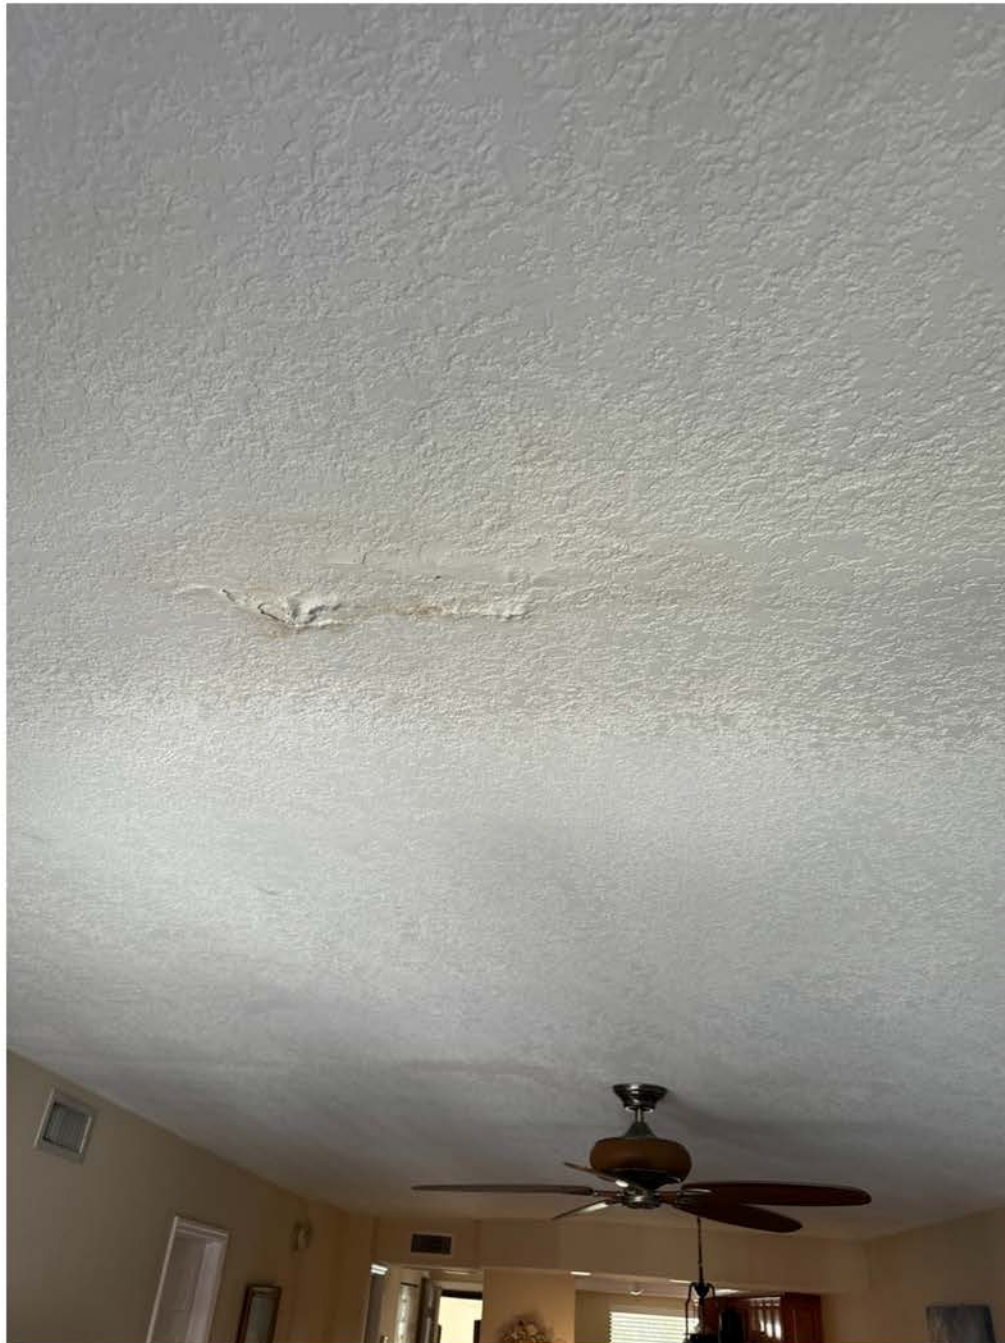
Unit 107, interior staining observed on ceiling.

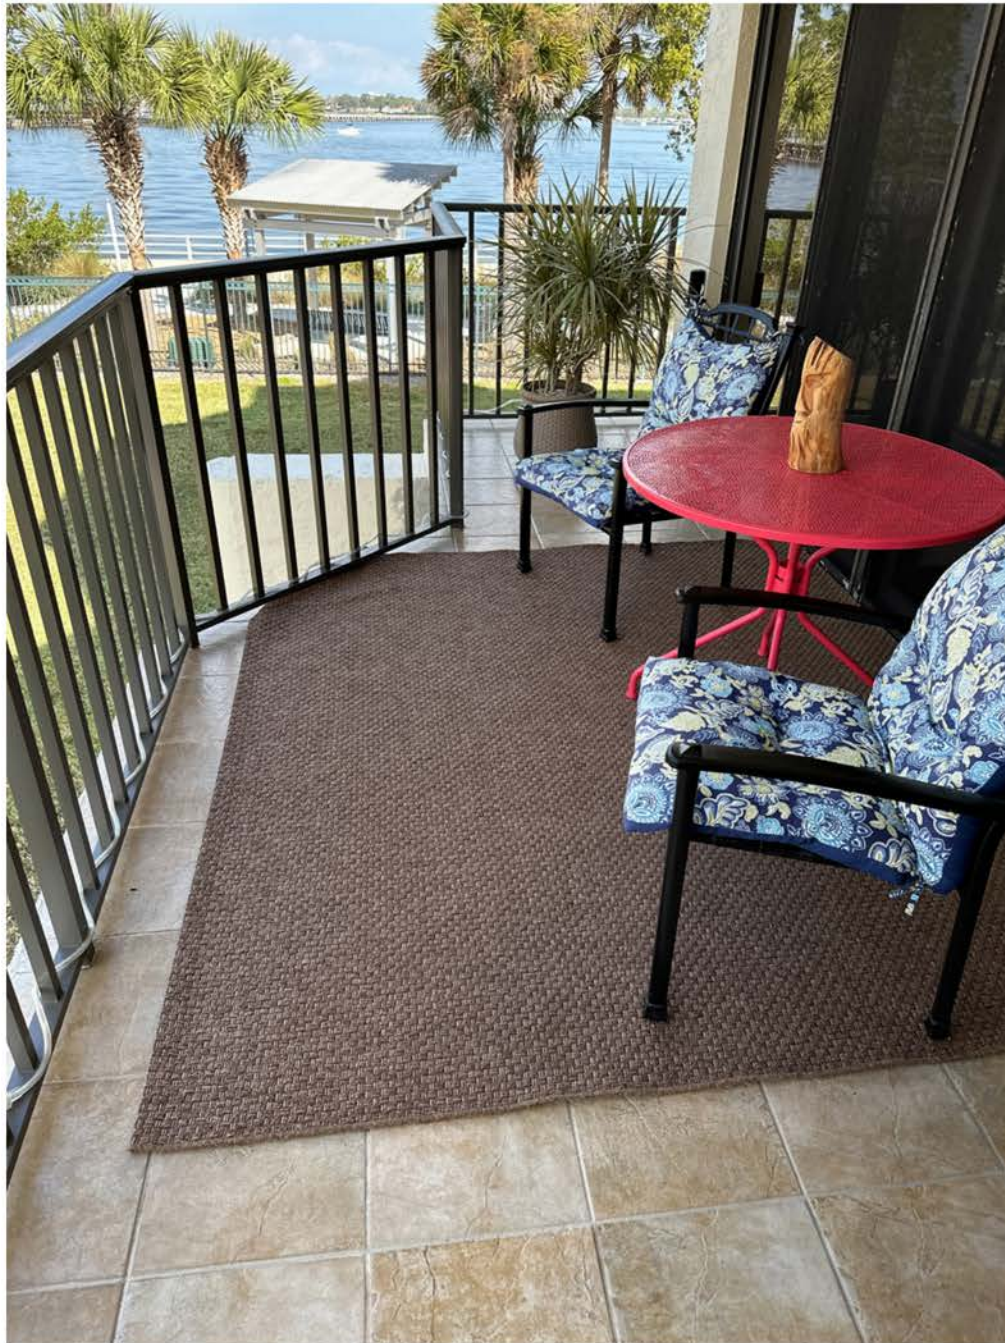
**Unit 108 Balcony floor (clad in outdoor tile brown and white color mixed with area rug and chairs)
Balcony slab is in good condition. No issues. No cracking or spalling on walls or ceiling. Minor cracking
at balcony tile slab edge in the grout line--nonstructural issue.**

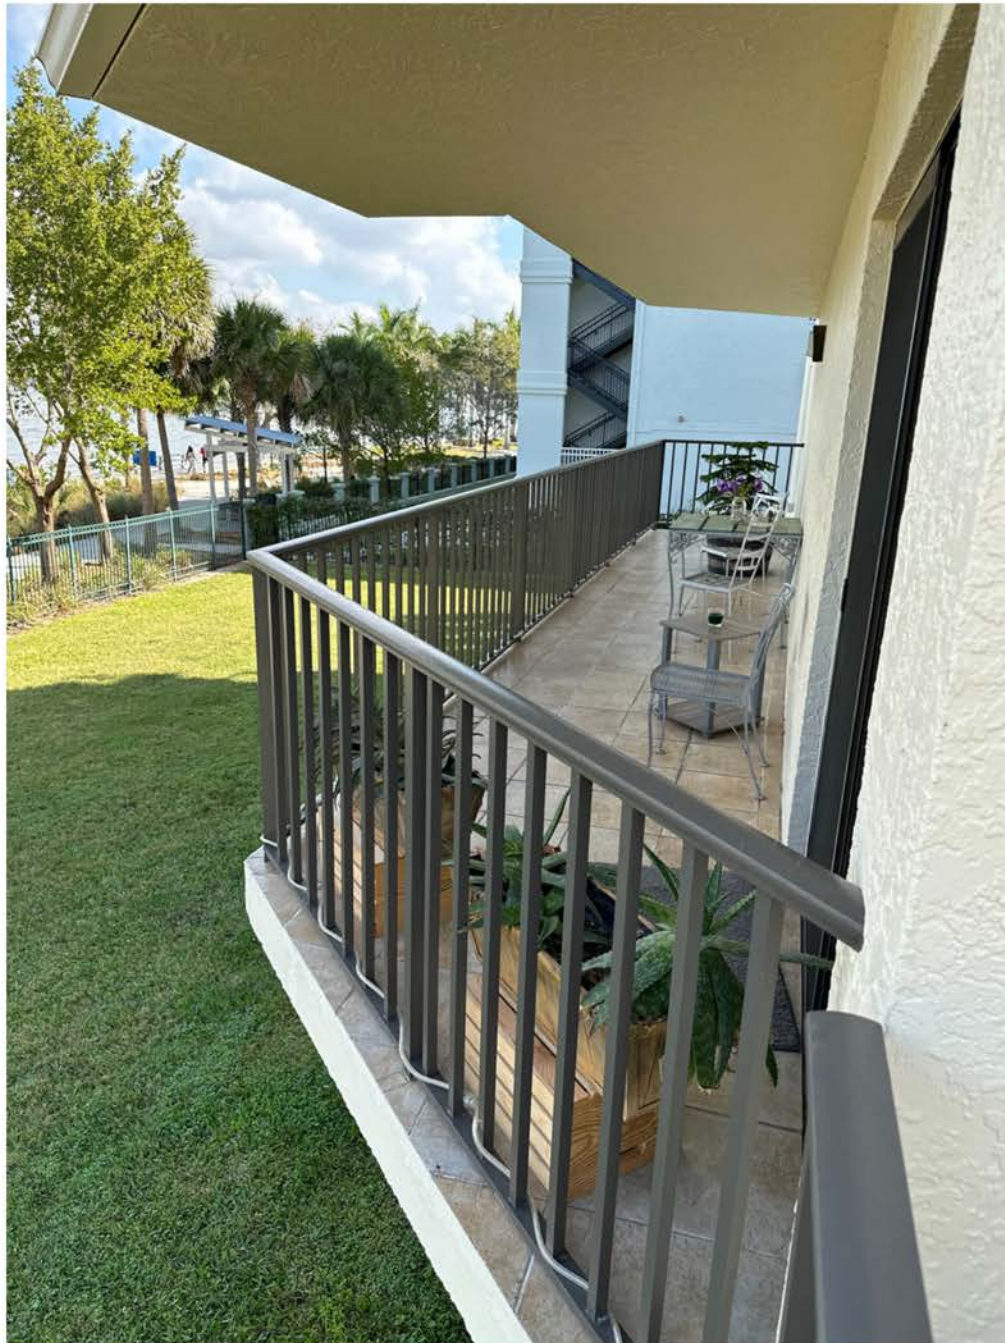
Unit 108 balcony is clad in outdoor tile brown and white color. Balcony is in good condition. No issues. No cracking or spalling on walls or ceiling. Minor cracking at balcony tile slab Edge in the grout line-- nonstructural issue.
