APRIL 8, 2023

THIS MILESTONE PHASE 1 ENGINEERING INSPECTION WAS PRODUCED FOR RIVER YACHT & RACQUET CLUB CONDOMINIUM LOCATED AT 204 3RD ST. W, BRADENTON, FL 34205

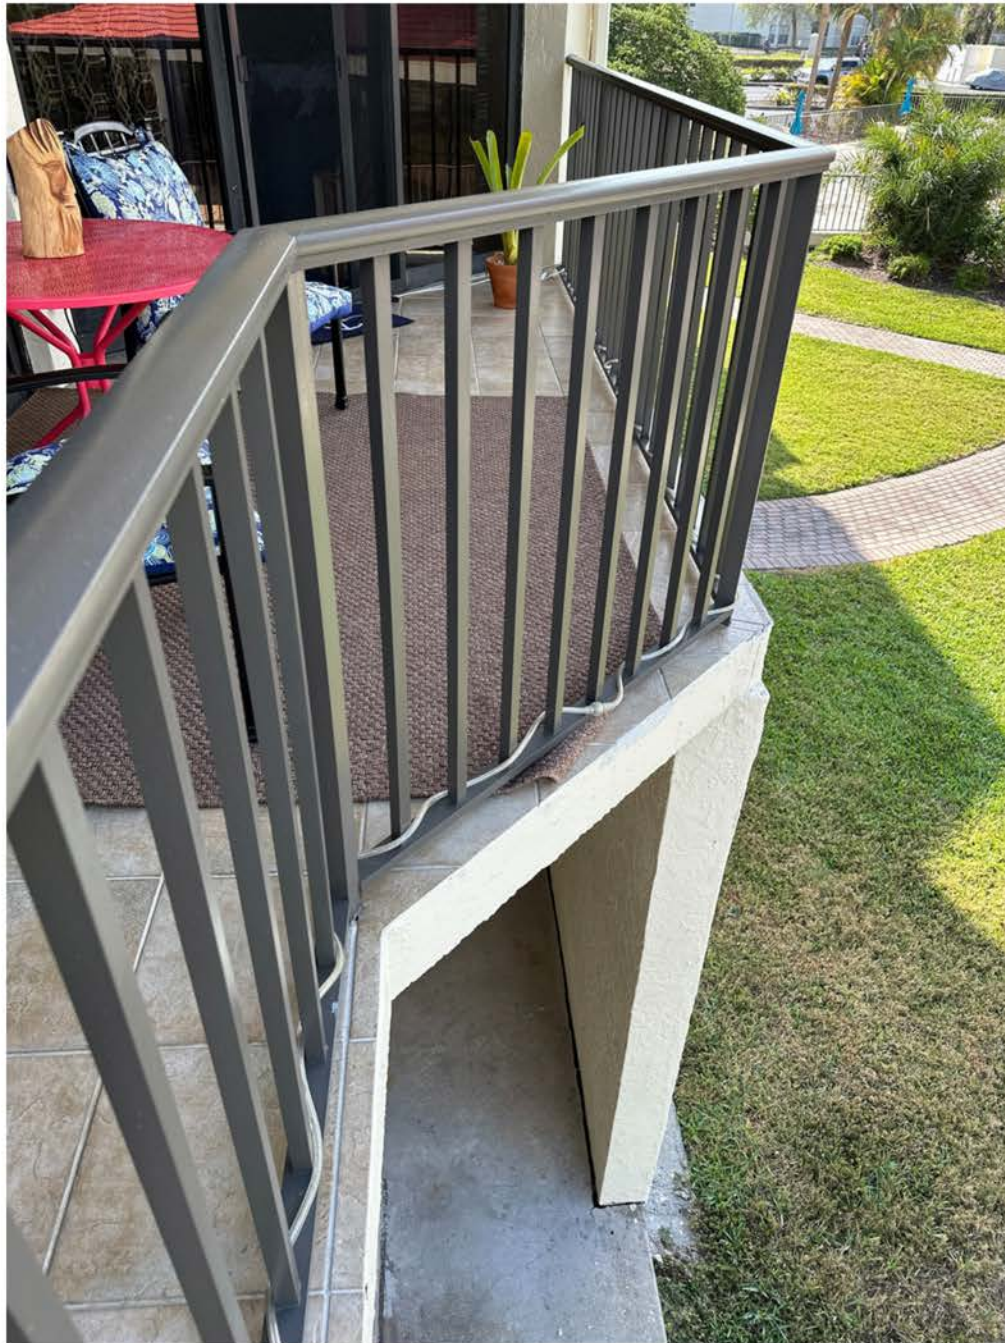
Unit 108 balcony is clad in outdoor tile brown and white color. Minor cracking at balcony tile to slab Edge in the grout line-- nonstructural issue.

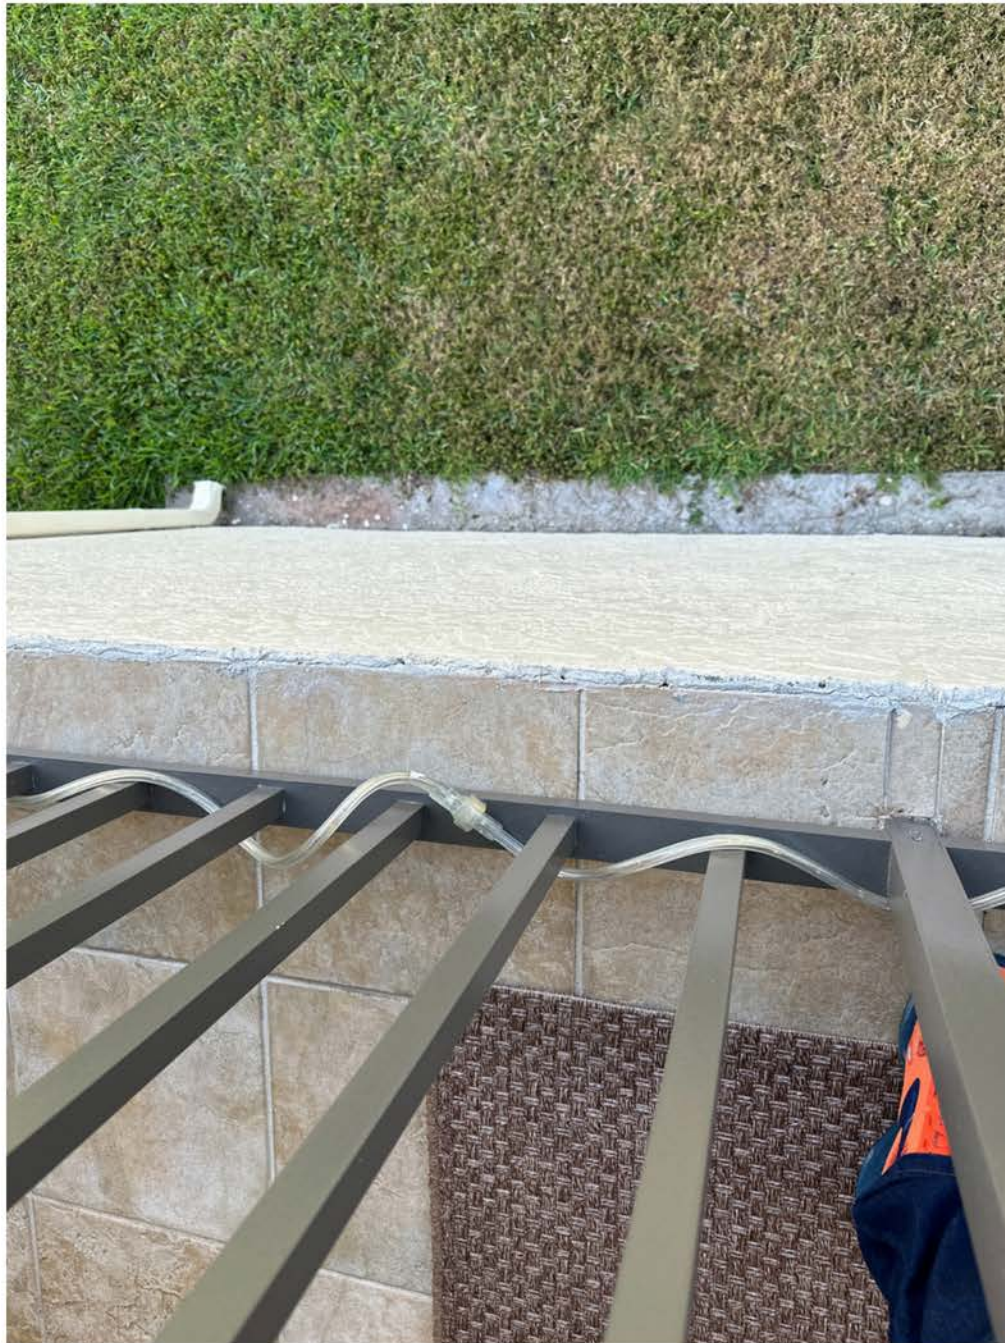
**Unit 108 balcony is clad in outdoor tile brown and white color. Minor cracking at balcony tile to slab
Edge in the grout line--nonstructural issue.**

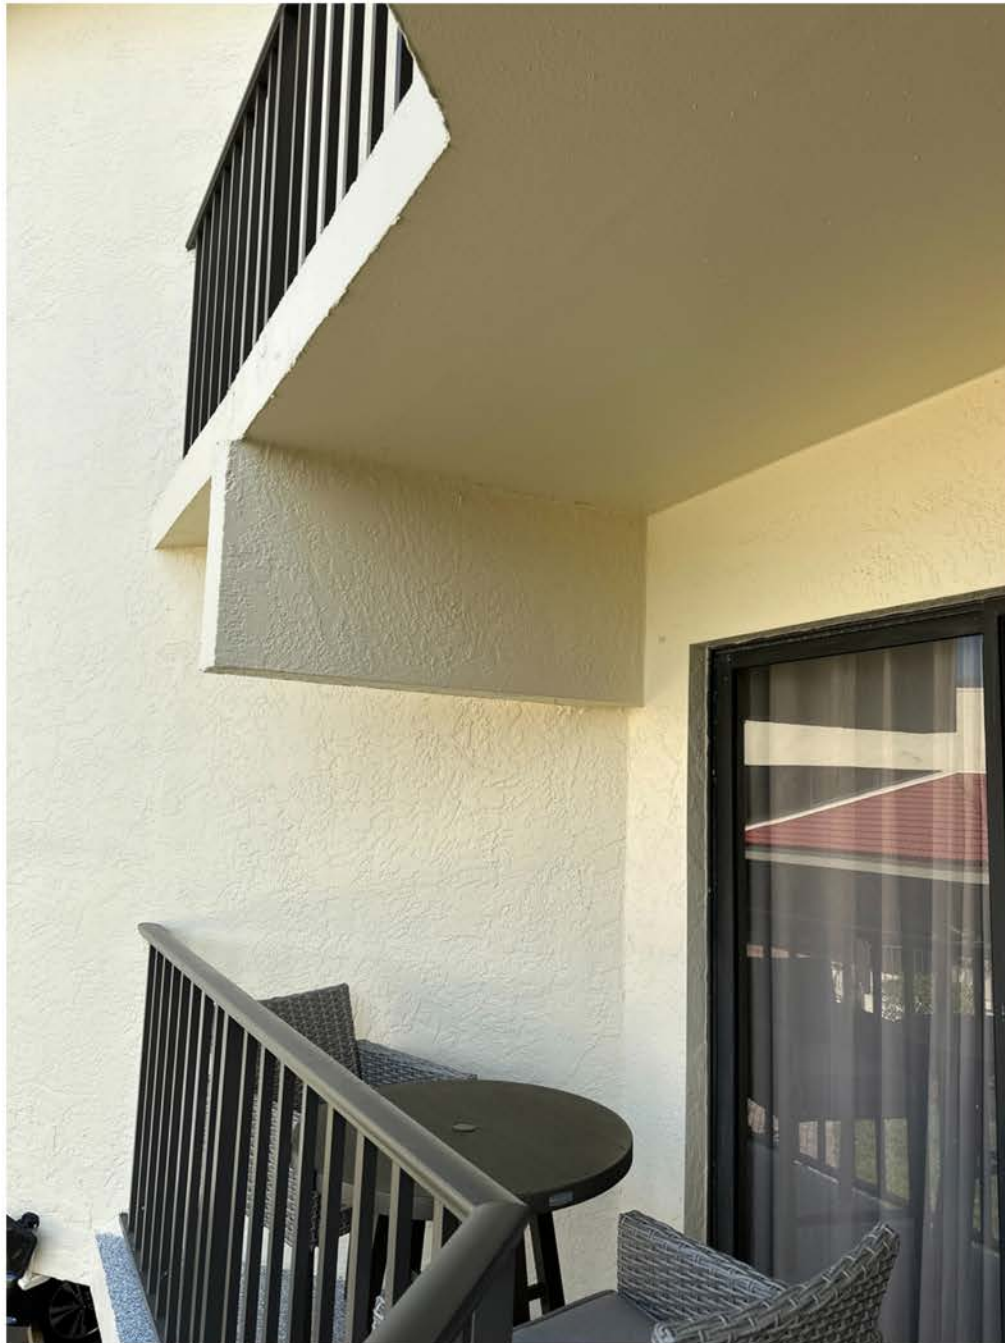
Unit 105. Balcony exterior is epoxy, aggregate, blue and white with blue area, rug and two chairs. Balcony is in good condition. Epoxy coating looks great. No spalls or cracking on walls or ceiling or any adjacent areas. Note that there is a potential water leak water coming down through slab from balcony above which is Unit 205. Minor cracking on interior drywall ceiling (nonstructural).

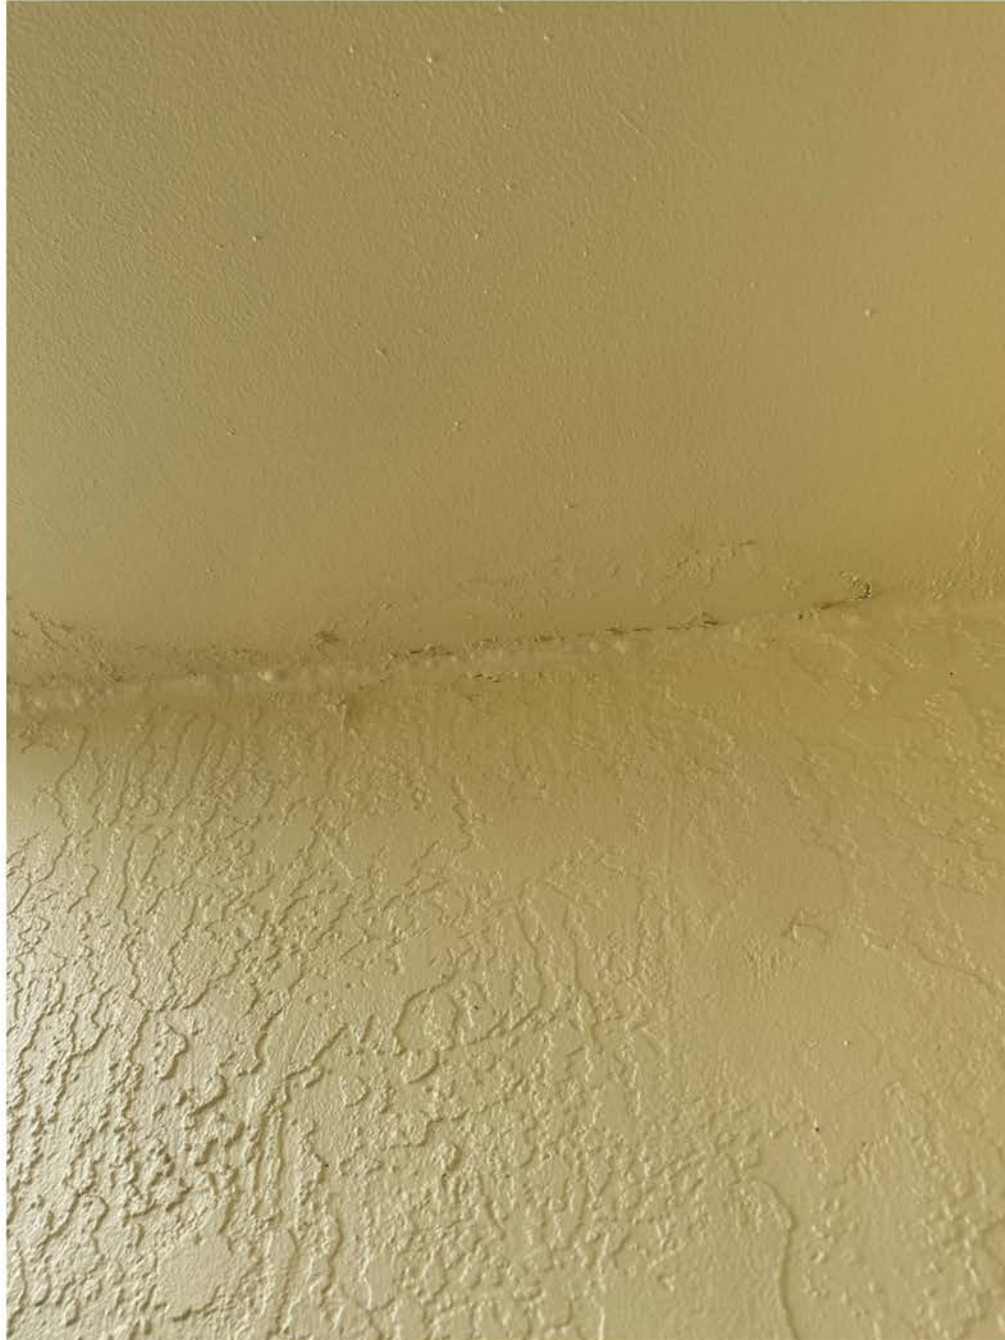
Unit 105. Balcony exterior, wall to ceiling intersection. Note the potential water leak water coming down through slab from balcony above which is Unit 205.

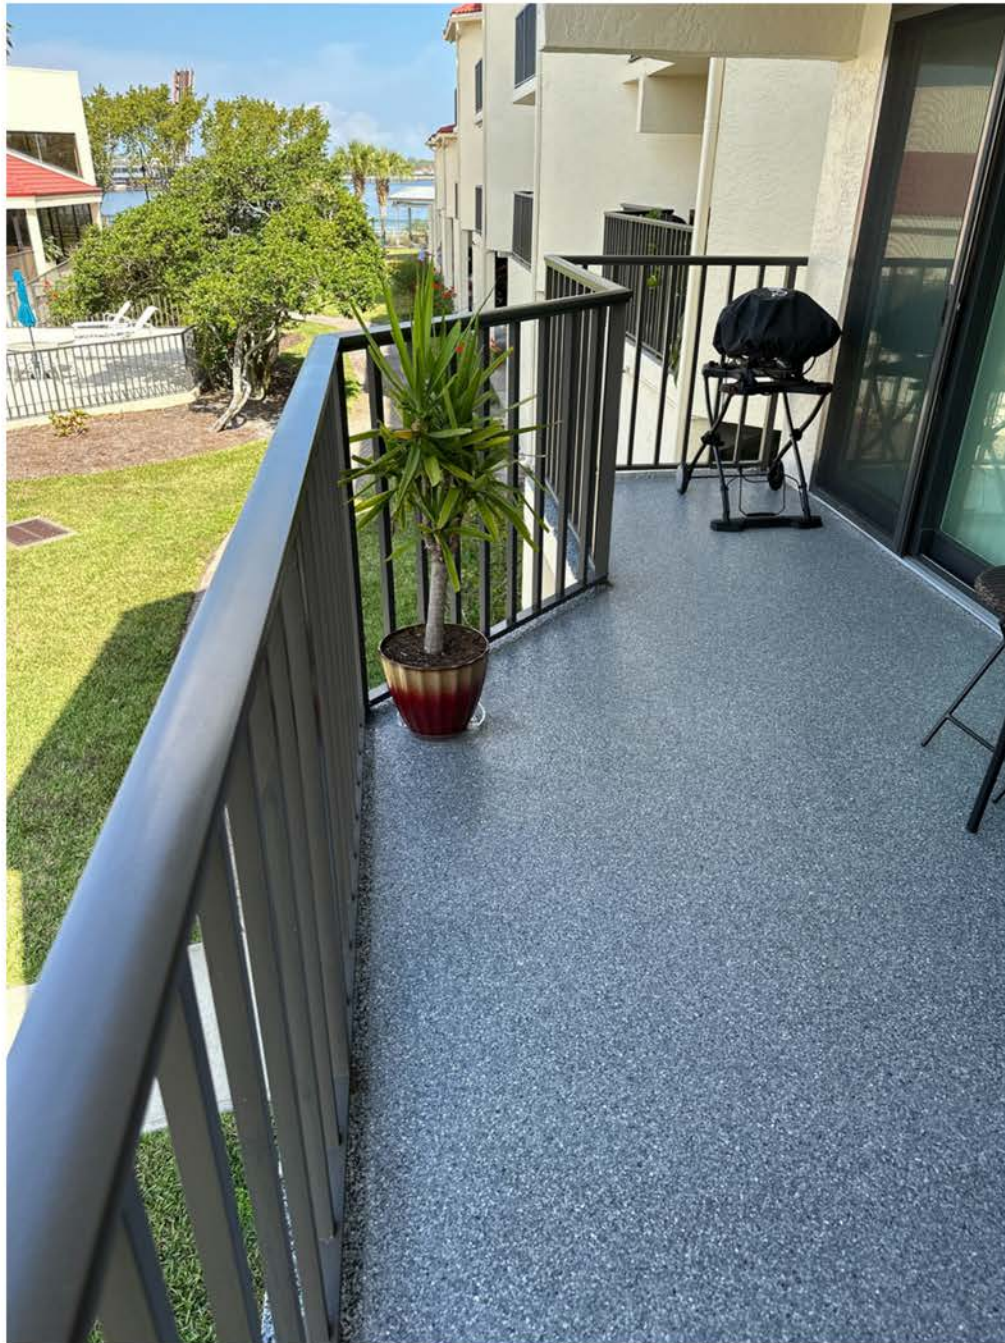
Unit 102 Balcony floor (dark gray epoxy coating with aggregate). Balcony slabs in good condition. no issues no cracking or spalling on walls or ceiling. Sliding glass doors are brand new in excellent condition. No issues observed on any adjacent balconies or walls.
