# Milestone Inspection Report Phase 1

## The Terra Ceia Club Condominium Association Inc.

**2320 Terra Ceia Bay Blvd.  
Palmetto, FL 34221**

Prepared on:  
**10/26/2023**

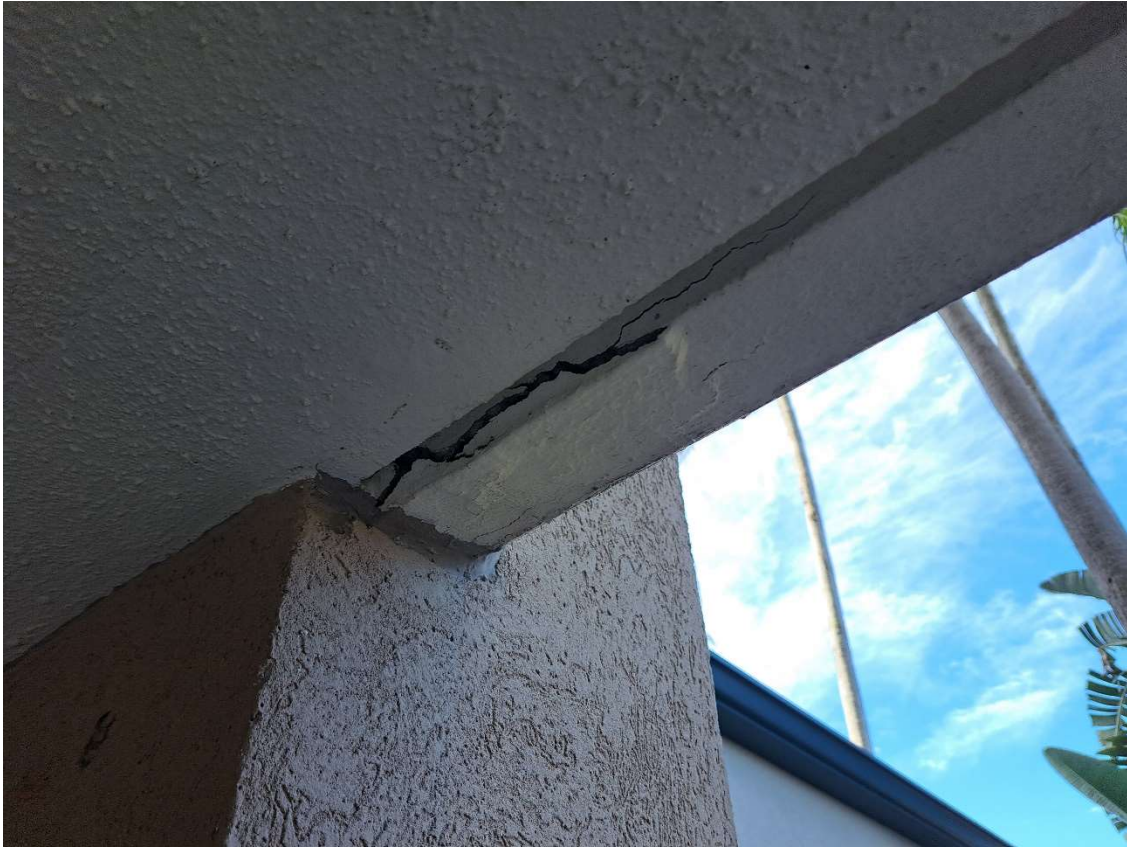
2.1.1.1 Spalling is occurring mainly at the old post pocket locations along the slab edges and above the old post pocket locations. Cracking is also occurring from the old post pocket locations into the walkways, (Photos 01 through 08).

2.1.1.2 The spalling and cracking are indications that water is infiltrating into the concrete structure and corroding the reinforcing steel.

2.1.1.3 Steel can expand up to four times its volume causing damage to the surrounding concrete.

*Photo 01 Ref: 2.1.1.1 – Old Post Pockets Causing Spalling On Slab Edges (Typcial)*

3.1.1.1 Perform a Phase Two Milestone Inspection of the items identified in Section 2.1 of this report in accordance with FS 553.899(7)(b). The engineer performing the Phase Two Milestone Inspection should provide recommended repairs to address the items identified in both reports.

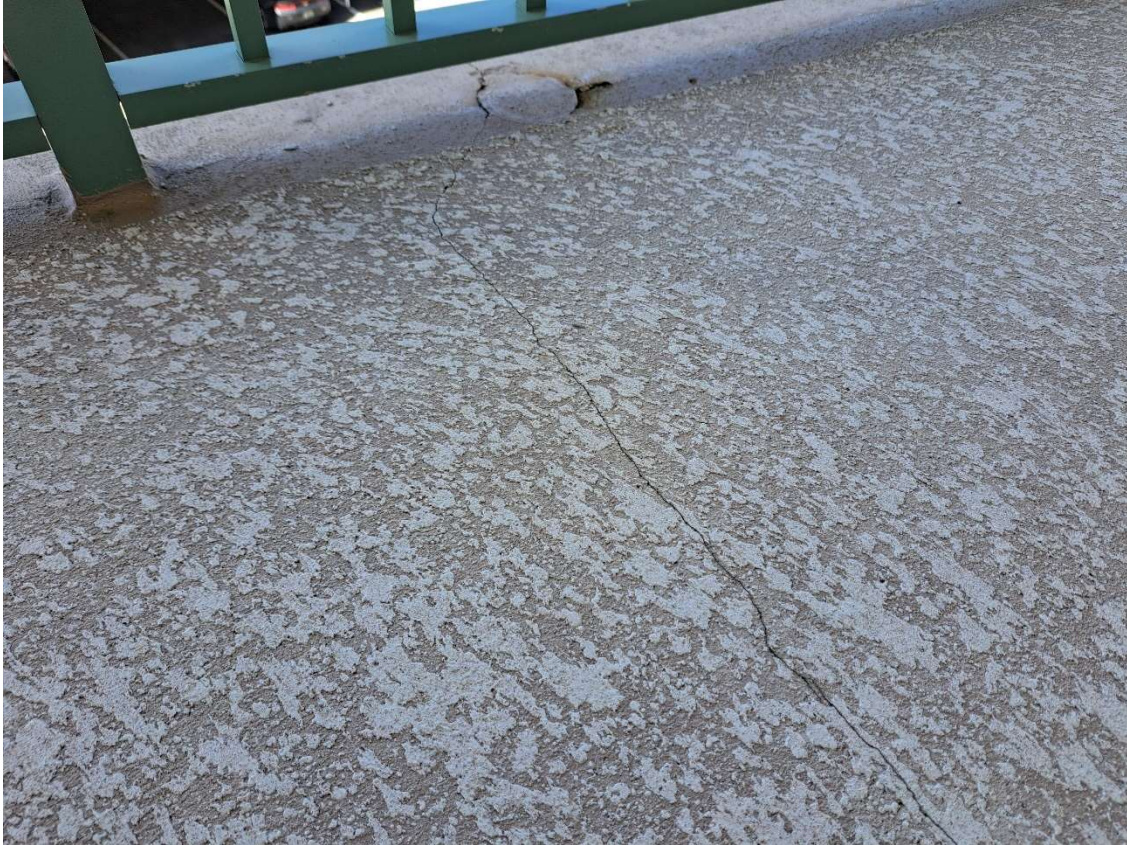
*Photo 02 Ref: 2.1.1.1 – Old Post Pockets Causing Cracks On Walkways (Typcial)*

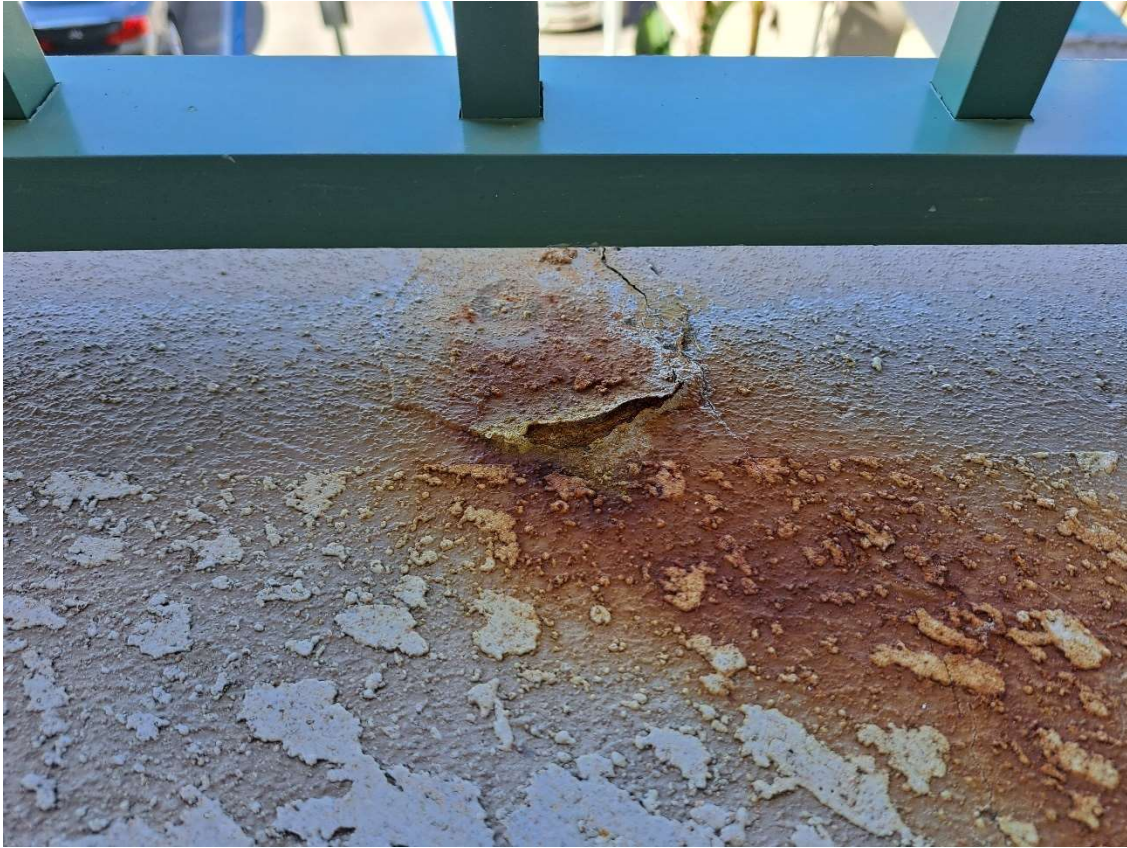
*Photo 03 Ref: 2.1.1.1 – Old Post Pockets Causing Spalling Above Post Pockets (Typcial)*

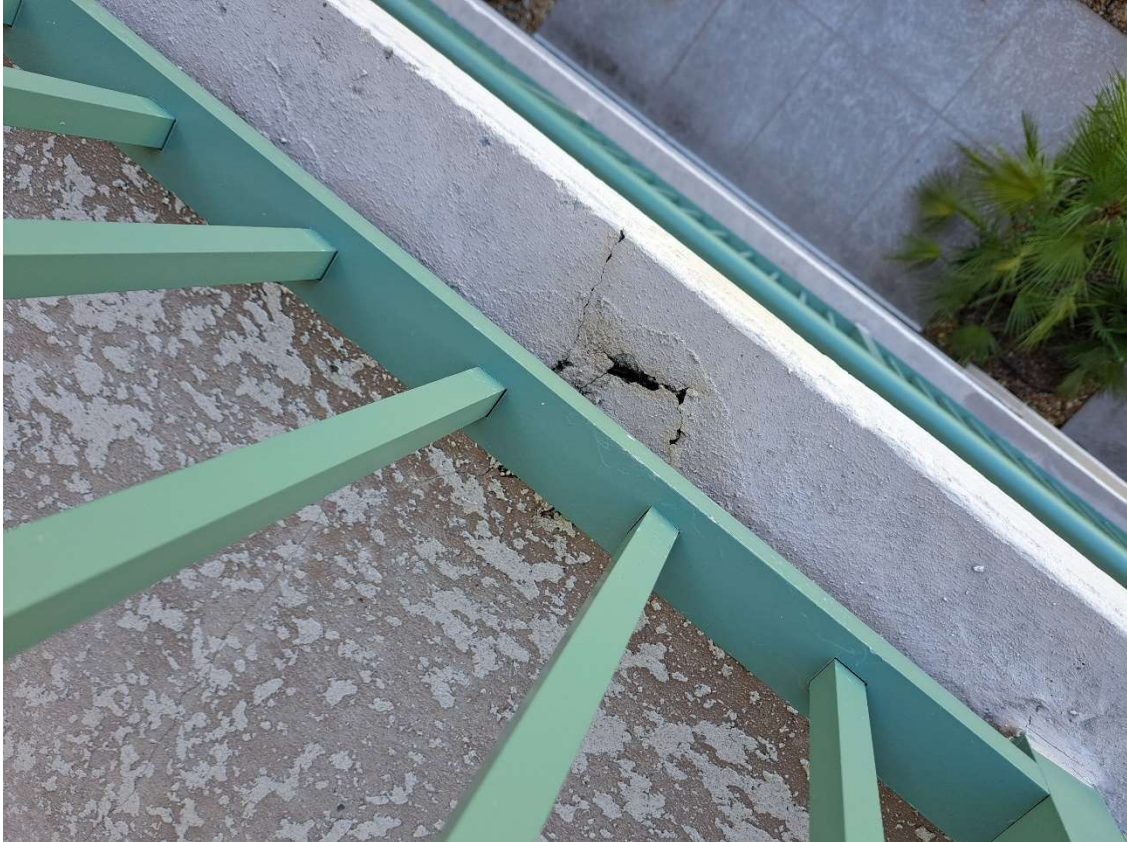
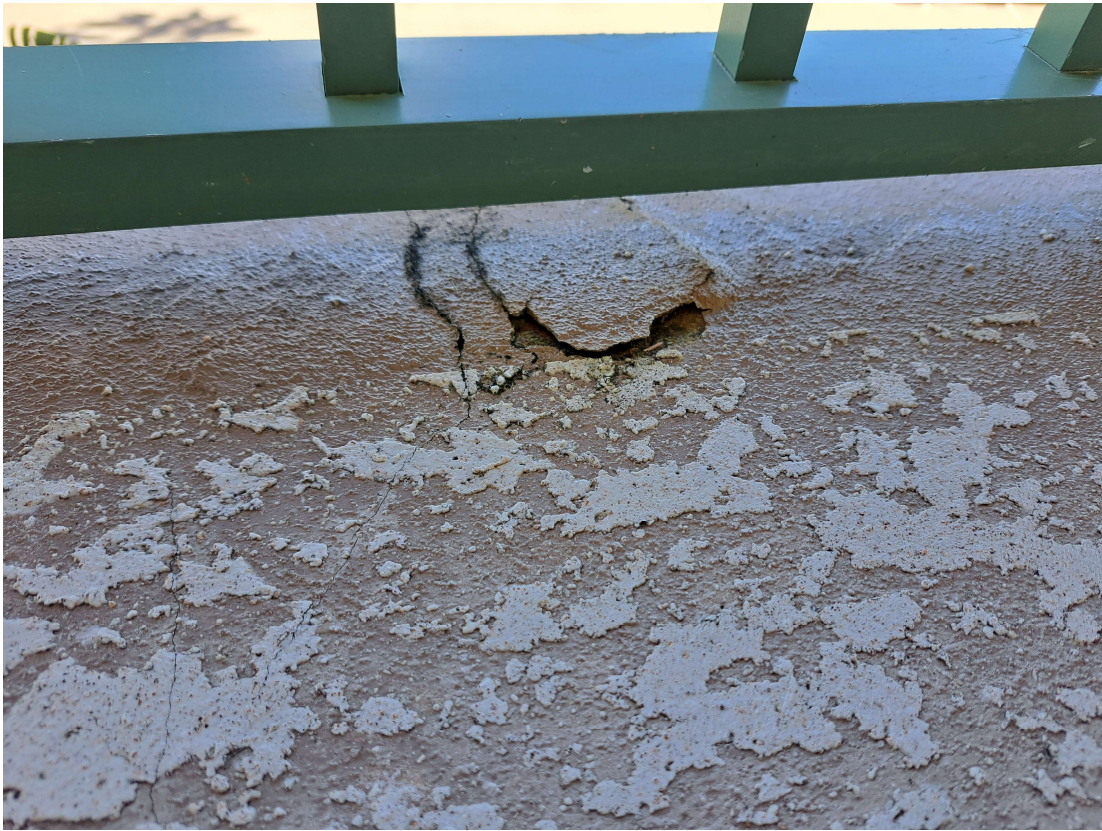
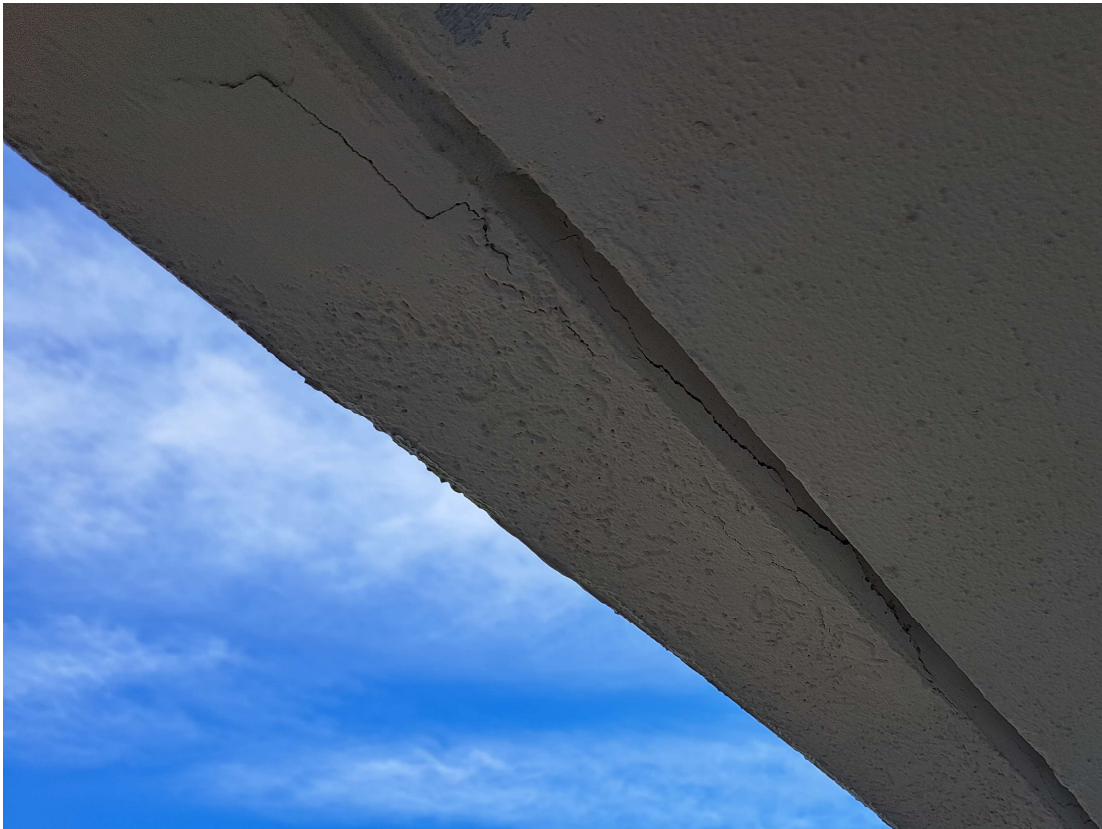
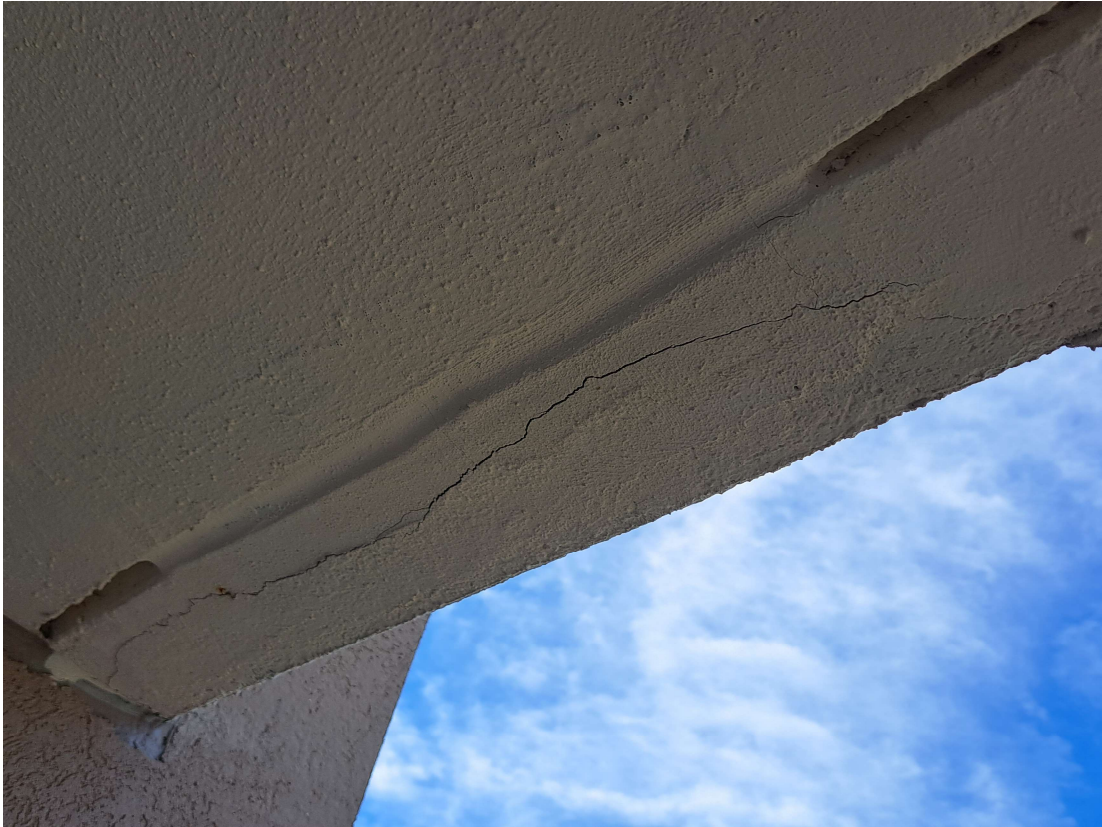
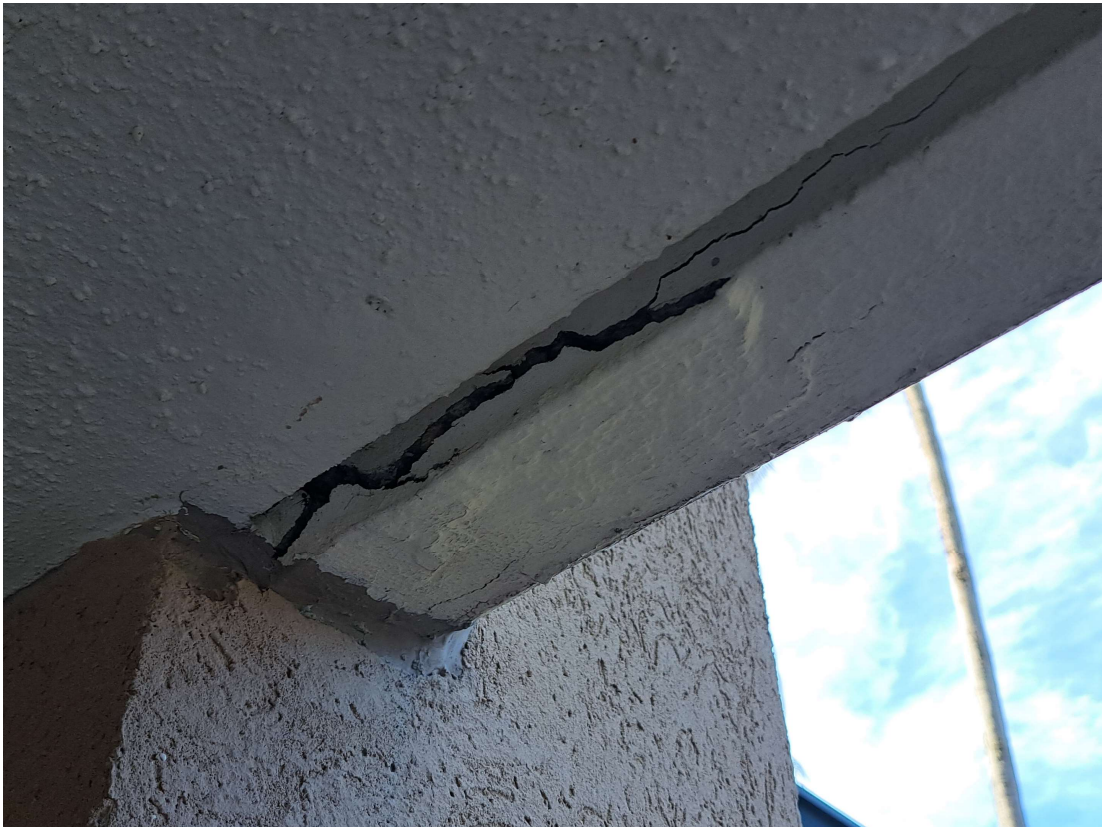
*Photo 04 Ref: 2.1.1.1 – Old Post Pockets Causing Spalling and Cracks (Typcial)*

*Photo 05 Ref: 2.1.1.1 – Old Post Pockets Causing Spalling and Cracks (Typcial)*

*Photo 06 Ref: 2.1.1.1 – Old Post Pockets Causing Spalling and Cracks (Typcial)*

*Photo 07 Ref: 2.1.1.1 – Old Post Pockets Causing Spalling and Cracks (Typcial)*

*Photo 08 Ref: 2.1.1.1 – Old Post Pockets Causing Spalling and Cracks (Typcial)*

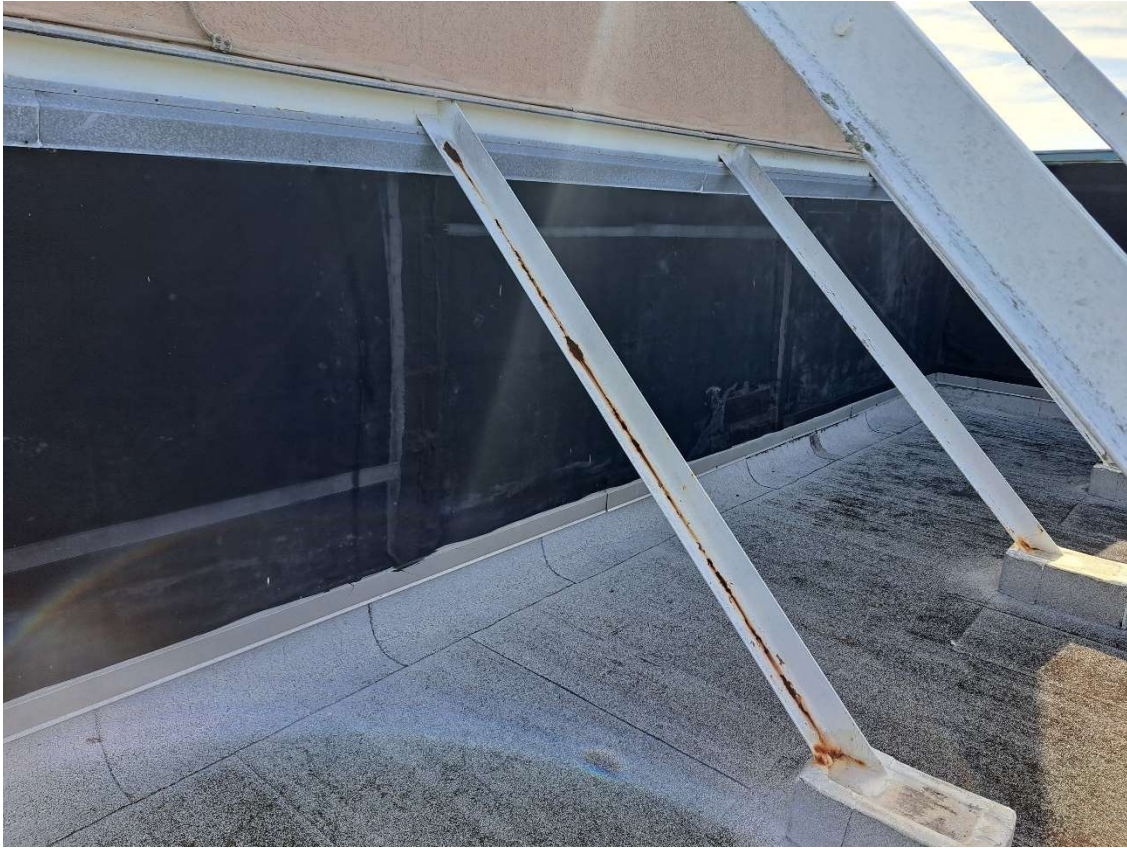
2.2.1.1 The steel L-channel braces supporting the decorative parapet extension façade are rusting (Photo 09 Typical) which can lead to structural capacity reduction.

*Photo 09 Ref: 2.2.1.1 – Corroded Façade Supports*

- 3.1.2.1 Roof Façade braces and stair landing brackets should be wire brushed to remove all rust and repainted.
- 3.1.2.2 All caulk should be removed from the underside joints of the stair landings where the precast slab meets the tower side walls in order to prevent the trapping of water inside these joints. The cracks at the cold joints on these landing slabs should be routed out and filled with caulk to prevent water from entering the joint.

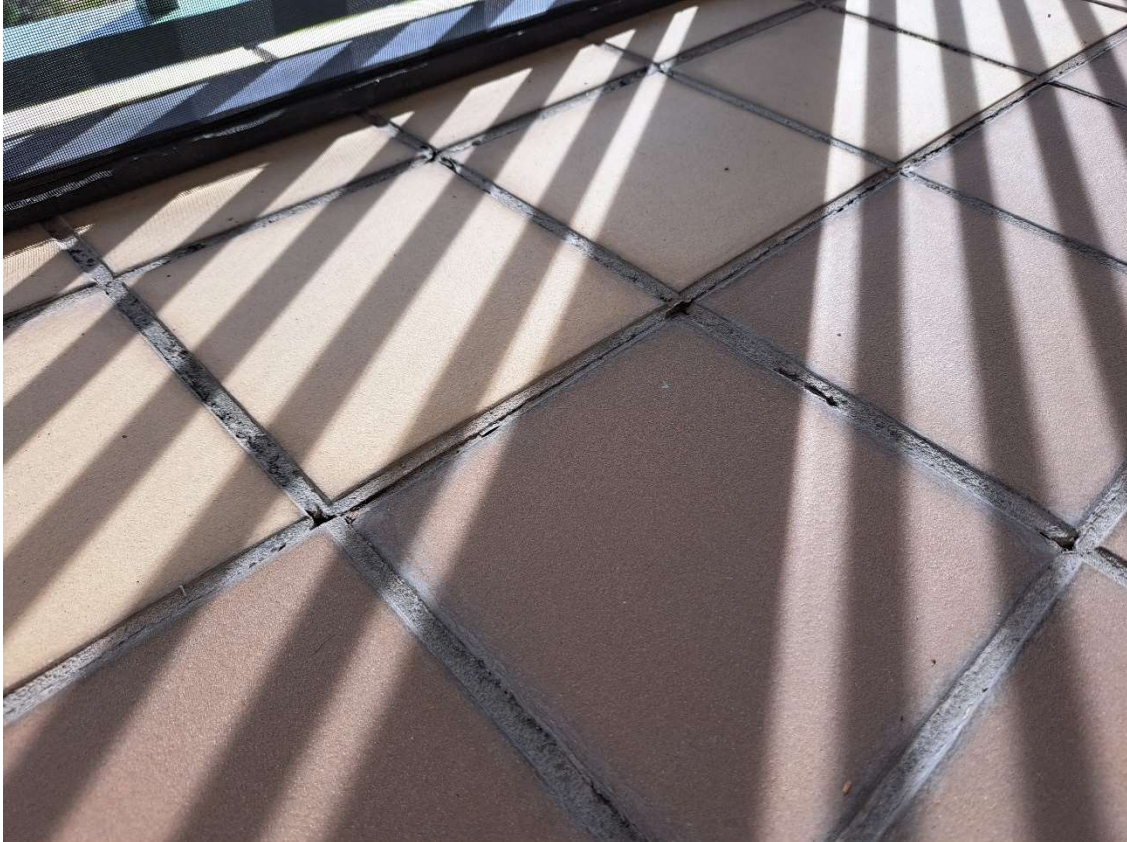
Lanai tile grout had staining and cracking (Photos 10 Typical).

Many areas of the tile appear to be deboned from the concrete substrate. This is an indication of concrete and mortar degradation usually by chronic water intrusion below the tile.

The backwards slope of the lanais also contributes to this tile and concrete degradation by allowing water to pool on the tile/concrete.

*Photo 10 Ref: 2.2.2.1 – Debonded Tile With Damaged Grout (Typical)*

- 3.1.2.3 Remaining lanais with tile should be sounded to check for debonding and potential concrete deterioration, stripped, sloped properly, and waterproofed if found to be de-bonded. After these lanais are finished, all screen enclosure fasteners driven into them should be constructed of stainless steel.

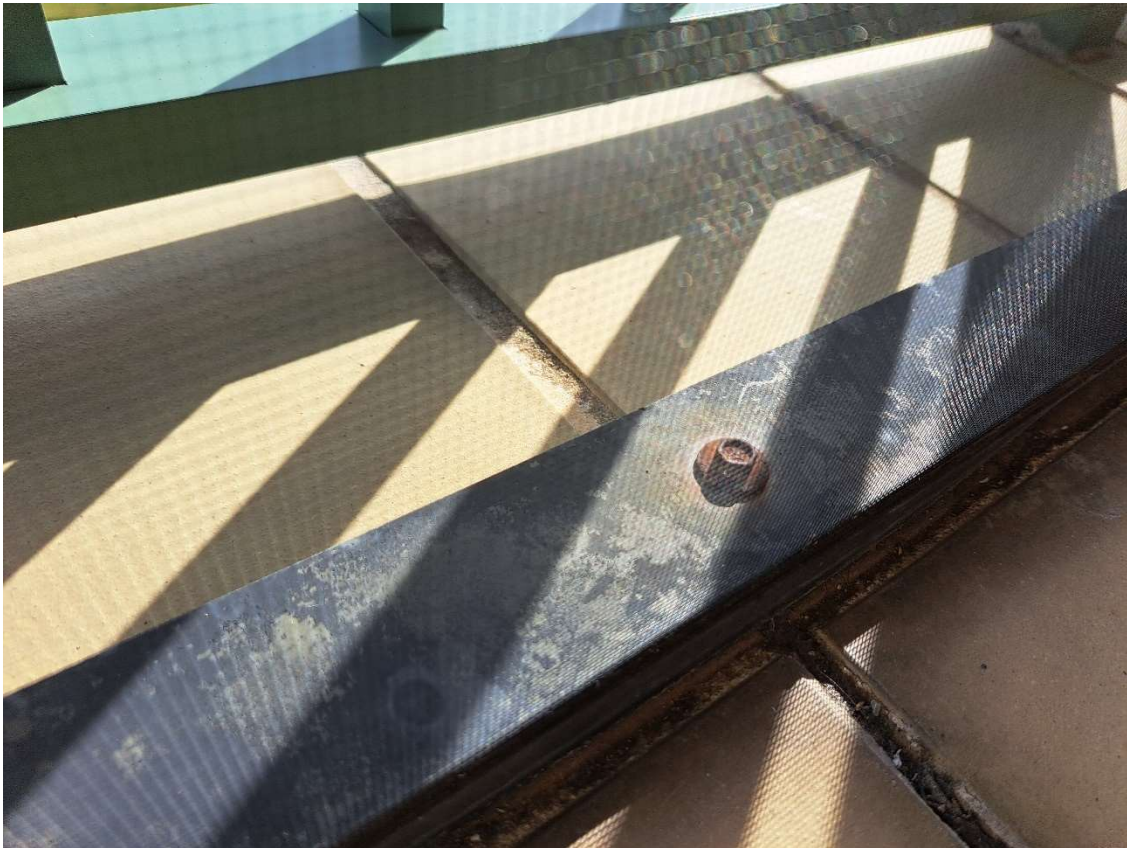
2.2.2.1 The screen enclosures are typically fastened to the concrete using corroded, non-stainless steel fasteners. These, in combination with the poor sloping; can further break apart the concrete substrate as these fasteners continue to corrode, expand, spall the concrete under the rail and give water a path to the concrete causing increased deterioration, (photos 11 Typical).

*Photo 11 Ref: 2.2.2.2 – Corroding Screen Enclosure Fasteners (Typical)*

- 3.1.2.4 All screen enclosure fasteners on lanais which are currently waterproofed should be replaced with stainless steel fasteners and isolators if not already.

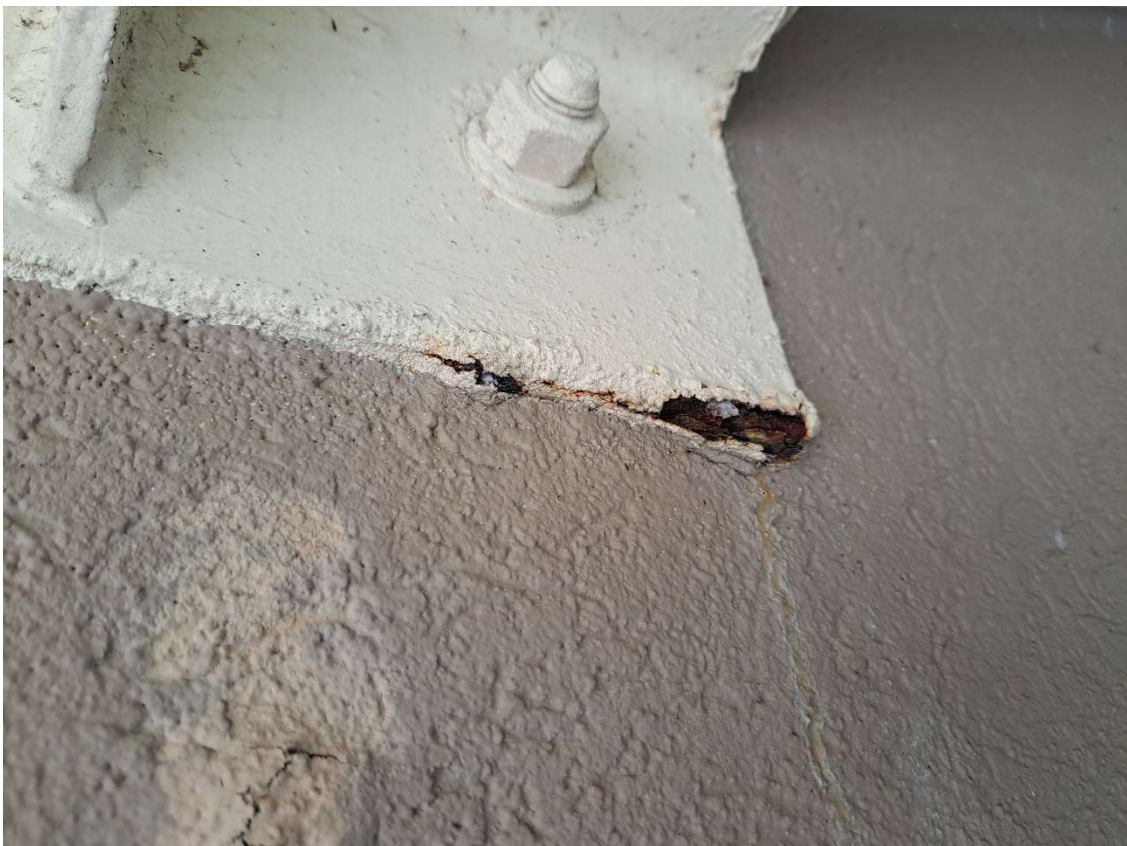
2.2.3.1 Steel support brackets are rusting (Photo 12 Typical). These brackets support the pre-cast stair landing slabs on 2 of the 4 sides.

*Photo 12 Ref: 2.2.3.1 – Rusting Steel Stair Support Brackets (Typical)*

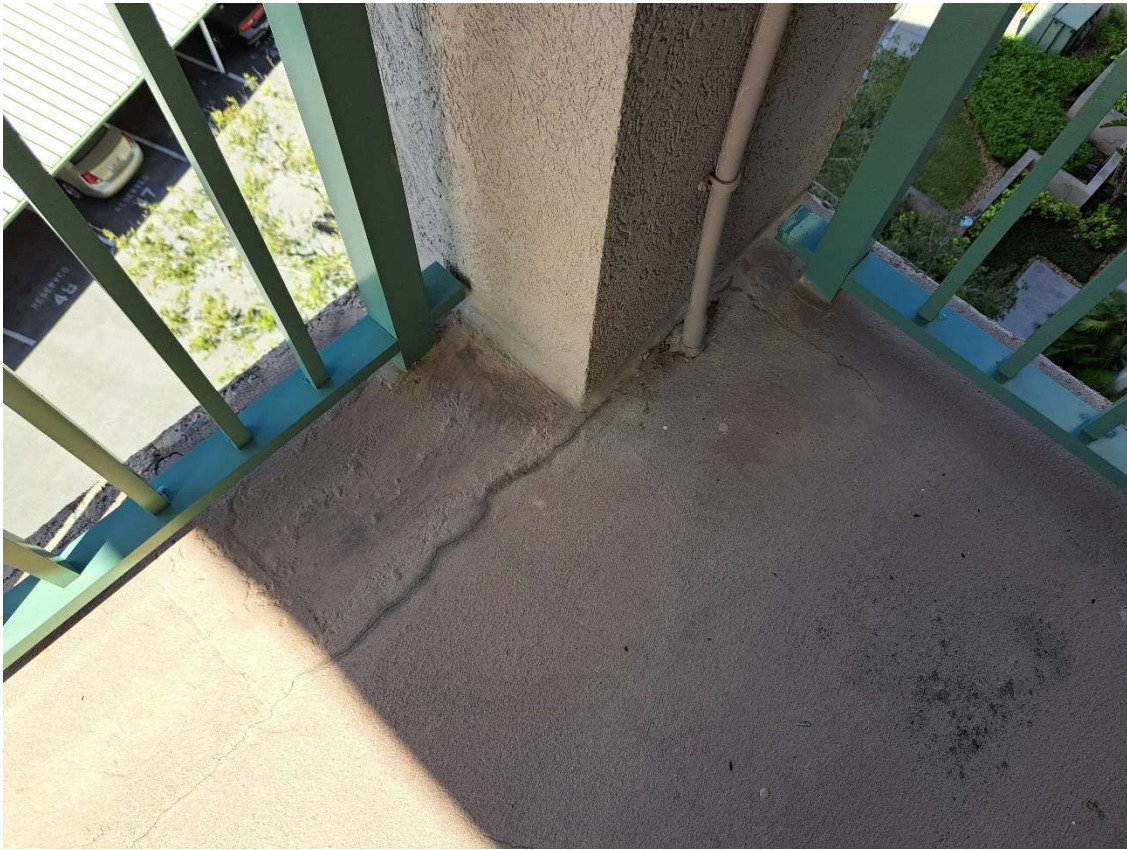
2.2.3.2 Cracks are present at the cold joints between the precast landing slabs and the surrounding tower structure (Photo 13 Typical). Moisture entrapment is also a strong possibility at these joints by the caulk along the underside of these joints.

*Photo 13 Ref: 2.2.3.2 – Stairway Cracks Along All Landing Slab Edges (Typical)*

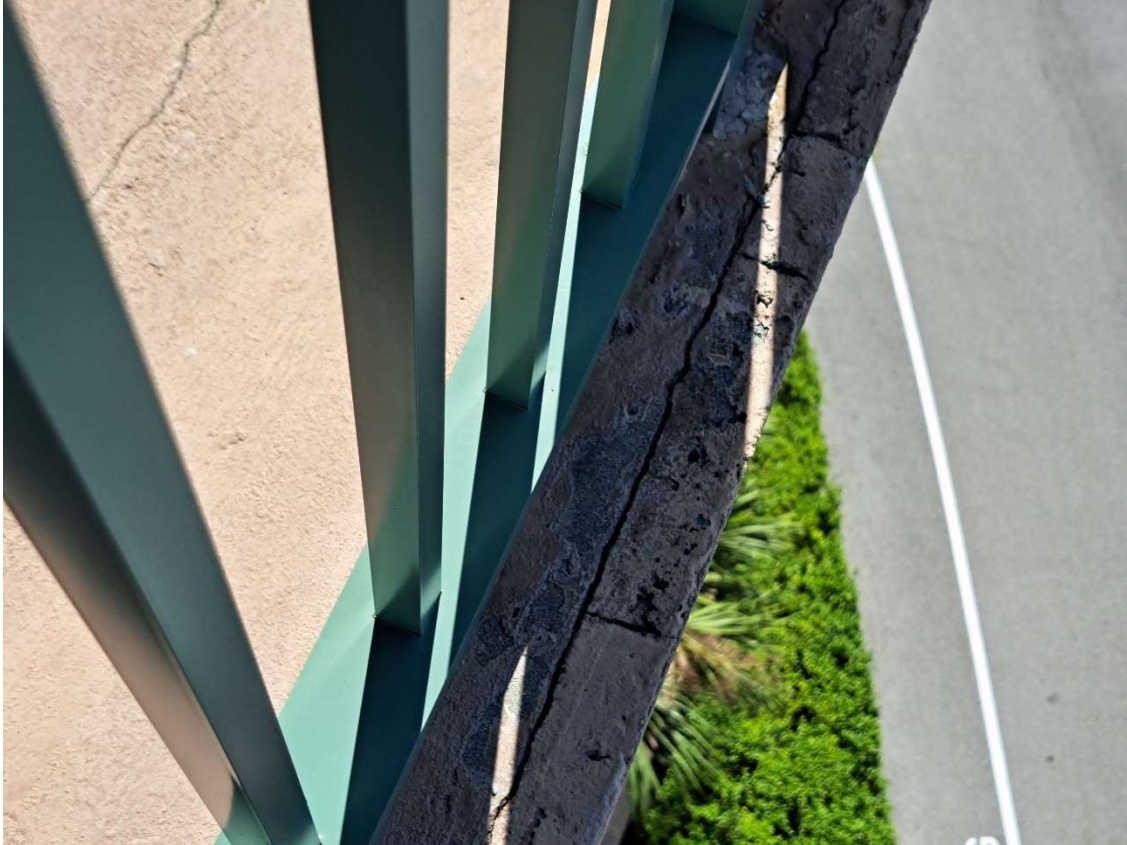
2.2.3.3 Consult observed cracking along the precast stair and Exterior Insulated Finish System (EIFS). This is an indication that moisture infiltration is also occurring between the exterior EIFS and the concrete on the outer edges of the landings (Photo 14 Typical).

*Photo 14 Ref: 2.2.3.3 – Stair EIFS Trapping Water (Typical)*

- 3.1.2.5 The spalling present on the floor of the 4<sup>th</sup> floor storage locker room should be repaired per ICRI and ACI.
- 3.1.2.6 The EIFS should be inspected, and any penetrations should be sealed, especially around the outer surface of the stair landings.

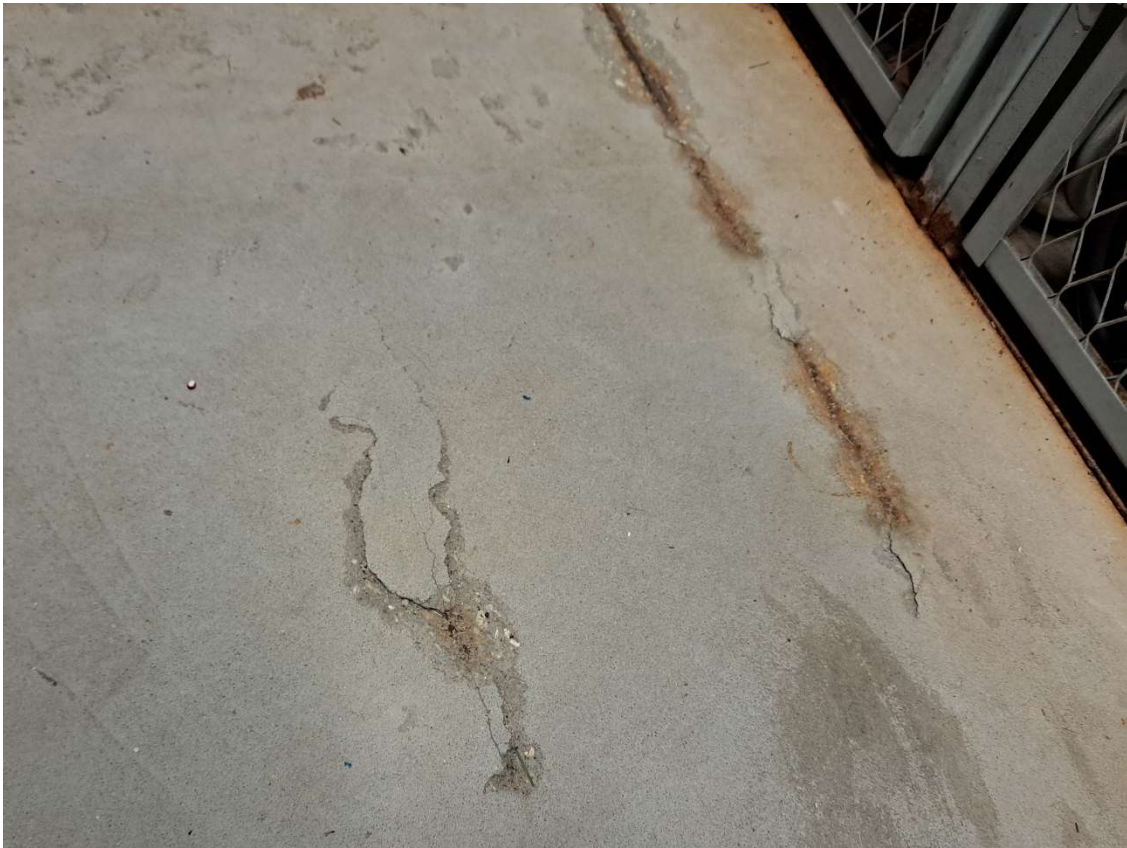
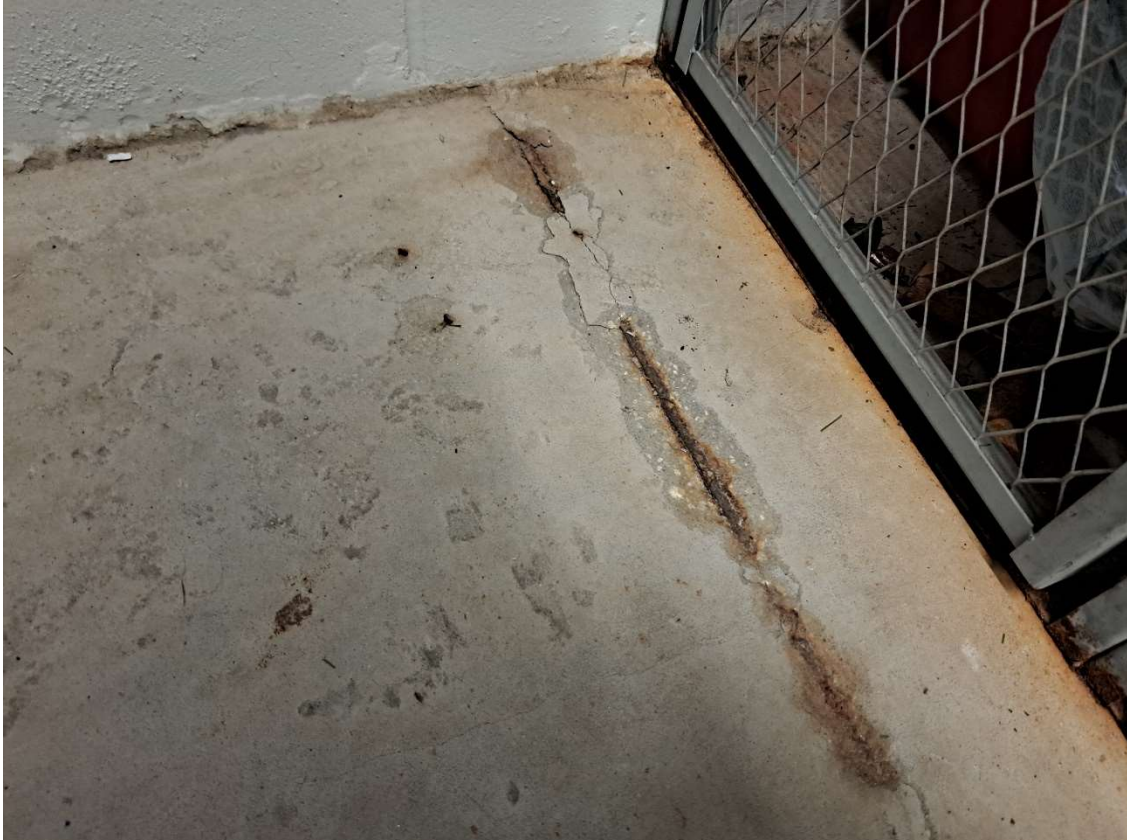
2.2.4.1 Concrete has spalled away from a section of rebar in the floor and is beginning in another location on this floor (Photos 15 and 16). This corrosion can spread (travel) along the rebar and further into the concrete support structure of the building.

*Photo 15 Ref: 2.2.4.1 – Spalling in 4<sup>th</sup> Floor Storage Closet Floor*

*Photo 16 Ref: 2.2.4.1 – Spalling in 4<sup>th</sup> Floor Storage Closet Floor*

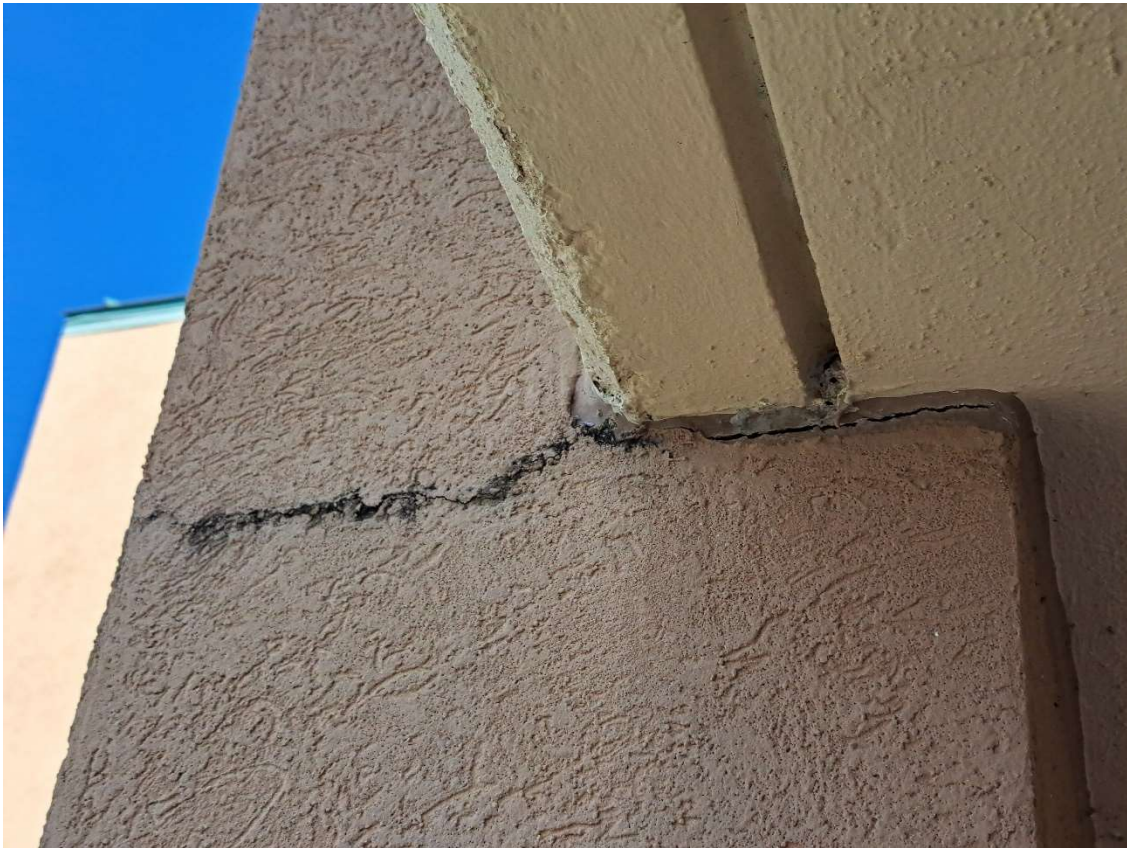
2.2.5.1 The EIFS around the building has sections which are cracking (Photos 17). This can allow for water infiltration and trap water against the concrete or steel framing underneath and degrade it quickly while hidden from non-destructive examination.

*Photo 17 Ref: 2.2.5.1 – EIFS Trapping Water (Typical)*
