Milestone Inspection Report

KEG Project #21RS-0682
May24th 2023

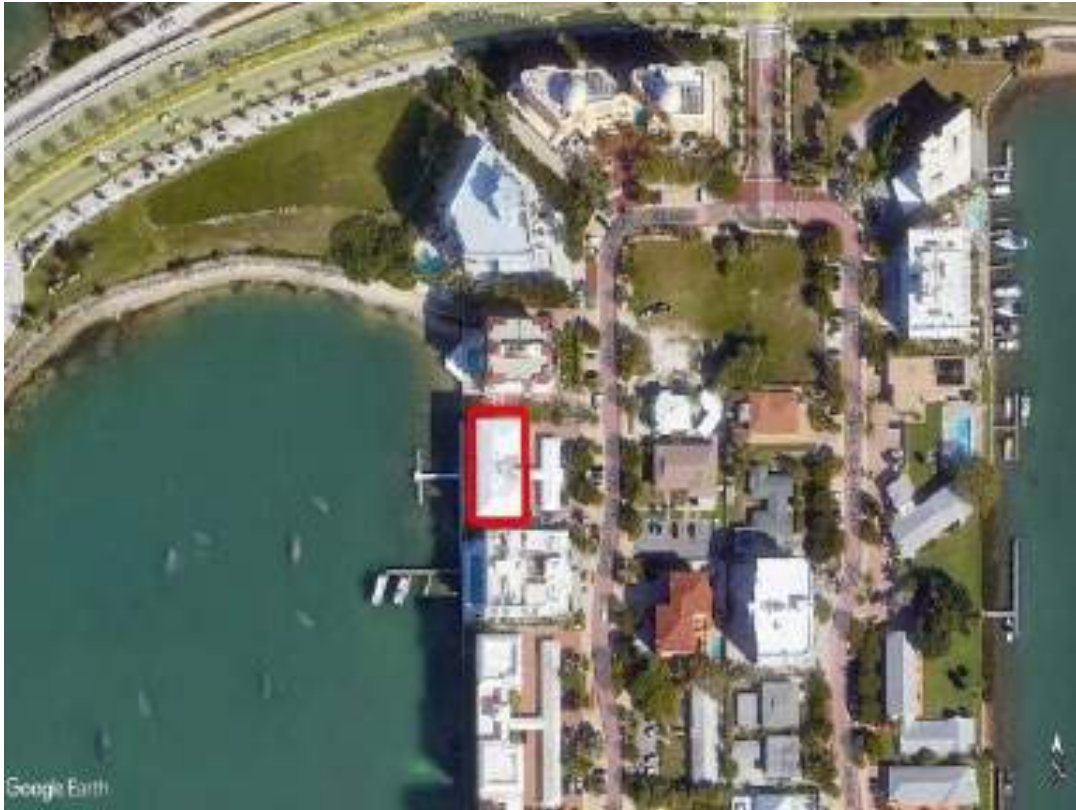
Figure 1: Aerial View of 174GPP from Google Earth Outlined in Red

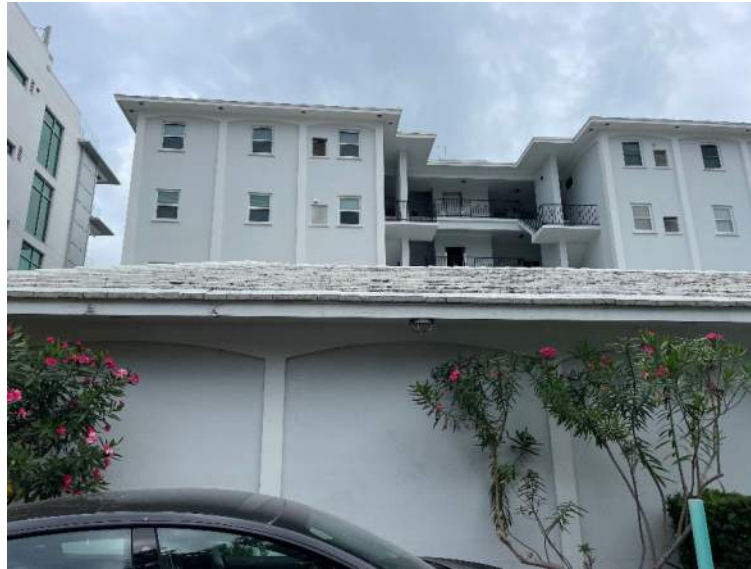
Figure 3: 174 Golden Gate Point

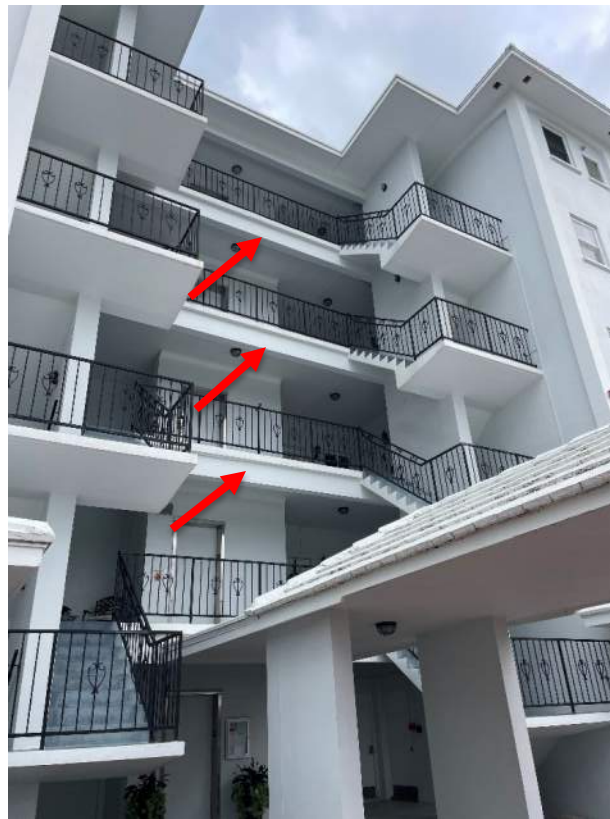
Figure 4: Typical Concrete Beams Observed.

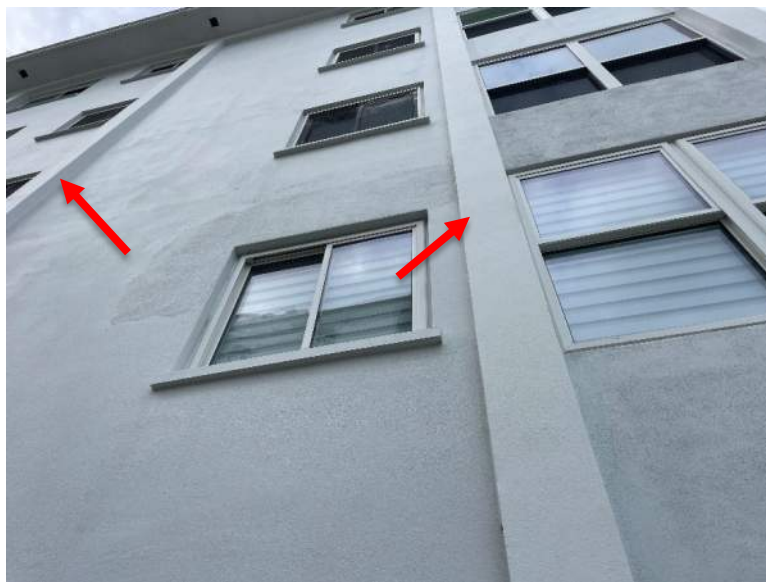
Figure 5: Typical columns observed.

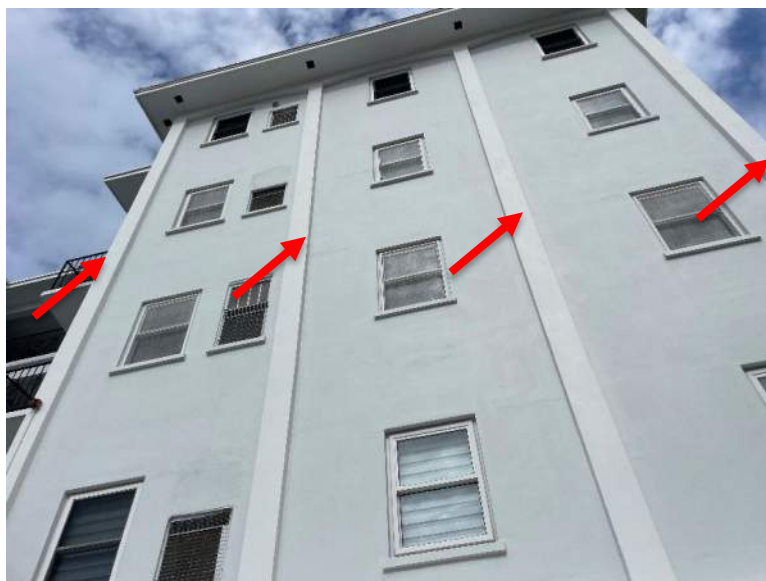
Figure 6: Typical columns observed.

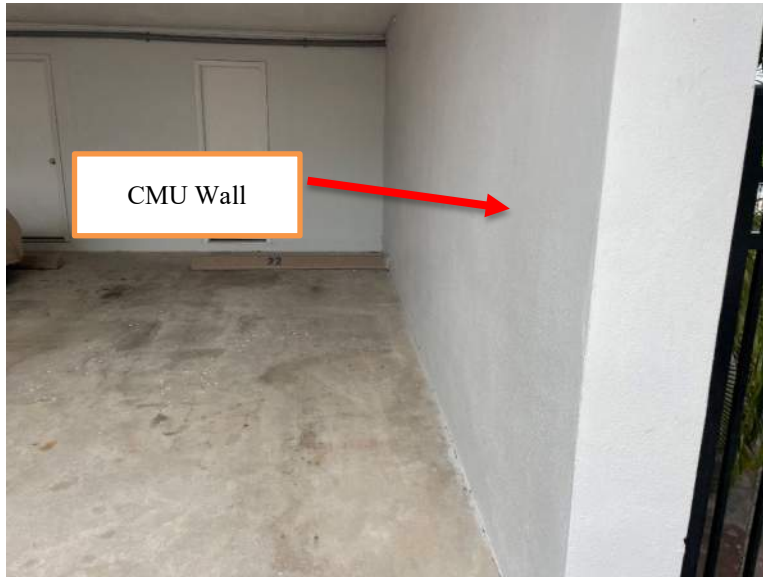
Figure 7: Example of CMU wall connected to an exterior column

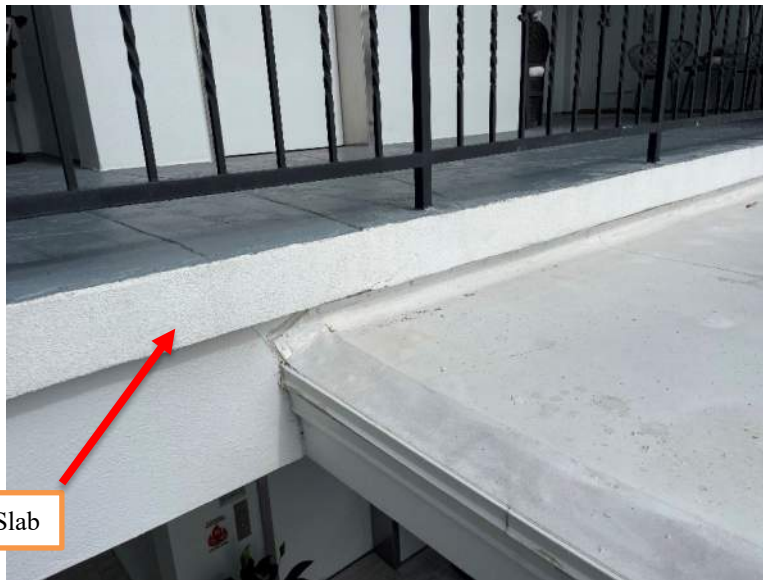
Figure 8: Flooring system

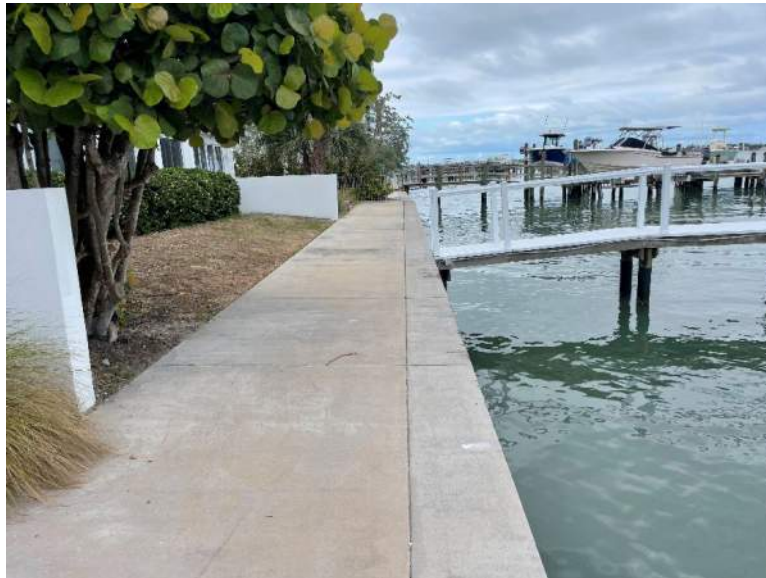
Figure 9: Seawall Observed.

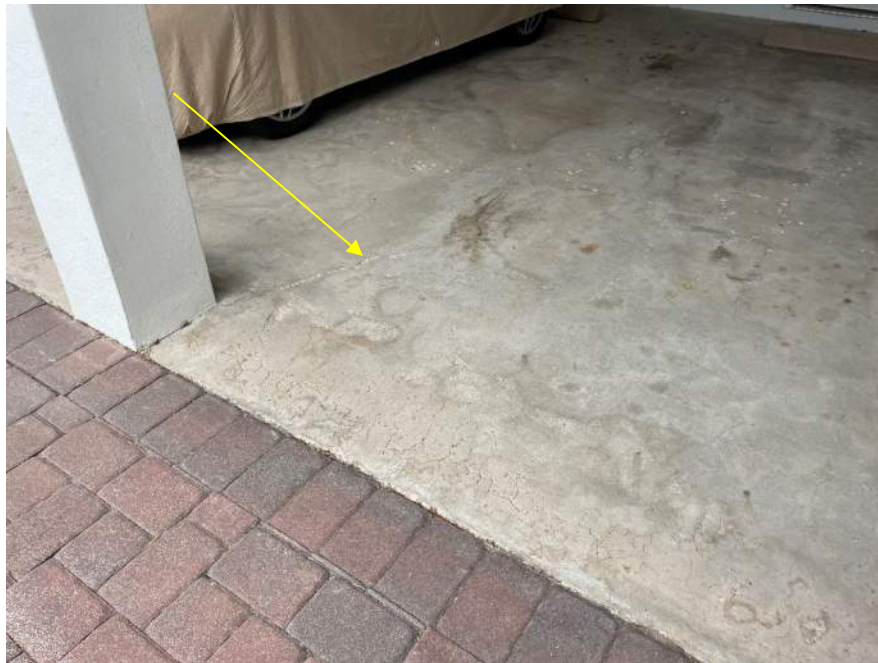
Figure 10 Existing condition of Slab-on-Grade with some nonstructural cracking

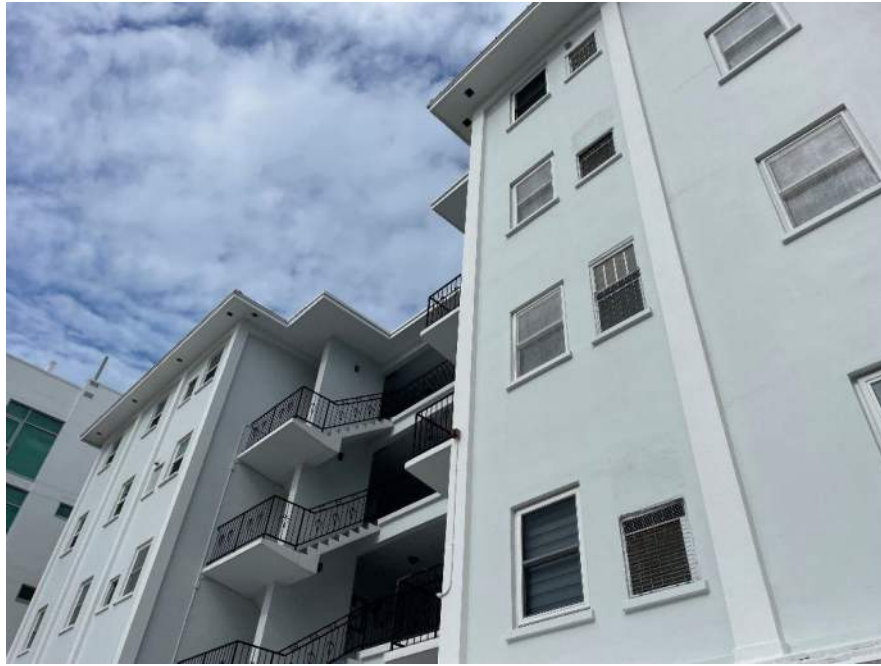
Figure 11 Typical building exterior.

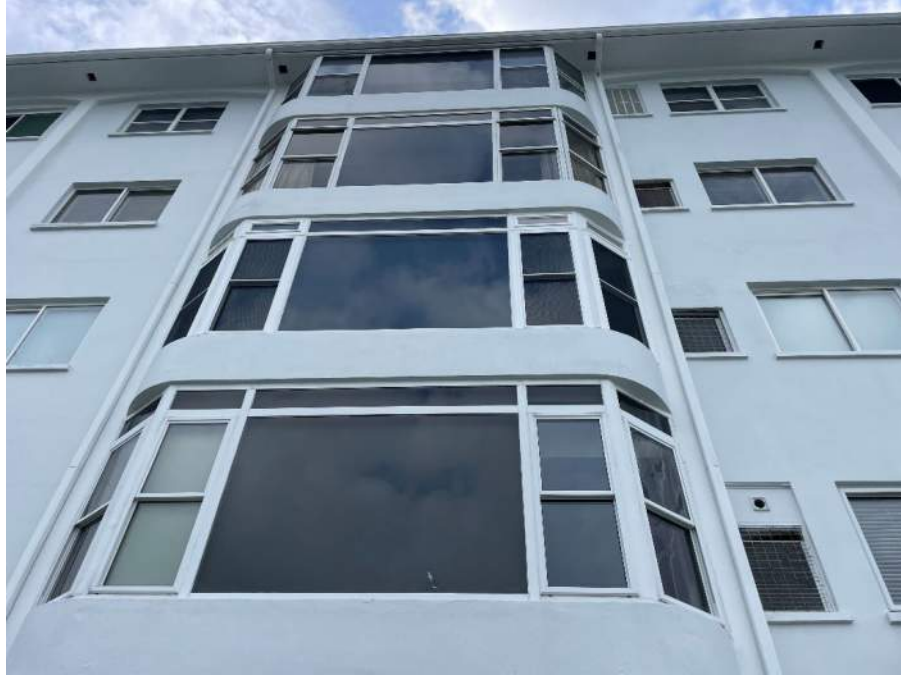
Figure 12: Typical window overview.

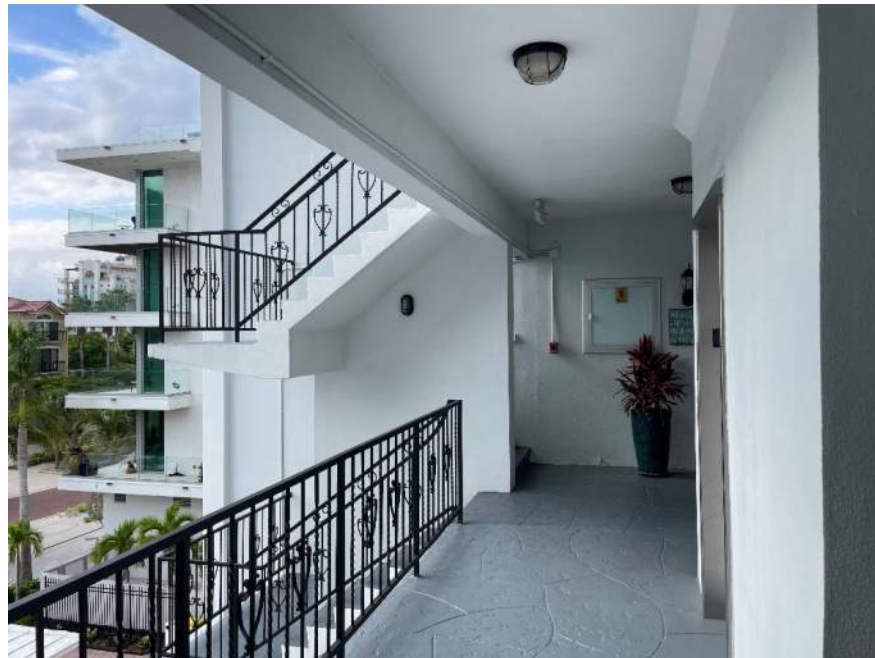
Figure 13: Typical walkway area observed.

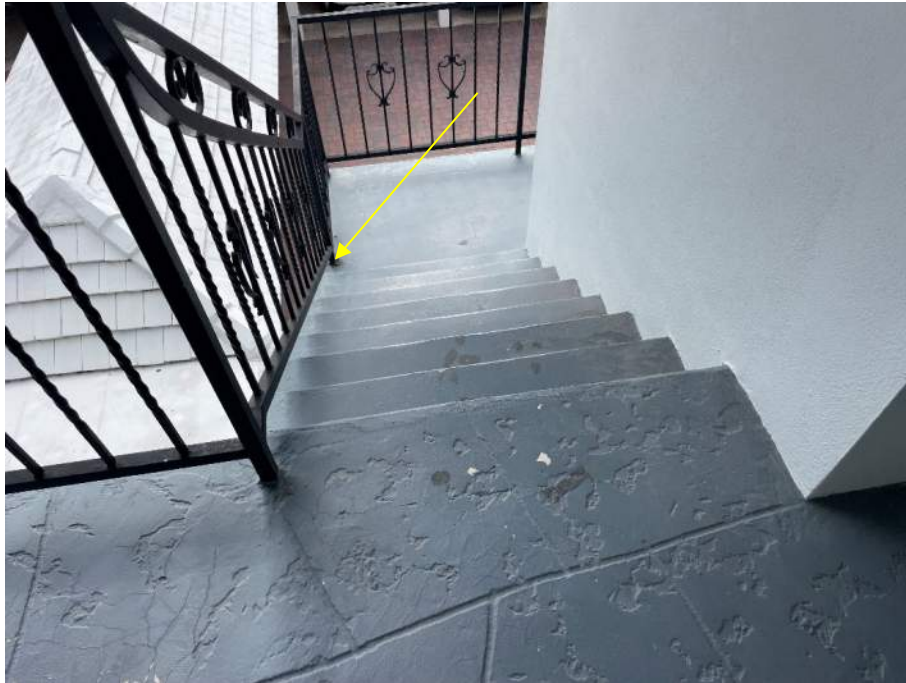
Figure 14: Typical stairwell overview.

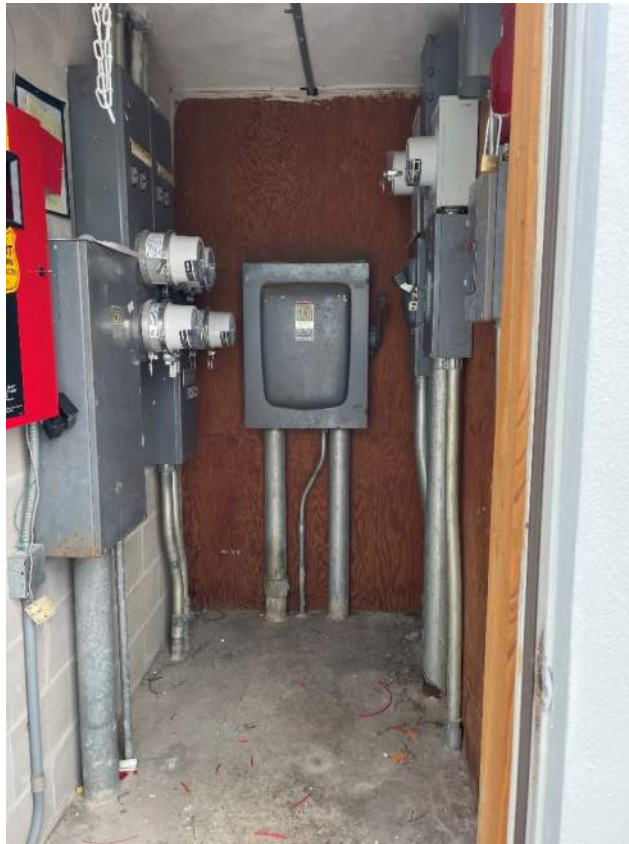
Figure 15: Typical mechanical room overview.

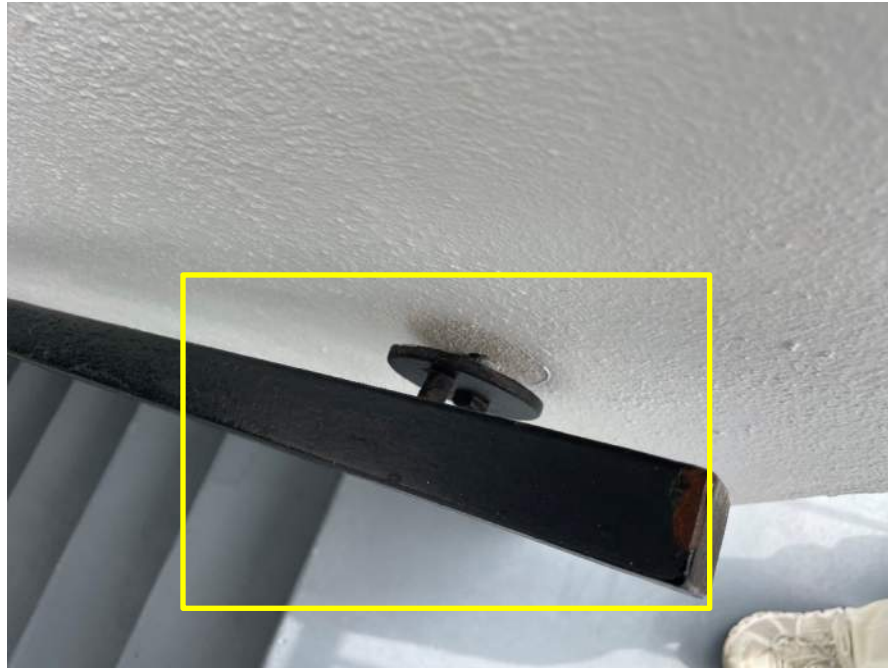
Figure 16: Typical Loose railing connection near stairwell

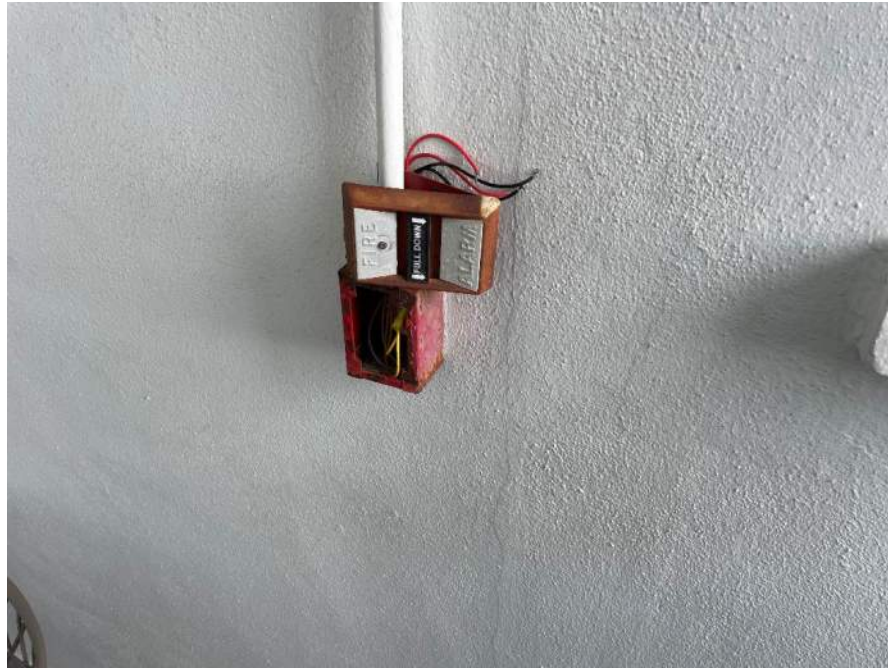
Figure 17: Disconnected fire alarm system.

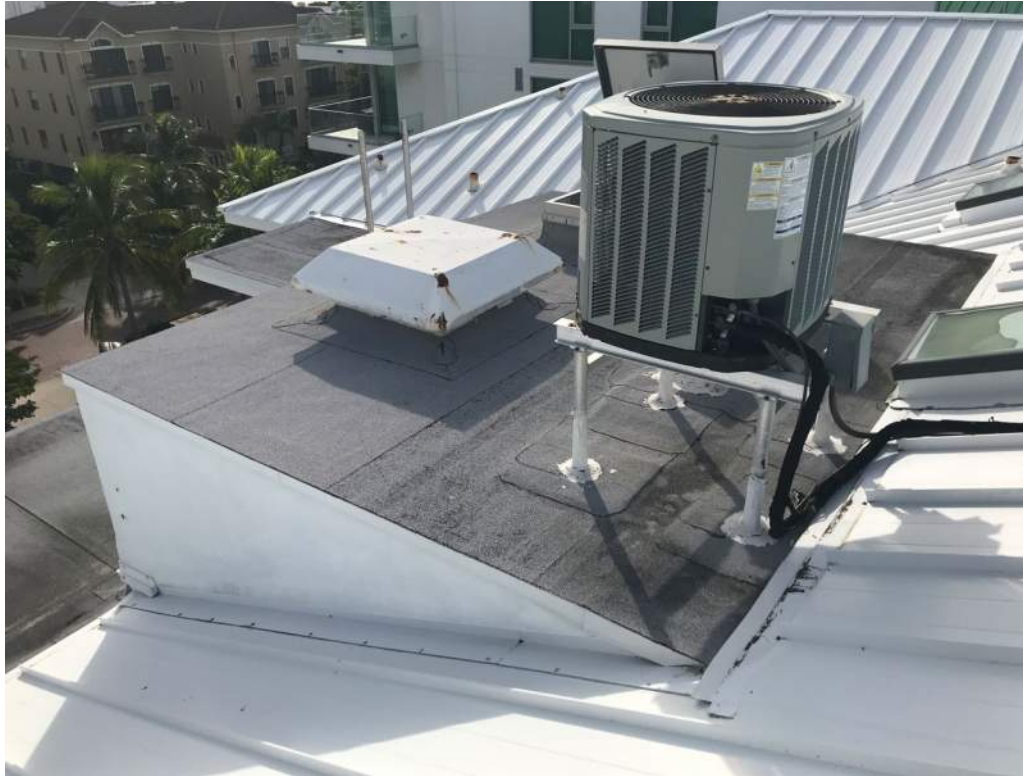
Figure 18: Roof existing condition

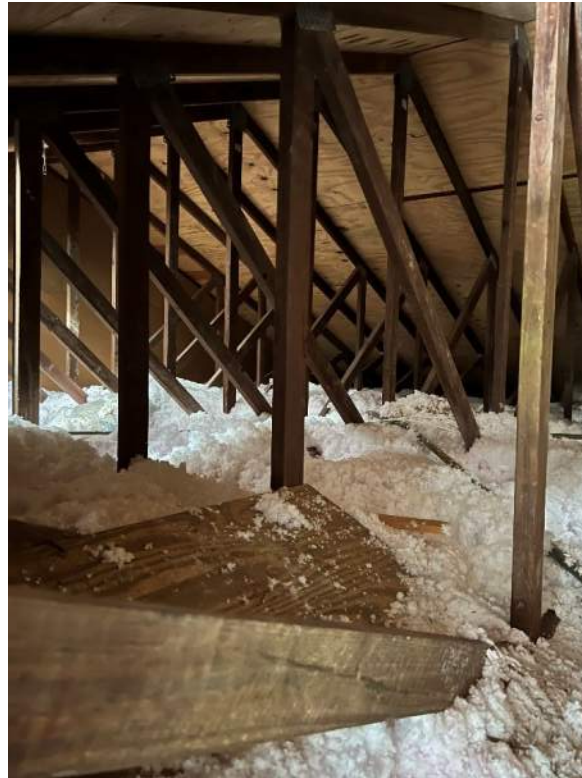
Figure 19: Attic and trusses

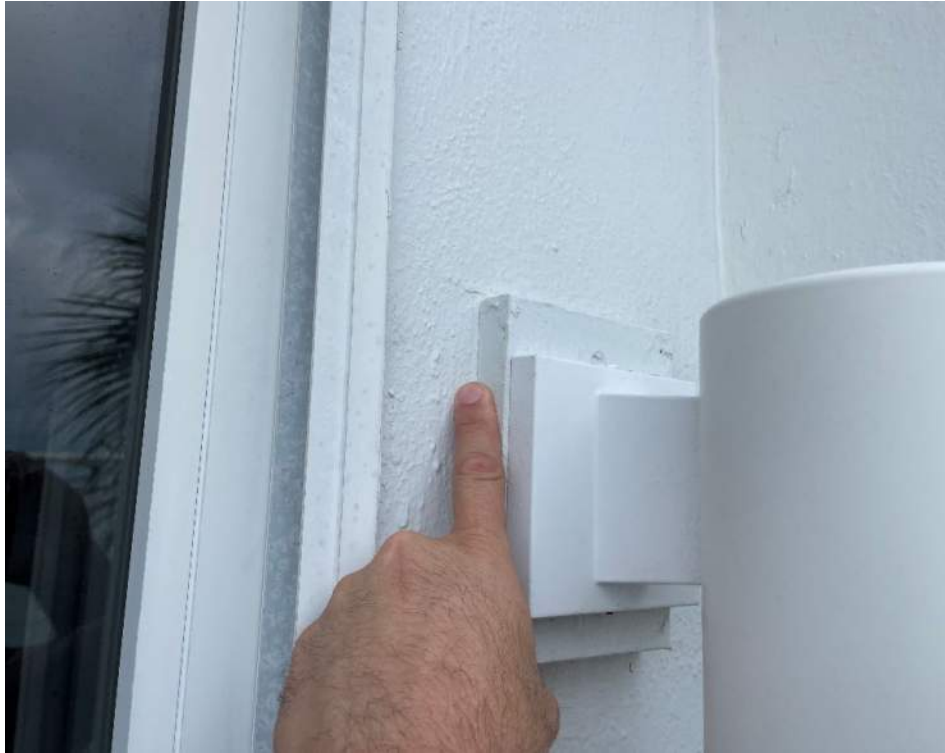
Figure 2 – Missing sealant at ground floor light fixtures.

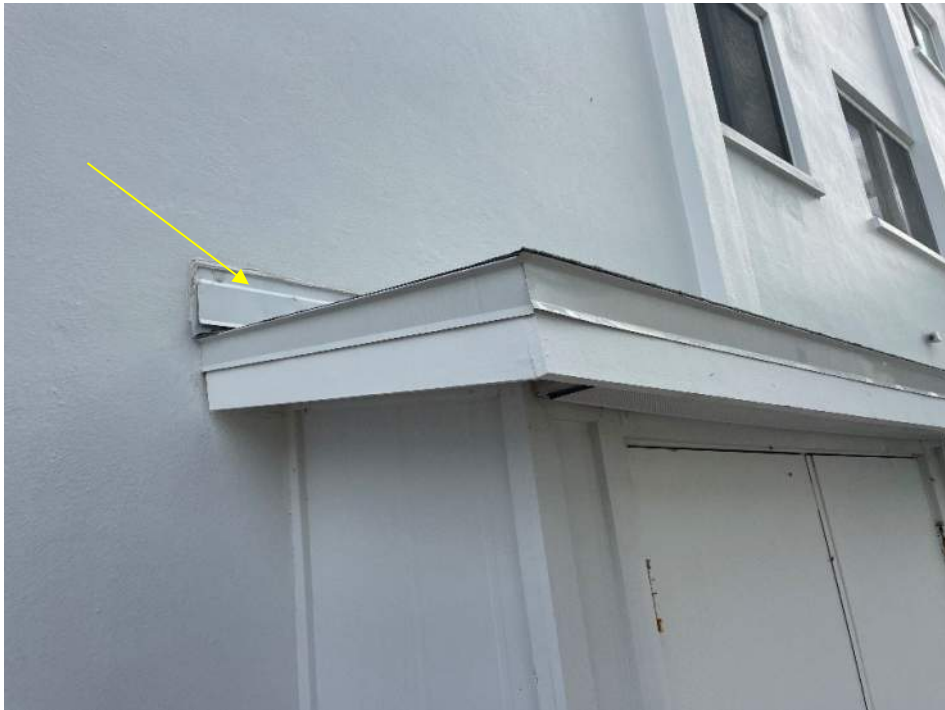
Figure 3 – Flashing and sealant opening on shed roof.

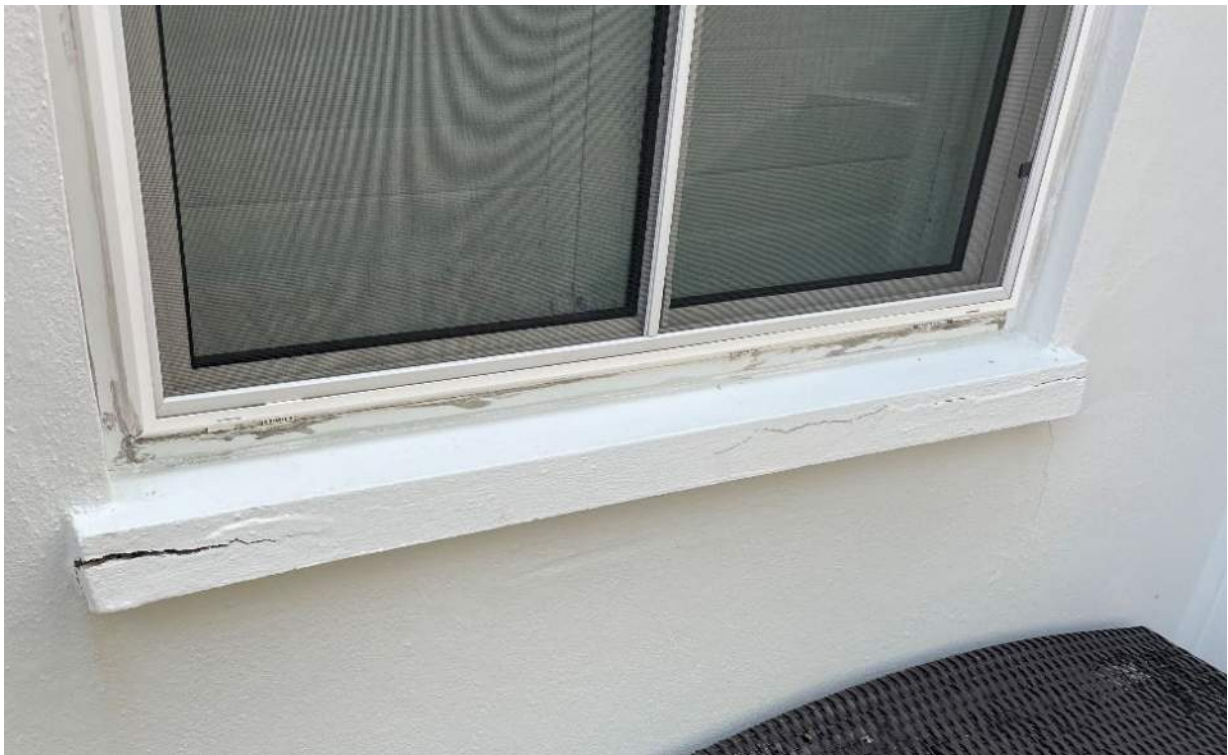
Figure 5 – Spalling at windowsill on ground floor.

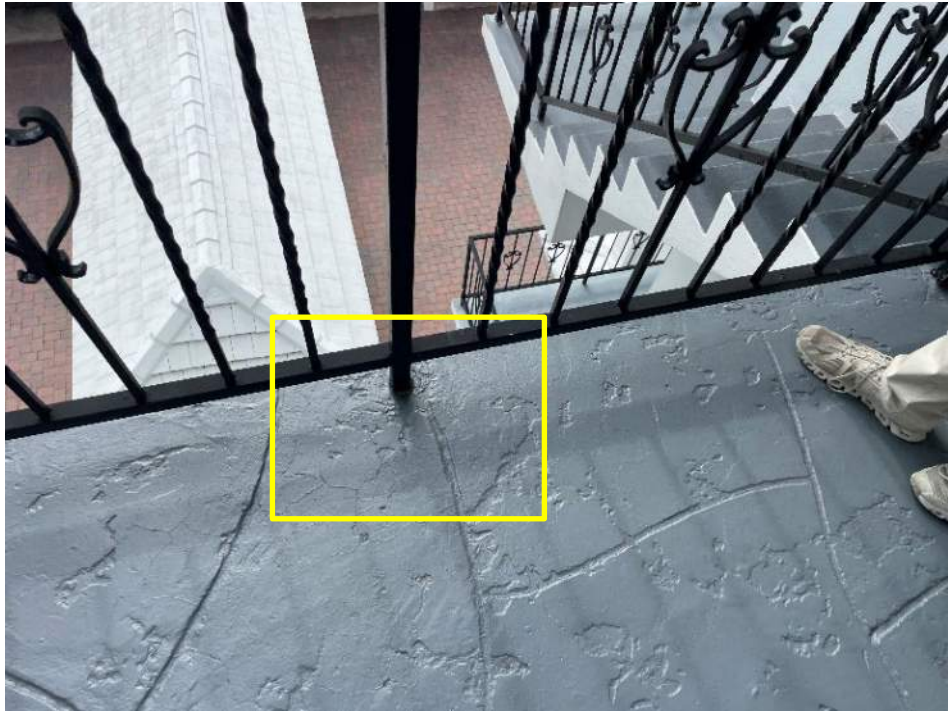
Figure 6: Possible delamination of 3rd floor balcony at post pocket.

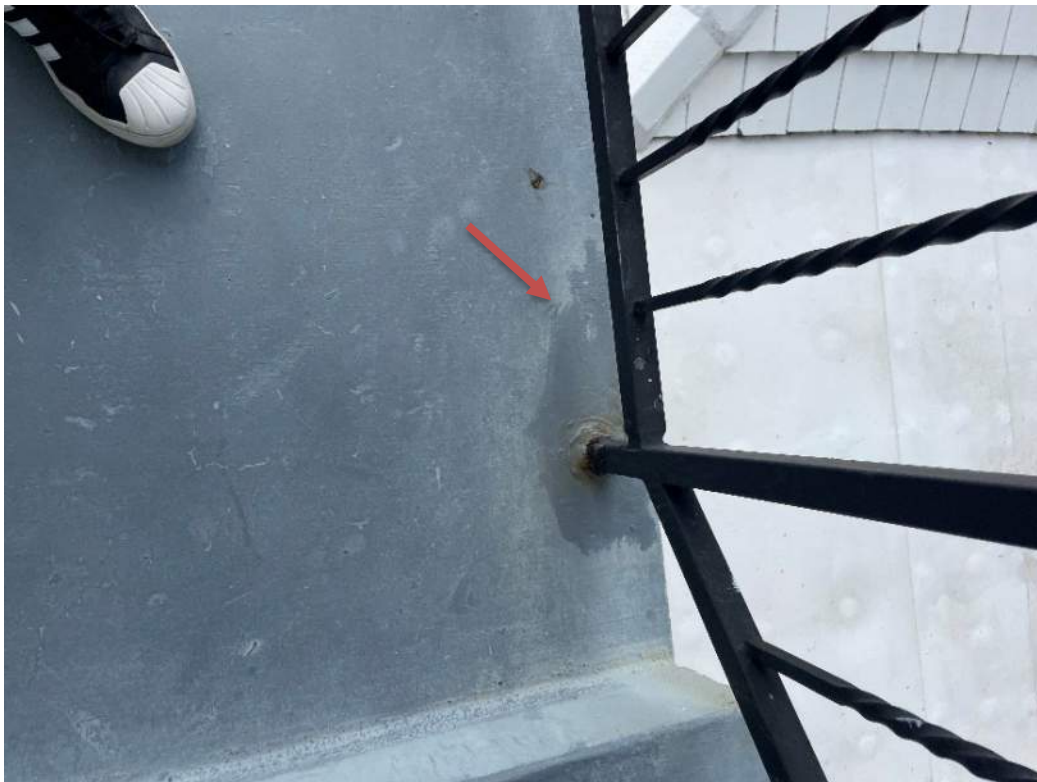
Figure 7 – rusted railing at post pocket connection.

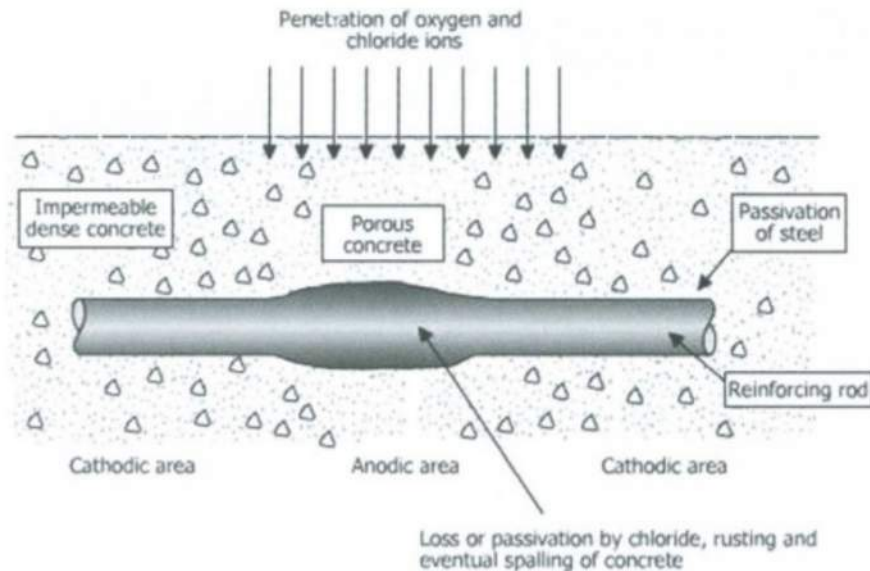
Figure 1 Corrosion of rebar

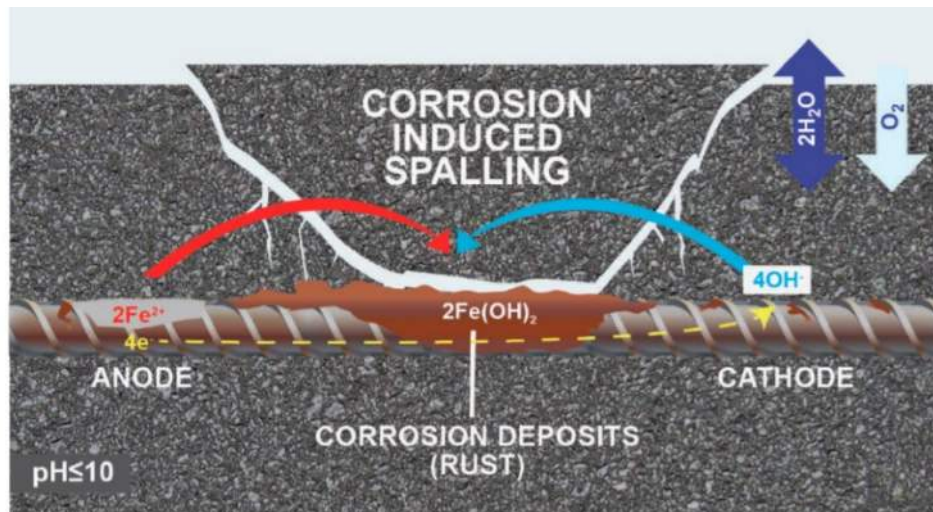
Figure 2 Before Halo Effect

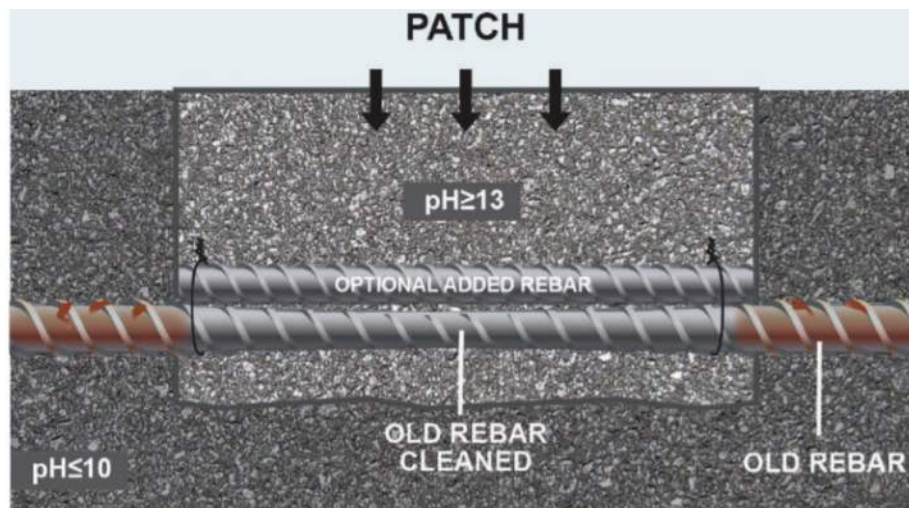
Figure 3 Ring anode corrosion
