Wind Mitigation Inspection

Fairway Trace II

4227 Caddie Dr E
Bradenton FL, 34203

12/02/2021

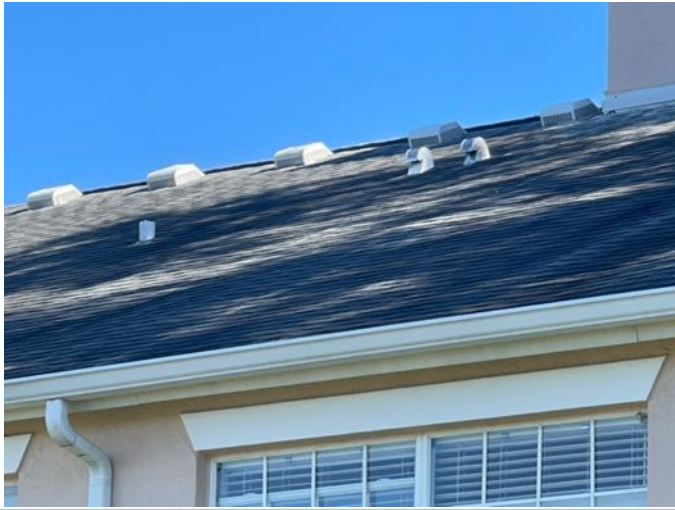
2.1 Roof Covering Type:	Permit Application Date	FBC or MDC Product Approval #	Year of Original Installation or Replacement	No Information Provided for Compliance
<input checked="" type="checkbox"/> 1. Asphalt/Fiberglass Shingle	419 11	_____	_____	<input type="checkbox"/>
<input type="checkbox"/> 2. Concrete/Clay Tile	____/____/____	_____	_____	<input type="checkbox"/>
<input type="checkbox"/> 3. Metal	____/____/____	_____	_____	<input type="checkbox"/>
<input type="checkbox"/> 4. Built Up	____/____/____	_____	_____	<input type="checkbox"/>
<input type="checkbox"/> 5. Membrane	____/____/____	_____	_____	<input type="checkbox"/>
<input type="checkbox"/> 6. Other _____	____/____/____	_____	_____	<input type="checkbox"/>

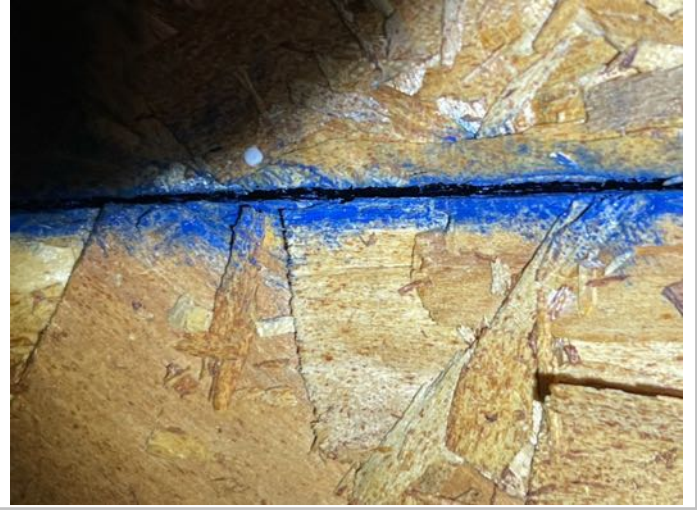
SWR/Decking

- A. SWR (also called Sealed Roof Deck) Self-adhering polymer modified-bitumen roofing underlayment applied directly to the sheathing or foam adhesive SWR barrier (not foamed-on insulation) applied as a supplemental means to protect the dwelling from water intrusion in the event of roof covering loss.
- B. No SWR.
- C. Unknown or undetermined.

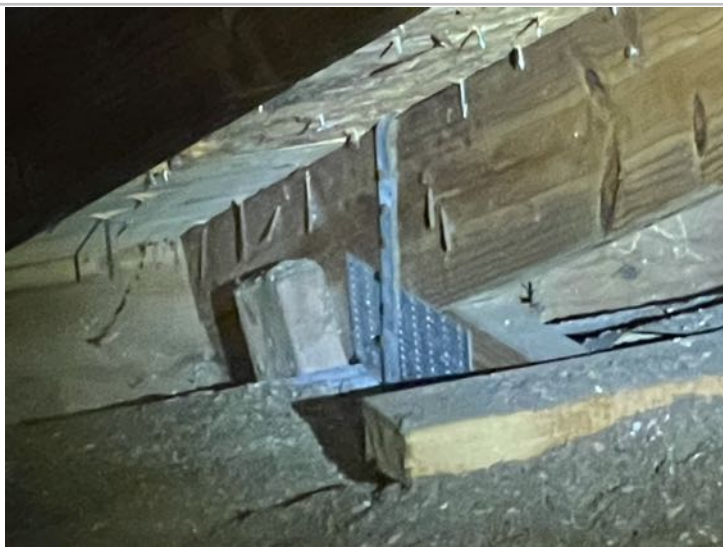
Strap- Anchor Side

4. **Roof to Wall Attachment:** What is the **WEAKEST** roof to wall connection? (Do not include attachment of hip/valley jacks within 5 feet of the inside or outside corner of the roof in determination of WEAKEST type)
