Wind Mitigation Inspection

Fairway Trace II

4706 Sand Trap St Cir
Bradenton FL, 34203

12/02/2021

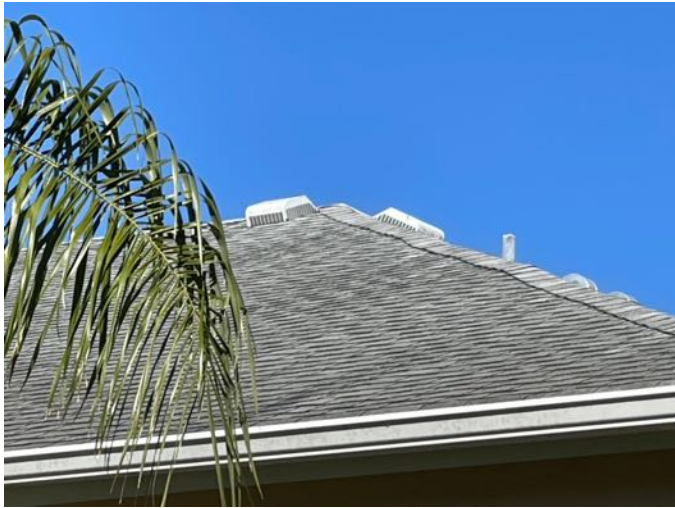
2.1 Roof Covering Type:	Permit Application Date	FBC or MDC Product Approval #	Year of Original Installation or Replacement	No Information Provided for Compliance
<input checked="" type="checkbox"/> 1. Asphalt/Fiberglass Shingle	419 11	_____	_____	<input type="checkbox"/>
<input type="checkbox"/> 2. Concrete/Clay Tile	____/____/____	_____	_____	<input type="checkbox"/>
<input type="checkbox"/> 3. Metal	____/____/____	_____	_____	<input type="checkbox"/>
<input type="checkbox"/> 4. Built Up	____/____/____	_____	_____	<input type="checkbox"/>
<input type="checkbox"/> 5. Membrane	____/____/____	_____	_____	<input type="checkbox"/>
<input type="checkbox"/> 6. Other _____	____/____/____	_____	_____	<input type="checkbox"/>

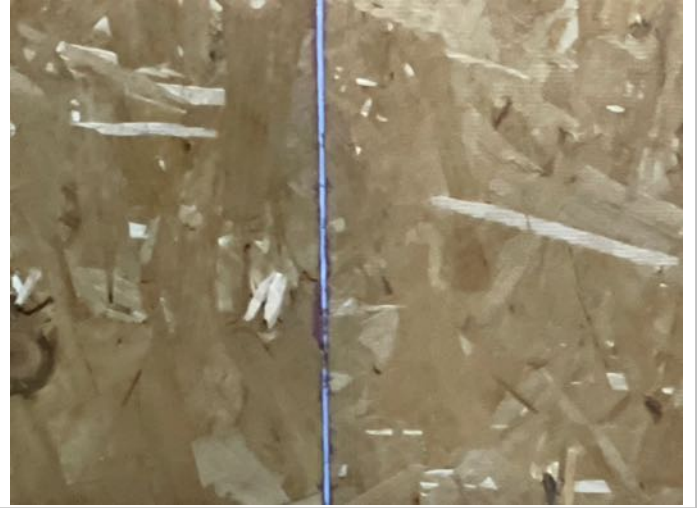
- A. SWR (also called Sealed Roof Deck) Self-adhering polymer modified-bitumen roofing underlayment applied directly to the sheathing or foam adhesive SWR barrier (not foamed-on insulation) applied as a supplemental means to protect the dwelling from water intrusion in the event of roof covering loss.
- B. No SWR.
- C. Unknown or undetermined.

Synthetic membrane

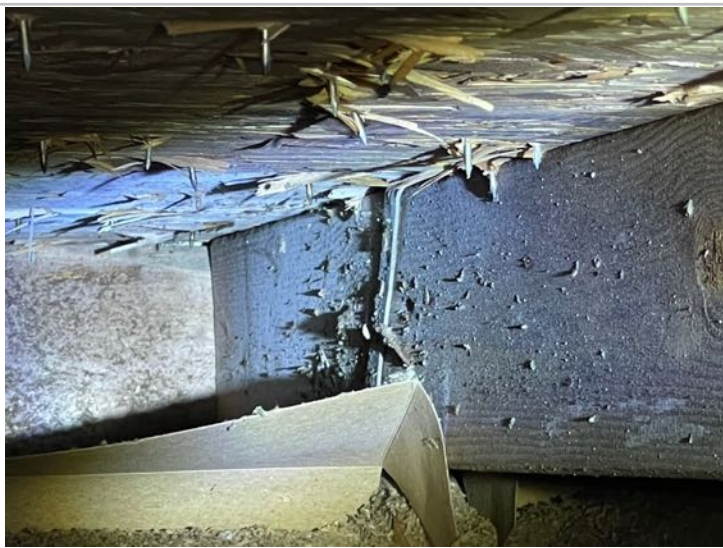
- C. Single Wraps
 - Metal connectors consisting of a single strap that wraps over the top of the truss/rafter and is secured with a minimum of 2 nails on the front side and a minimum of 1 nail on the opposing side.

Strap- Anchor Side

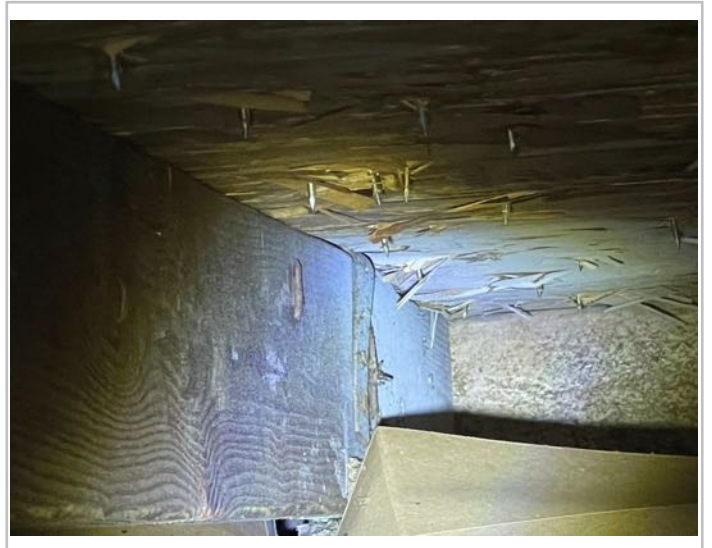
Strap- Opposing Side
