Milestone Inspection Report

Hudson Harbor SIRS# 22RS-1083

Hudson Harbor SIRS; Milestone Inspection

RE: *Hudson Harbor Condominium Association, Inc.*
KE File # 22RS-1083
Milestone Inspection – Report

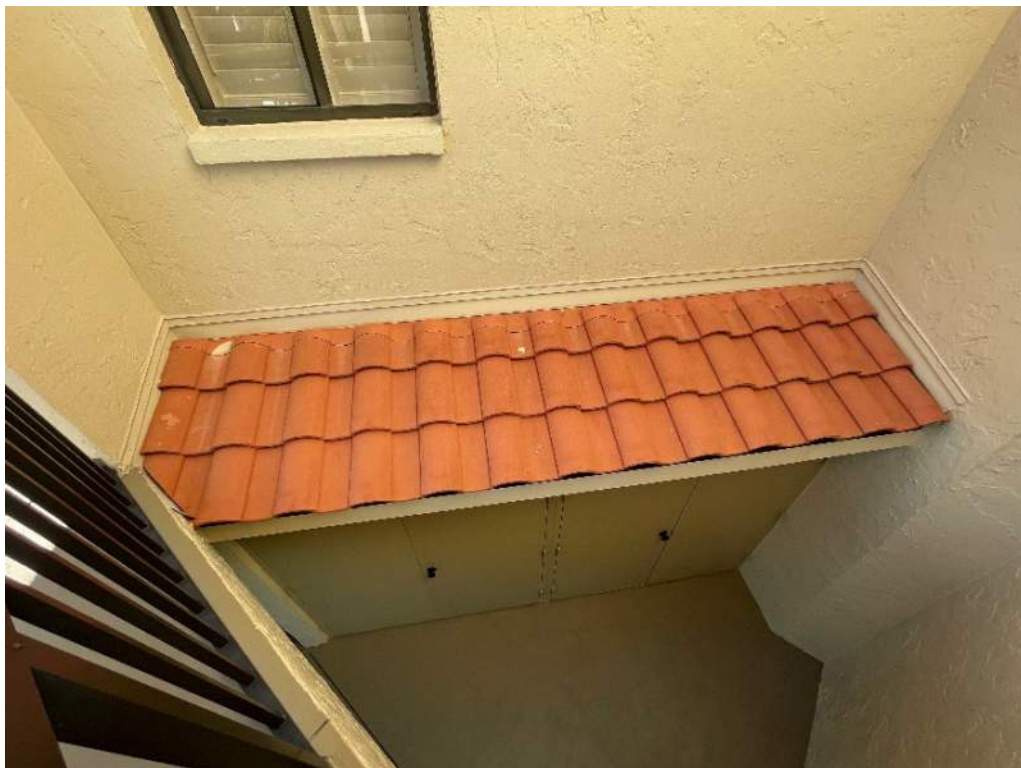
Type: The roofing system at Hudson Harbor appears to consist of concrete tiled sloped roofing, over underlayment, over plywood, over wood trusses.

Limitations: Access to the roof was not available at the time of inspection. The condition of the roofing system, mechanical and electrical components, and related items are out of the scope of this report.

Figure 2: Roofing as Seen From 2nd Level

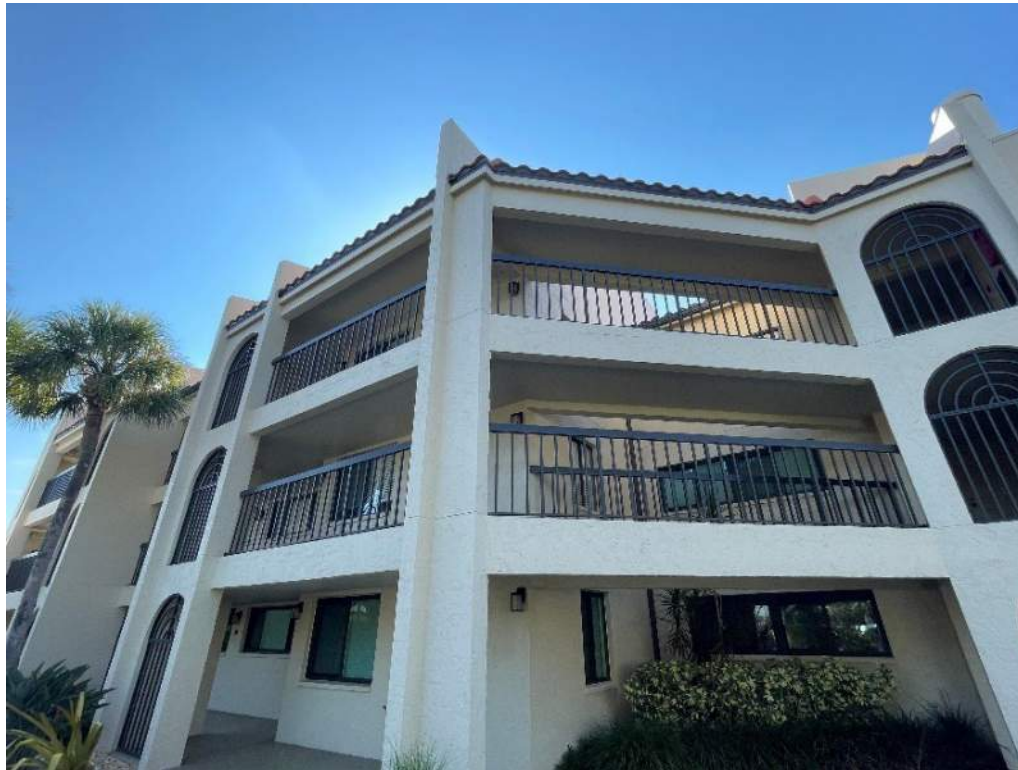
Type: Conventionally reinforced concrete columns.

Figure 3: Exterior Concrete Columns

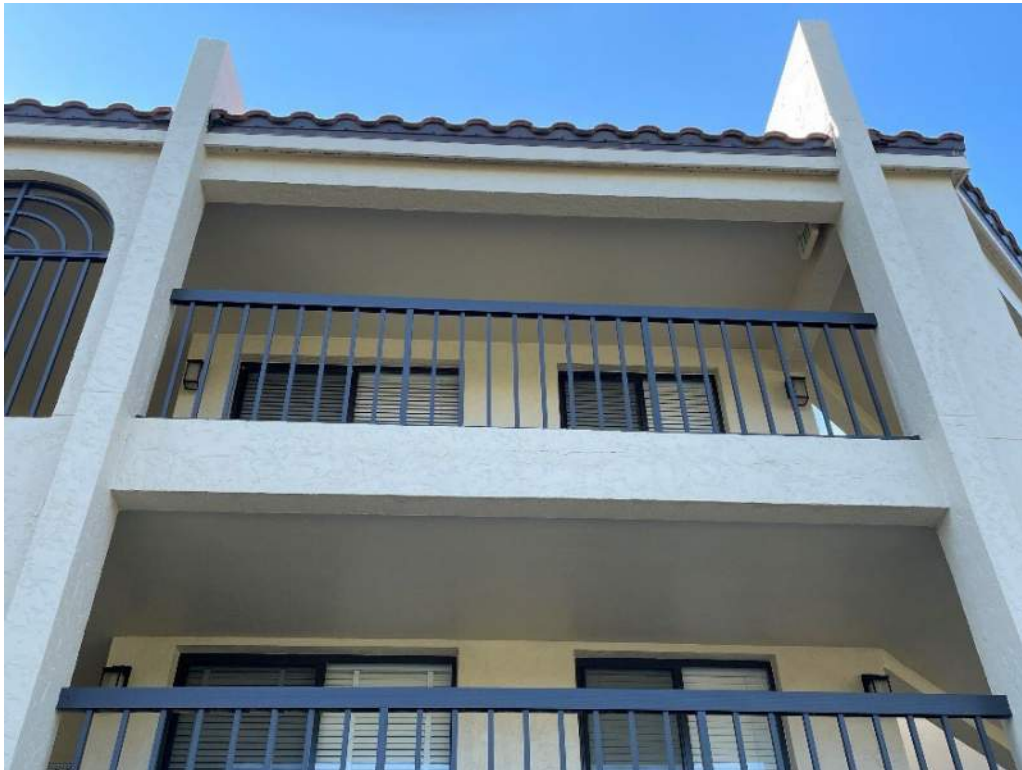
Type: Conventionally reinforced concrete beams.

Figure 4: Exterior Concrete Beam

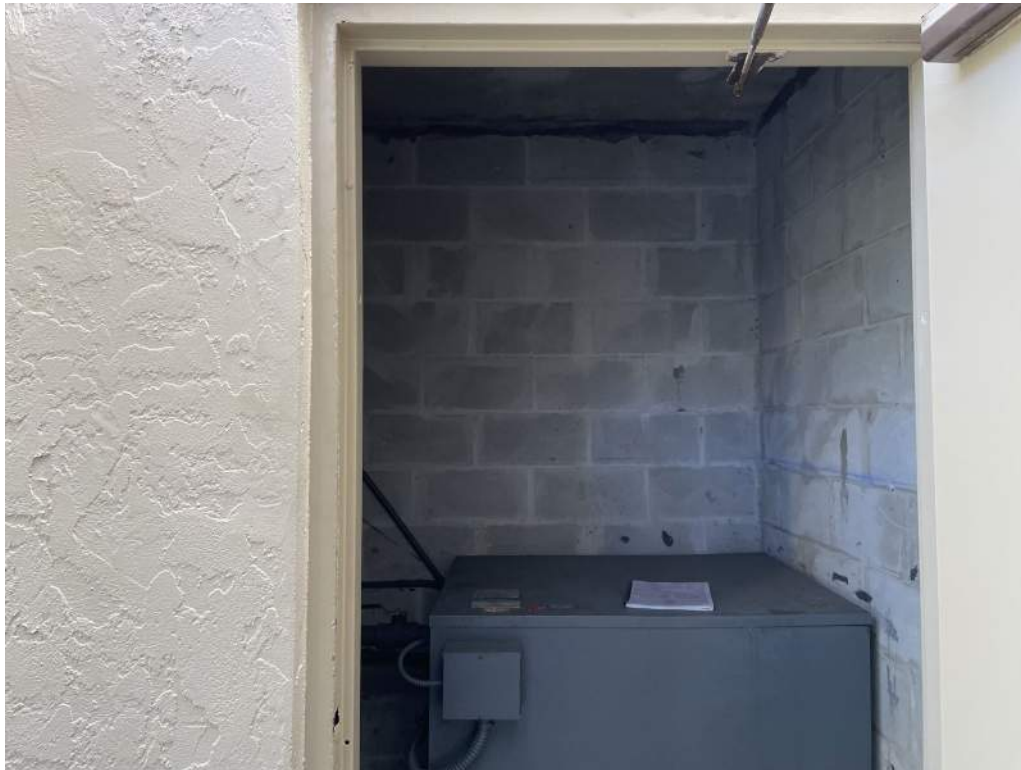
Type: Conventionally reinforced concrete shearwalls and non-load bearing masonry in-fill walls.

Figure 5: Mechanical Room Concrete Masonry Unit Wall

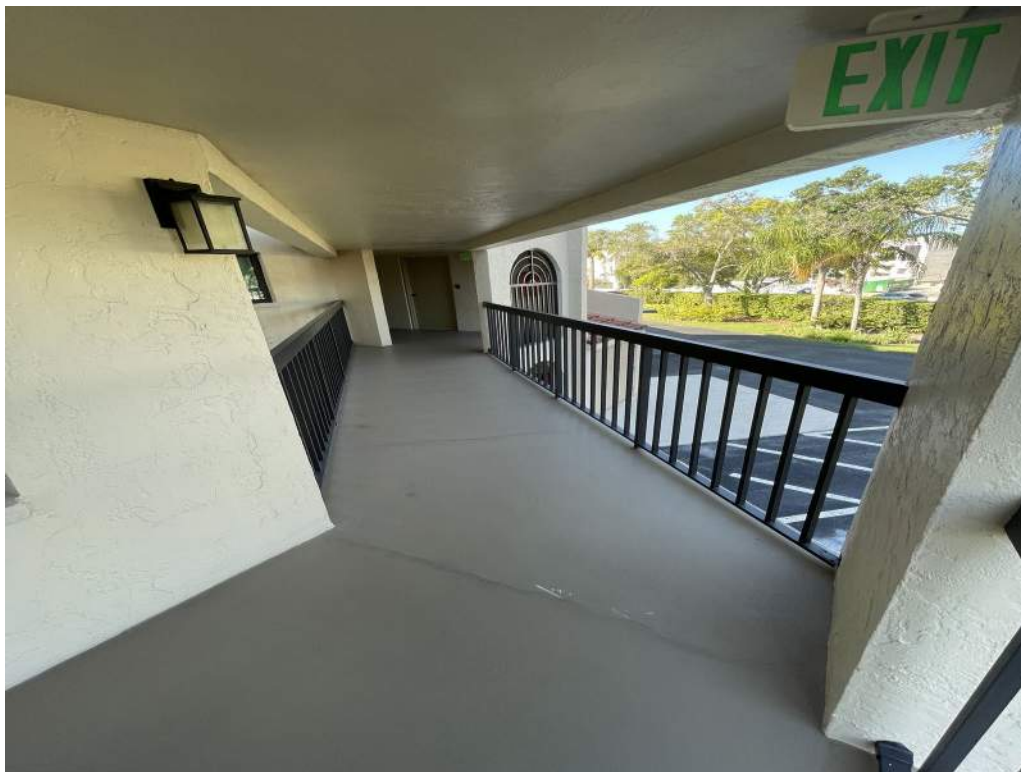
Type: Conventionally reinforced concrete slab floors, walkways, and balconies.

Figure 6: Exterior Concrete Walkway Slab

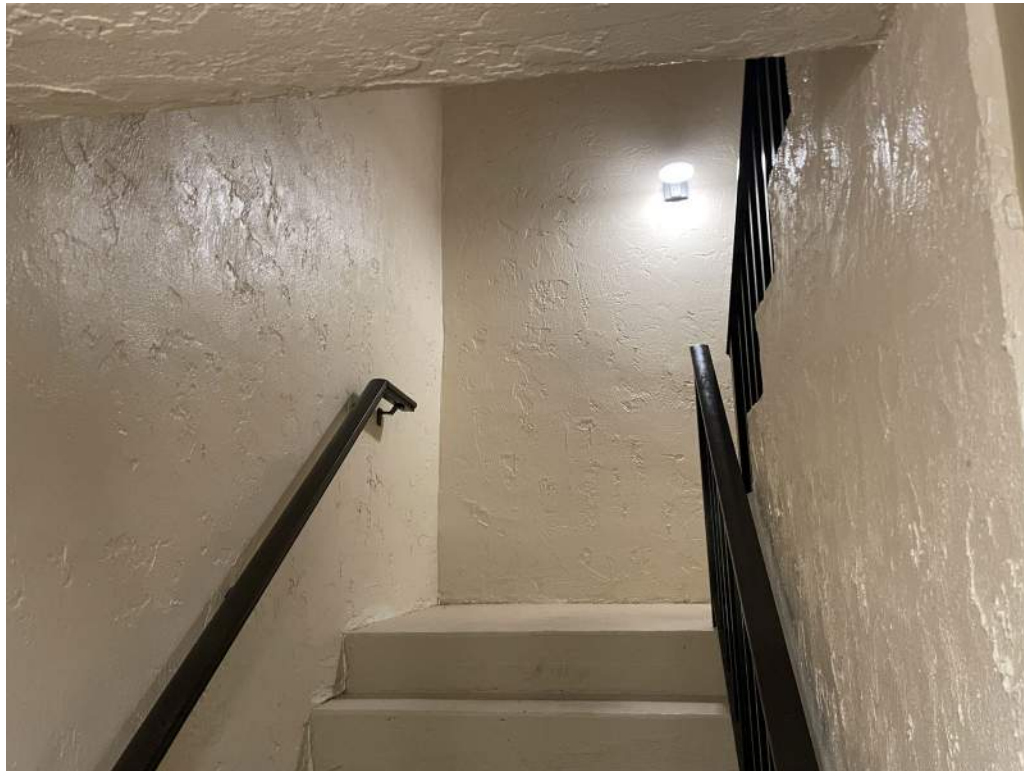
Type: Conventionally reinforced concrete stairwells and landings with standard masonry in-fill walls.

Figure 7: Interior Stairwell
